**Condition Appraisal  
Of  
Listed Buildings at Risk  
In  
Forest of Dean District Council Area  
For Forward Planning**

Survey carried out by Tony Gwynne & Samm Jarman

Survey Date: 2017-2018

Published: July 2019

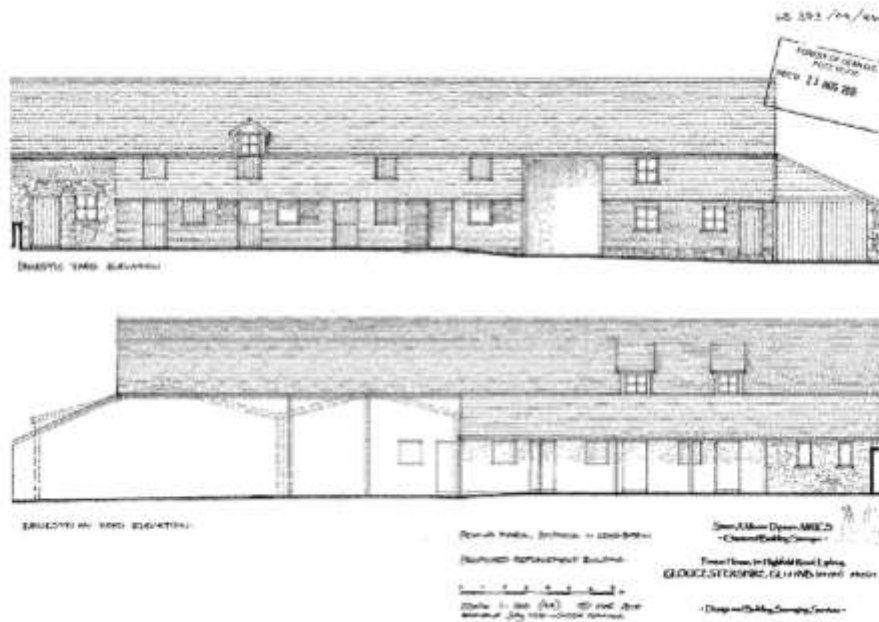
In March 2006 the barn and cow shed condition was reported in the buildings at risk register as worsening and was upgraded from risk category 3 to 1 which is an immediate priority risk. The building part timber framed upper portions upon a brick ground floor continued to decay to a point of no return.

This historic building which was listed in its own right as well as forming part of the curtilage and setting of the Grade II\* farm house was in an advanced stage of structural collapse an application was made for its demolition. Many of the original materials had been removed prior to the current owners occupation.

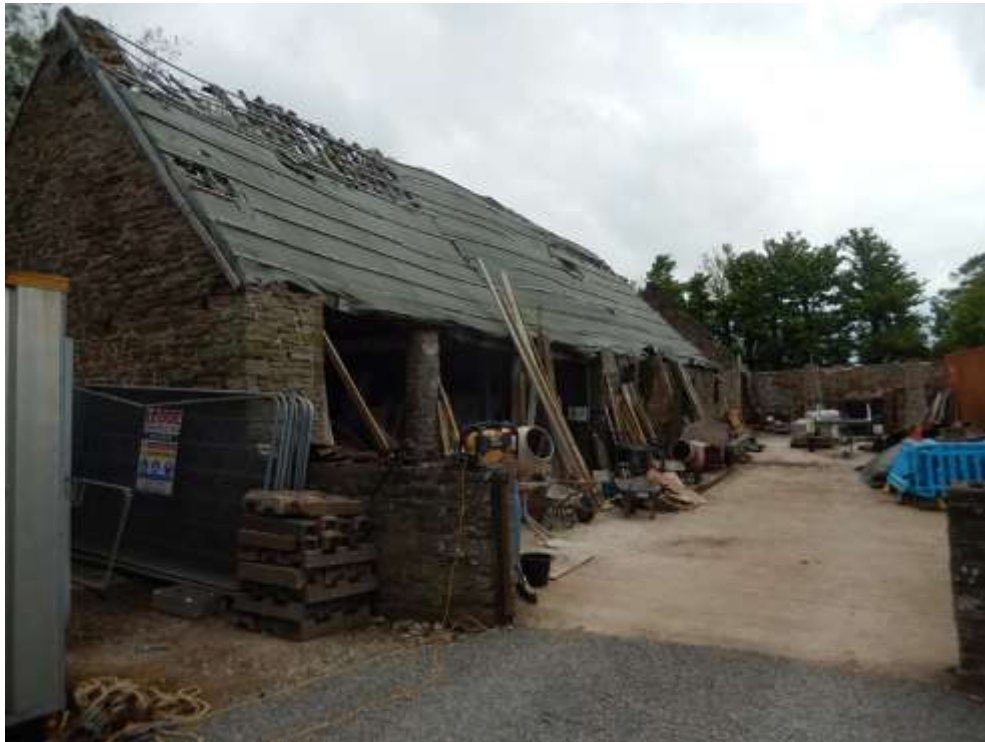
The North Barn has not been maintained and is in a deteriorated condition and requires extensive repairs/replacement of defective roof timbers and re-fixing of sound roof tiles to make the building watertight. The external walls require repairs and localised rebuilding/re-pointing to stabilise the walls to prevent further deterioration of the structure.

1. The owner has already carried out emergency works to prevent further collapse and to stabilise the structure and has confirmed that he intends to carry out urgent repairs/replacement works to make it watertight (possibly re-roofing with profiled metal sheeting- subject to listed building consent) and carry out total renovations within the next five years and any urgent works will be carried out as they become necessary to stabilise the structure and prevent any further decay and loss of the original fabric.
2. This building should remain on the buildings at risk register and the condition of the building should be monitored.

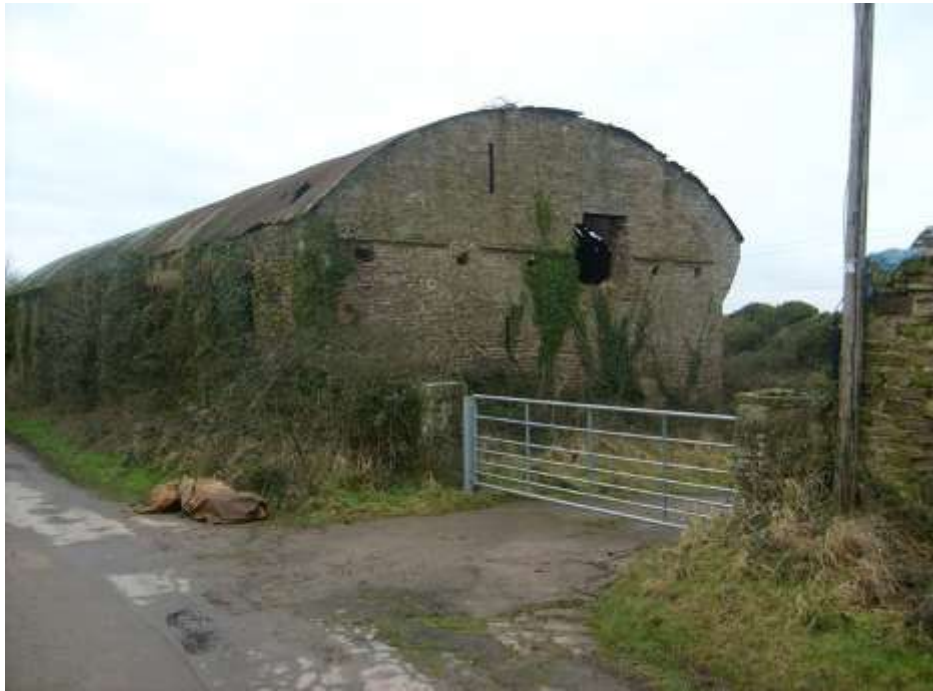
The external walls require repairs and localised rebuilding/re-pointing to stabilise the walls to prevent further deterioration of the structure.

*Pictured 2009 in a dilapidated state*

1. The owner has already replaced the roof and has confirmed that he intends to carry out total renovations within the next five years and any urgent works will be carried out as they become necessary to stabilise the structure and prevent any further decay and loss of the original fabric.
2. This building should remain on the buildings at risk register and the condition of the building should be monitored.

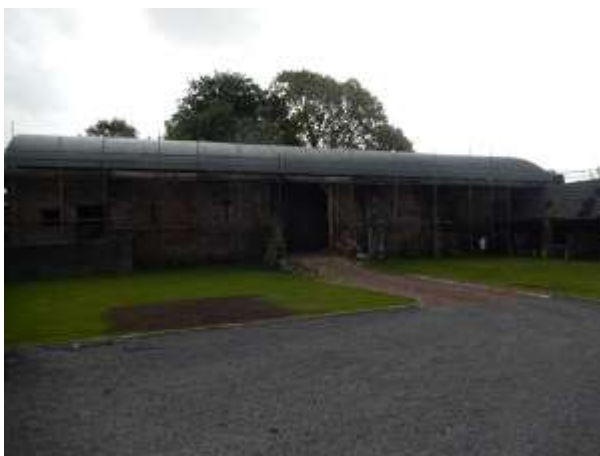
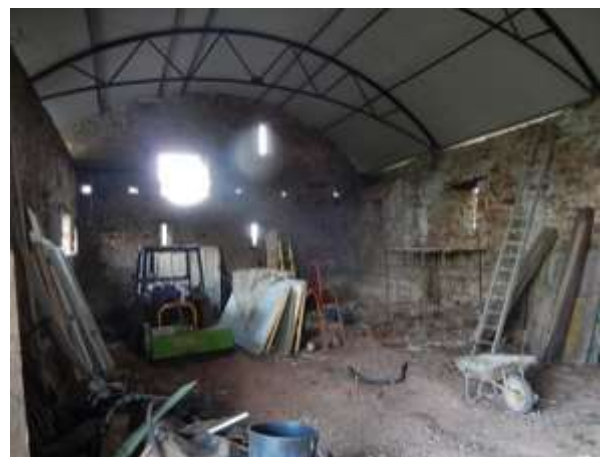
*Pictured 2017, new roof and the building is slowly being renovated.*

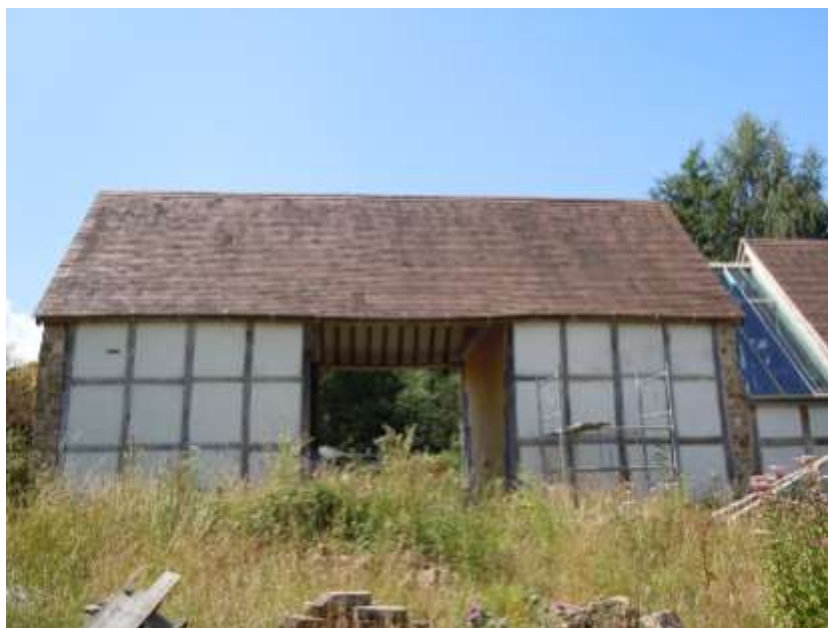
*2017*

The building has been restored in its entirety. The building is no longer considered to be at risk.

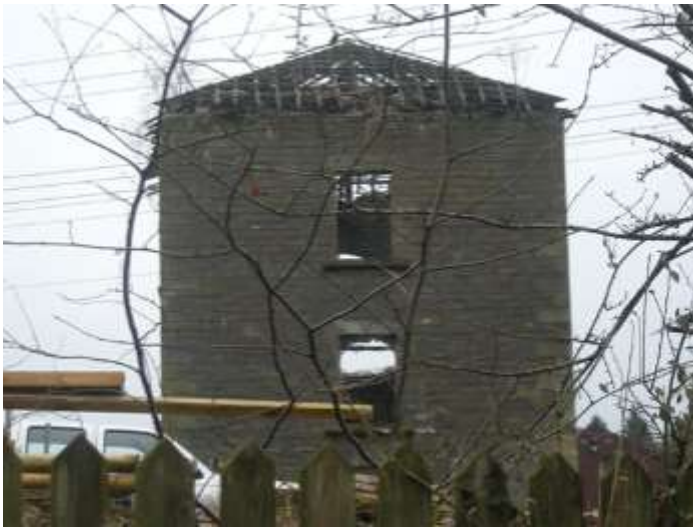
*2011 the Pumphouse has the remains of its roof.*

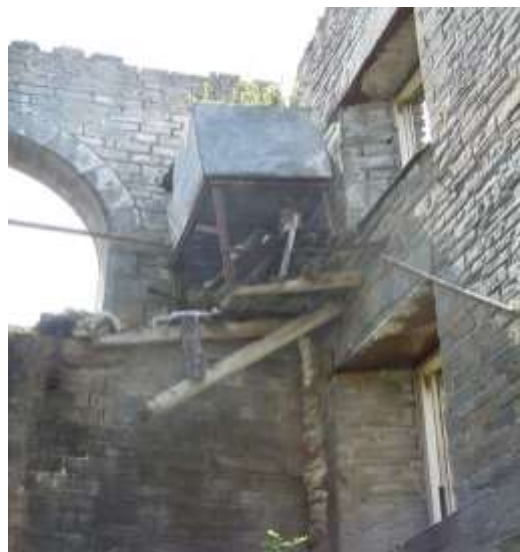
*2017 the Pumphouse is only a shell, all the floors are gone, roof structure and the masonry is very loose in various areas. This building is at high risk of collapse.*

In March 2006 the building was in risk category 1 and 2 and was in poor condition and at extreme risk of further deterioration. Since then it is apparent that there has been no maintenance and the roof has totally collapsed into the building.

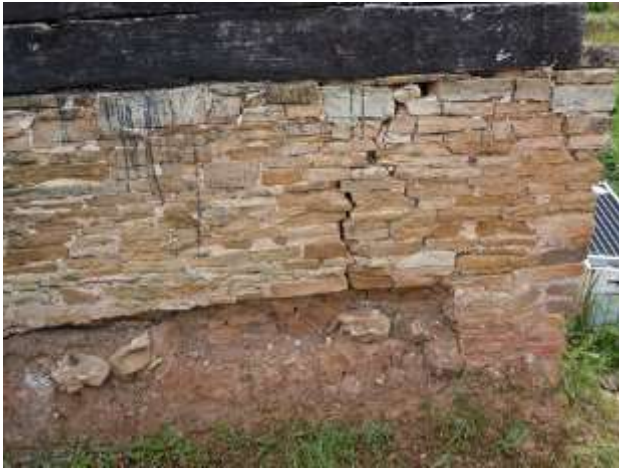
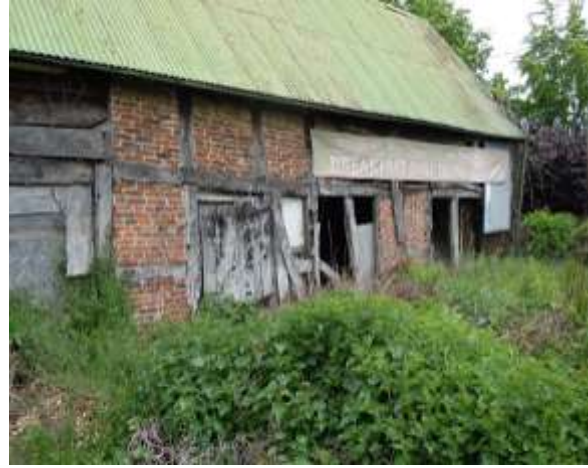
Urgent works are required to stabilise the building and make it weather proof.

The building is in danger of collapse, water penetration, external timbers rotten and damaged brickwork.

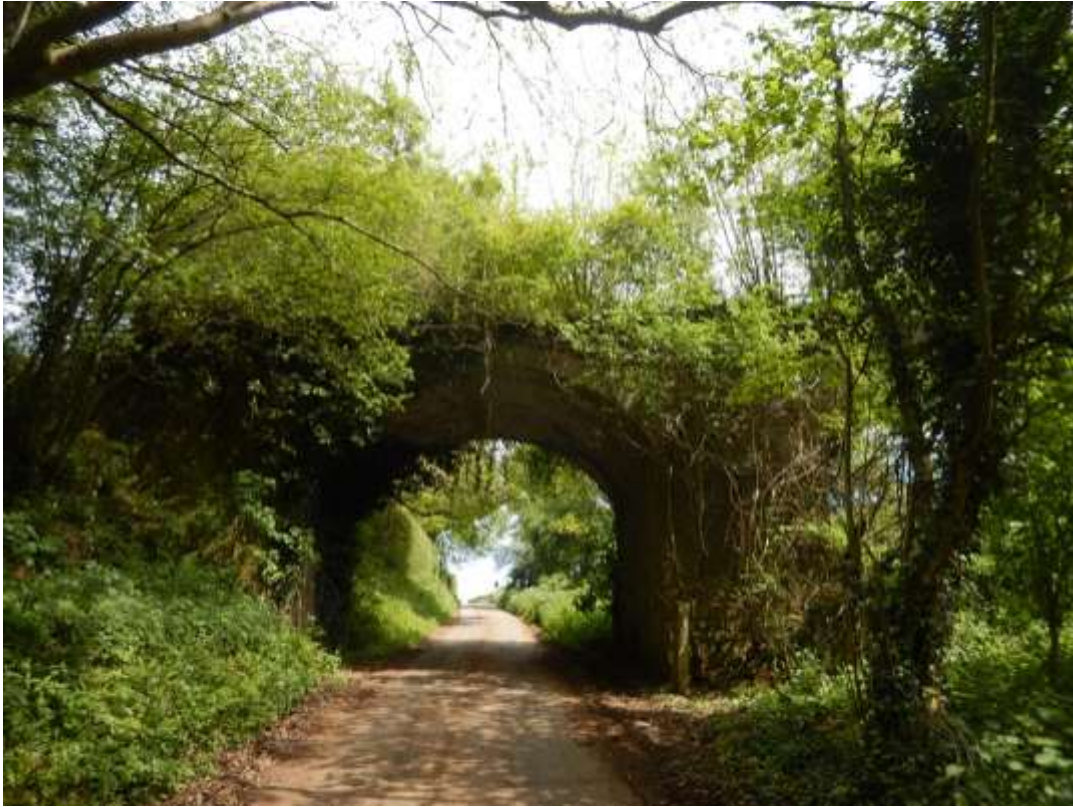
2017

The structure is becoming a potentially dangerous structure to the general public who use the main road below.

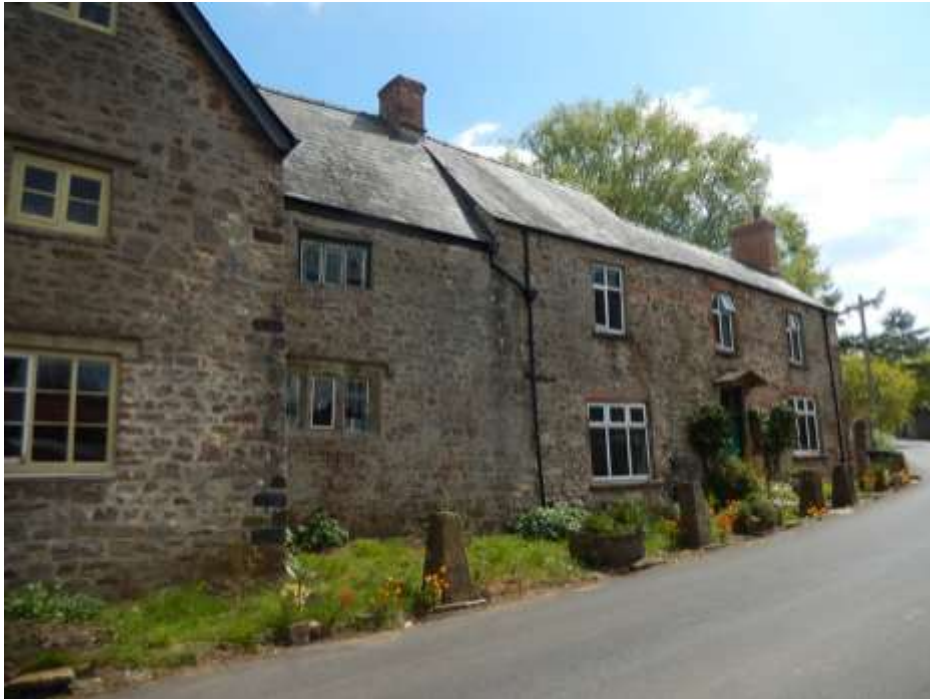
2017

- Ingress of water into the building through a lack of maintenance and defective roof coverings etc over the past decades has caused extensive water damage to the interior and the decay of roof and floor timbers which have partially collapsed in areas.
- The roof structure, slate roof coverings and windows are being repaired and the building is now water tight.
- The work is being inspected by building control and I can confirm that repairs have also been carried out to the first and second floors, chimneys and stone walls and repair / renovation works are still in progress.

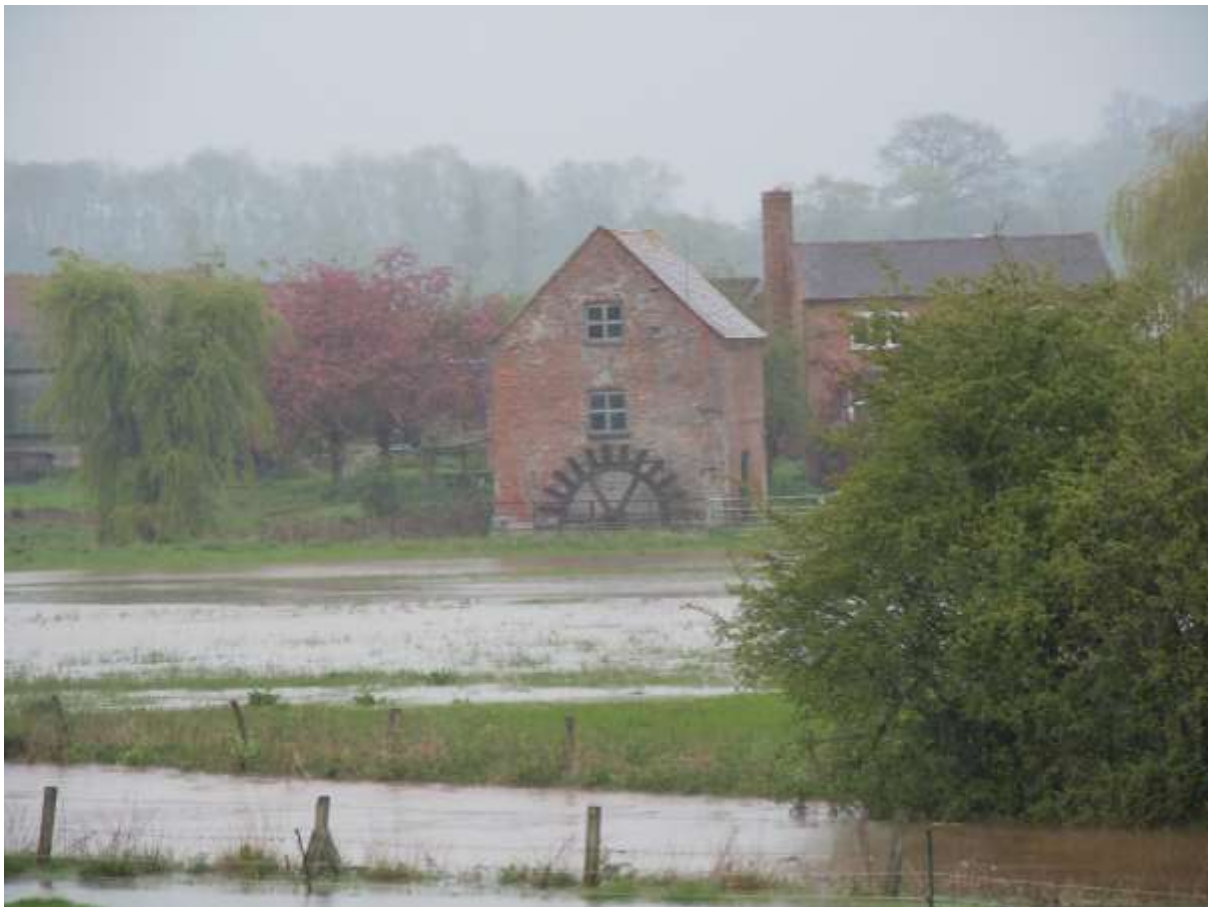
This building appears to be in good condition and should be taken off the buildings at risk register.

*Flooding in August 2012*

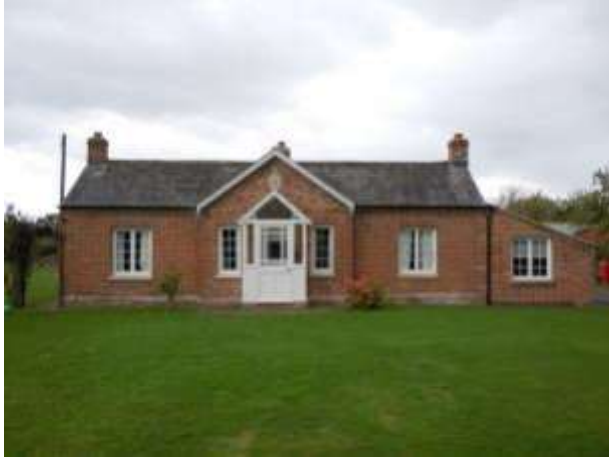
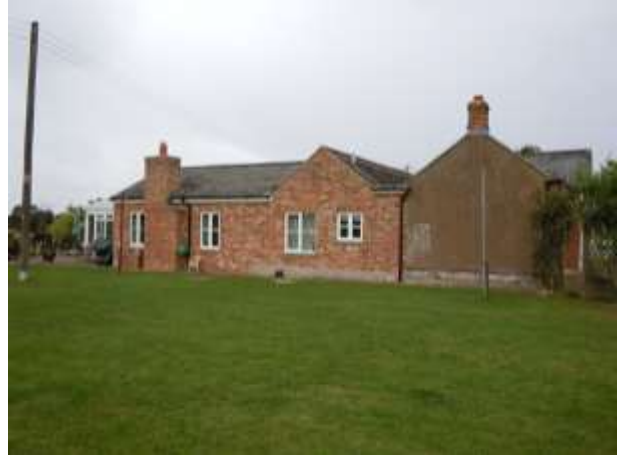
Long Course was inspected on 11th September 2017 and it was obvious that the building has been subject to extensive repair works since the last inspection in 2006 and is now in a good state of repair. The owners were out at the time of the inspection and there was no access internally.

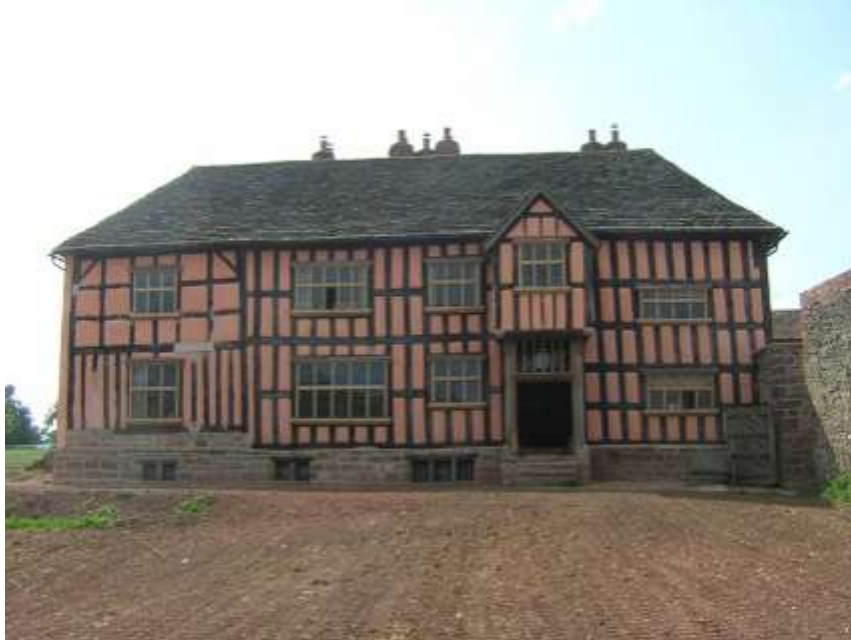
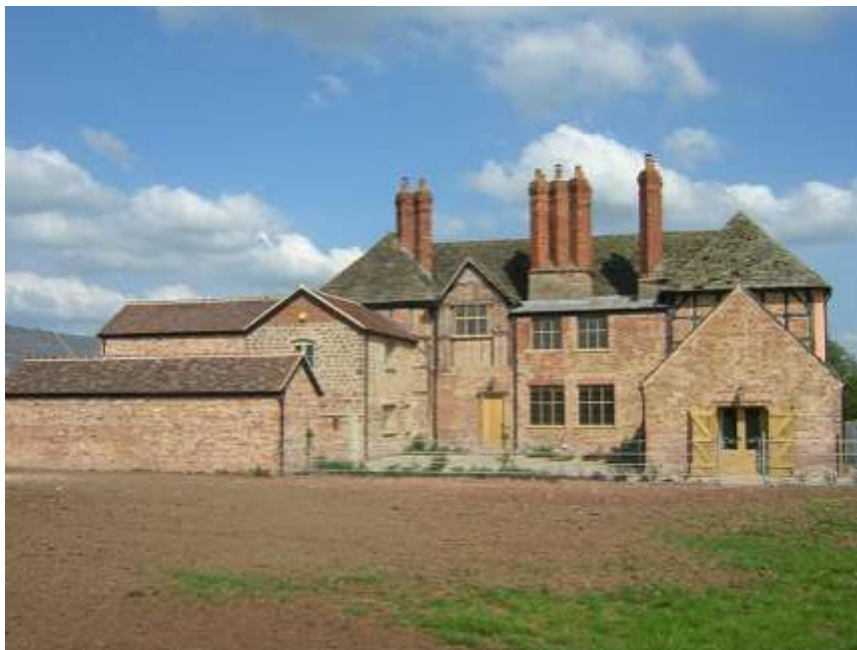
2017

**Farm House-** The building was completely repaired and restored in 2012 to a very high standard and is a credit to the owners, who used an agent and builders who were experienced in carrying out works to listed buildings.

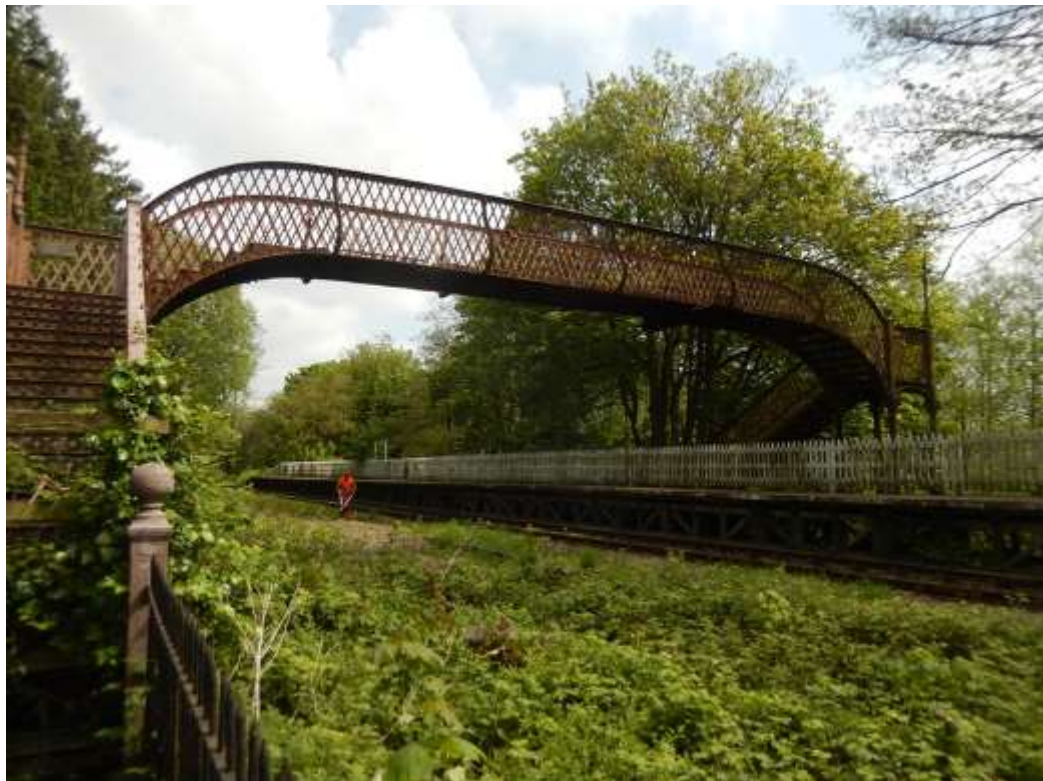
2017

In March 2006, the foot bridge was recorded as a risk category 4 and required a thorough maintenance programme, including structural strengthening, rust removal and repainting. The condition deteriorated and Forest of Dean Building Control served a dangerous structures notice as the bridge was reported to be unsafe, and it was cordoned off with danger keep out signs to prevent any access - which were still in place at the time of the initial inspection.

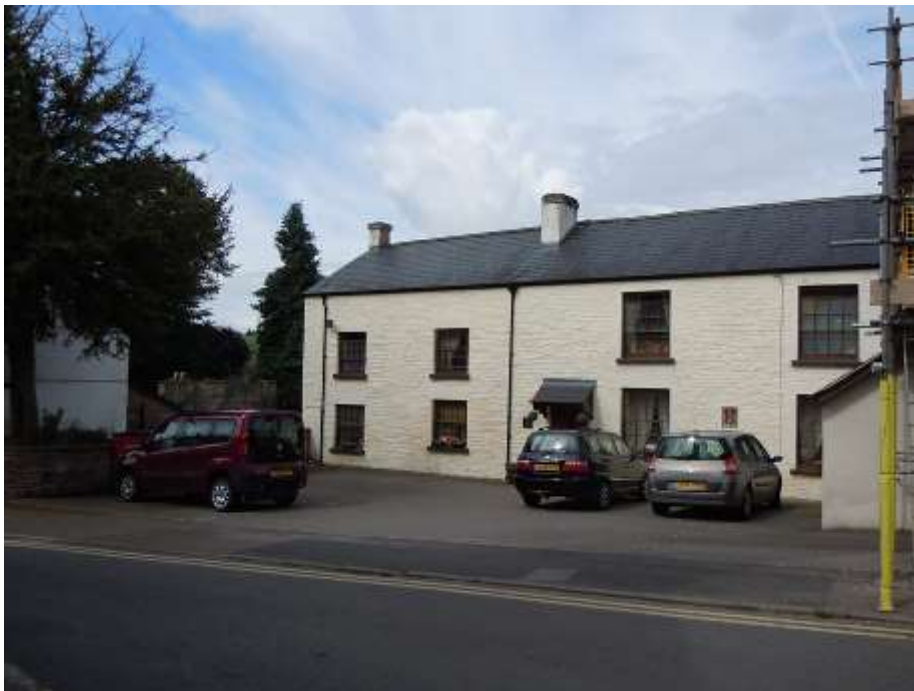
2017

Since then the building has been brought back into a good condition and is now occupied.
