## Technical Appendix B-

### Roost recreational disturbance early warning monitoring scheme

**Annex 1 – Northern United roosts external baseline conditions October 2015.**

## Annex 2 Disturbance monitoring and baseline

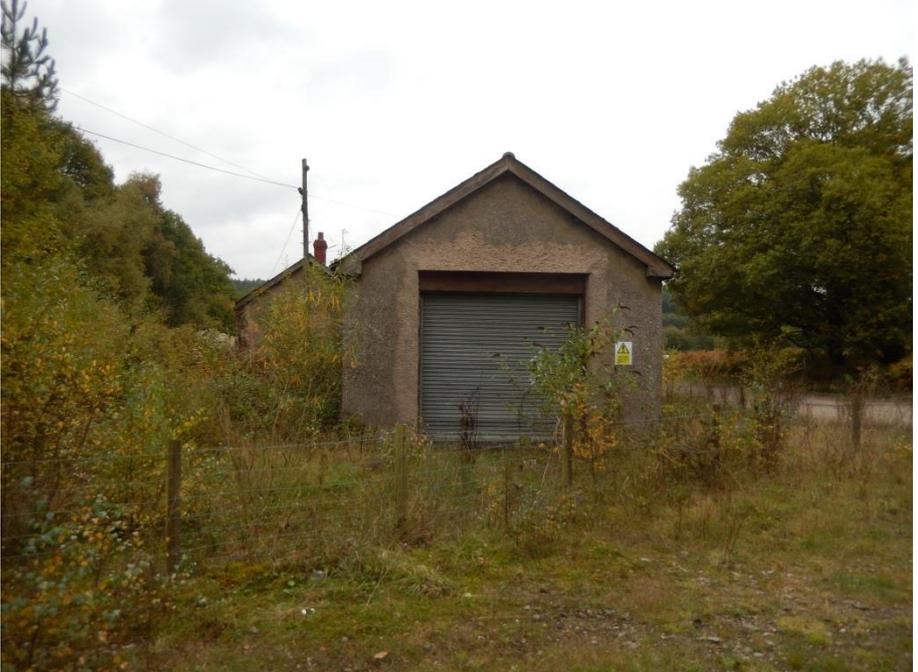
<p>Northern United Office building photographic baseline October 2015</p>	
<p>North elevation</p>

6.2.1. Both the Bath House and Office building are redundant and dilapidated. Year on year the condition of the buildings continues to decline as a result of weathering processes. Annex 1 records the current external conditions. Monitoring aims to identify human based disturbance rather than record the natural deterioration of the building as a result of weathering and successional vegetation growth.

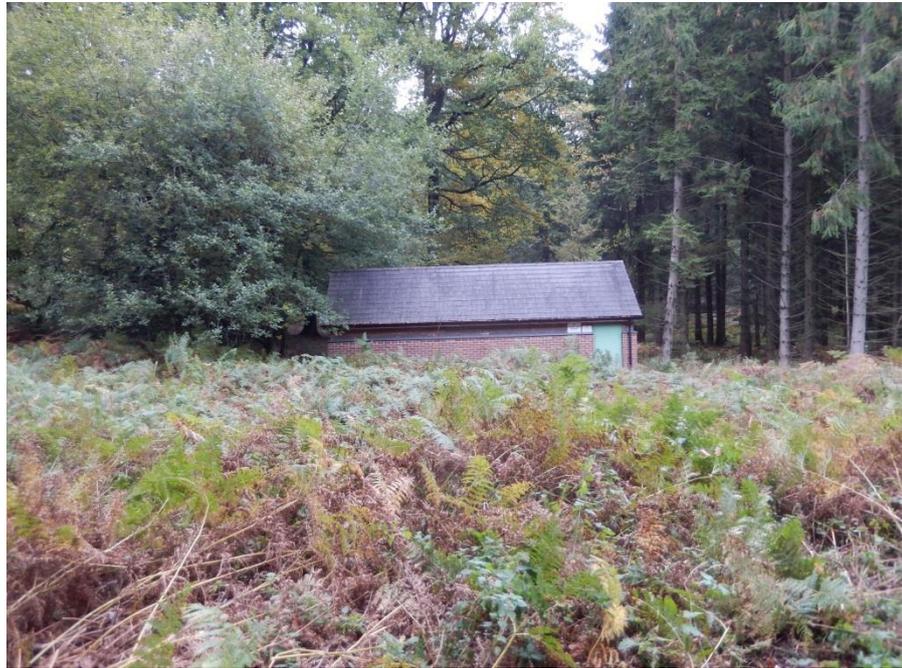
Fix point camera location A  
Description: 20m to the south of the long southern elevation of the roost  
Photo Direction: 00 degrees (North)  
Height above ground: 1.5m  
Camera details: f/3.4, Focal Length 4mm, Max aperture 3.3, 35mm focal length 25.

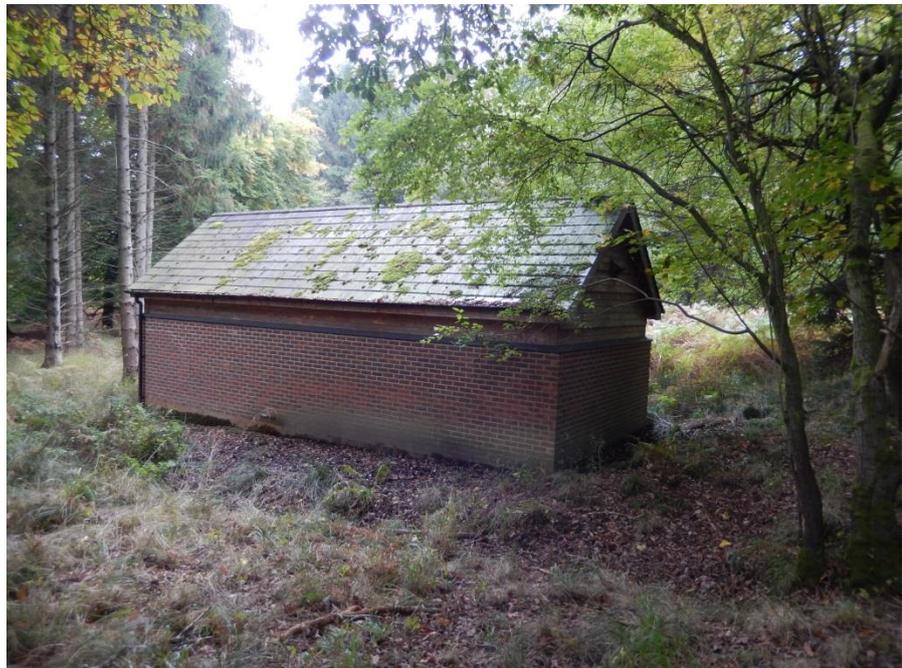
Fix point camera location B  
Description: 10m from NW roost corner  
Photo Direction: 190 degrees  
Height above ground: 1.5m  
Camera details: f/3.4, Focal Length 4mm, Max aperture 3.3, 35mm focal length 25.

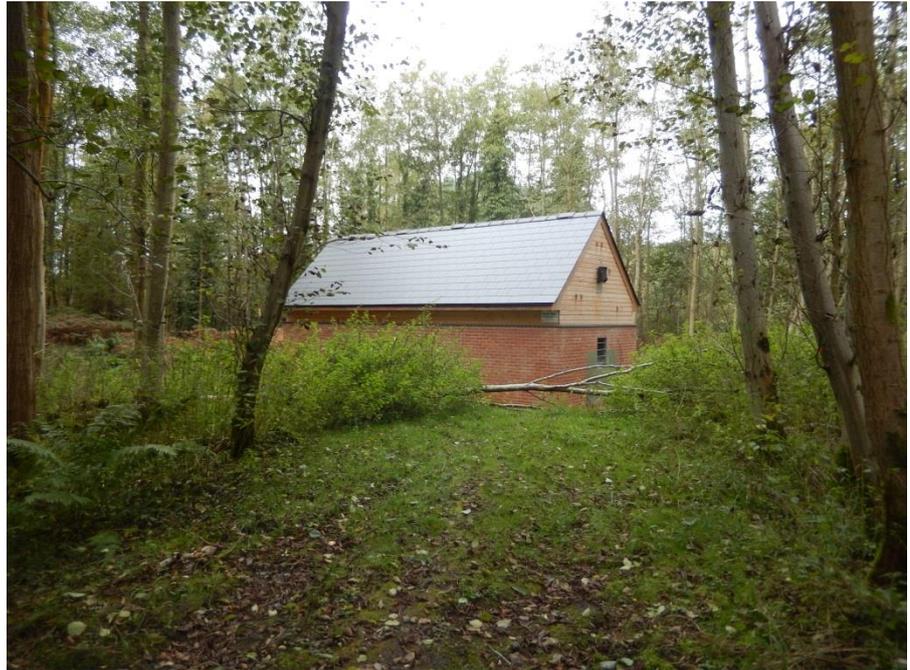
Fix point camera  
location A

Description: 15m from  
the SE corner of the  
roost

Photo Direction: 320  
degrees

Height above ground:  
1.5m

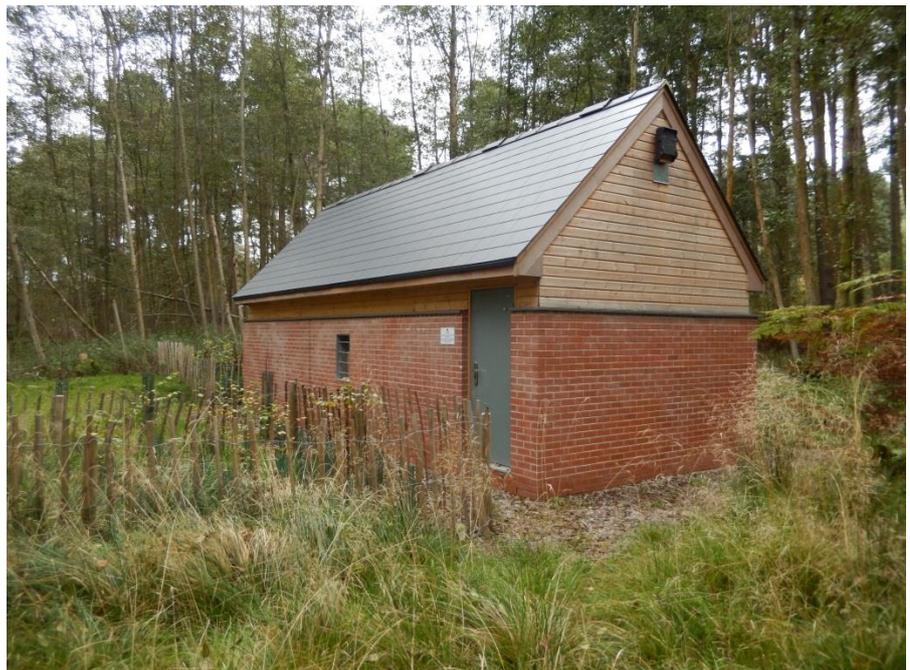
Fix point camera  
location B

Description: 8m from  
NW roost corner

Photo Direction: 130  
degrees

Height above ground:  
1.5m

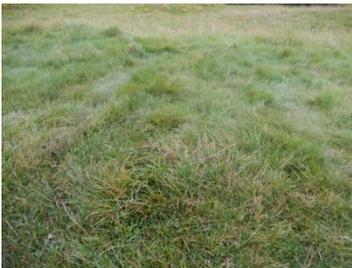
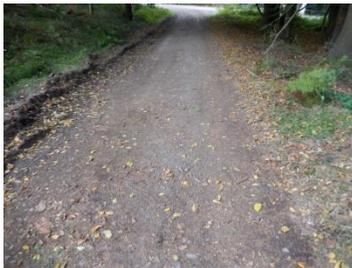
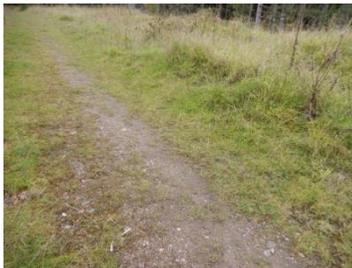
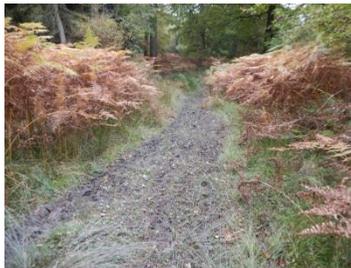
Examples

Recreational path assessment key				
Open	Forest road	Well used route way	Open path	Vegetated path
Limited scrub or woody vegetation. Short grassland allowing open dispersed access	Forestry service road of loose bound surfacing. On average in excess of 3m wide.	Well used route way of on average 1-3m wide at ground	Narrower walkway of around 1m in width (average) at ground. Possible to walk route without longer stretches (3m+) of overhanging vegetation	Small route way of less than 1m in width (average) at ground. Substantial sections of overhanging vegetation. Wet vegetation would make the user very wet.
