Building a new Lesser Horseshoe Bat Roost

Case Study - *How we did it*

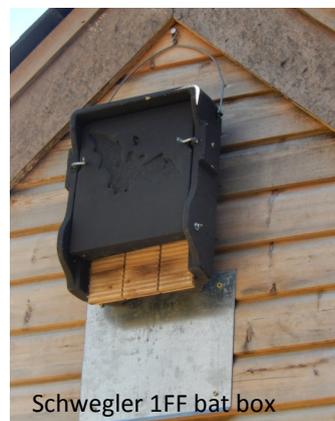
Schwegler 1FF bat box

In August 2015 there was evidence (scattering of 'bat poo', which was DNA tested) of Lesser Horseshoe bats using the larger roost. The external Schwegler boxes became used by Pipistrelle bats also in the first season. Monitoring continues and we shall provide updates on progress.
