# **Cinderford Northern Quarter, Forest of Dean Great Crested Newt Monitoring Survey**

**Forest of Dean District Council**

**July 2018**

**Report Ref:** 10856

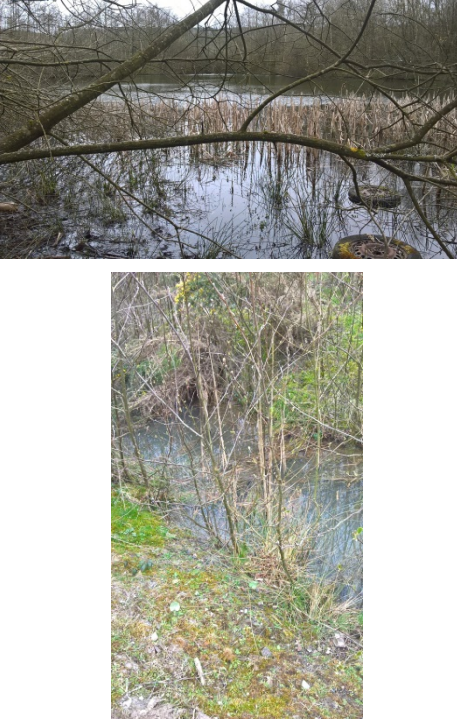
Location	1	<p>Total HSI Score: 0.49</p> <p>Poor suitability with fair pond condition</p>

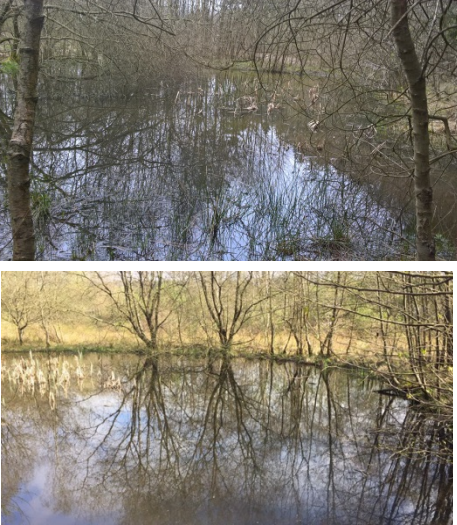
Location	1	<p>Total HSI Score: 0.71</p> <p>Good suitability with good pond condition</p>
			Pond area	0.4	
			Pond drying	0.9

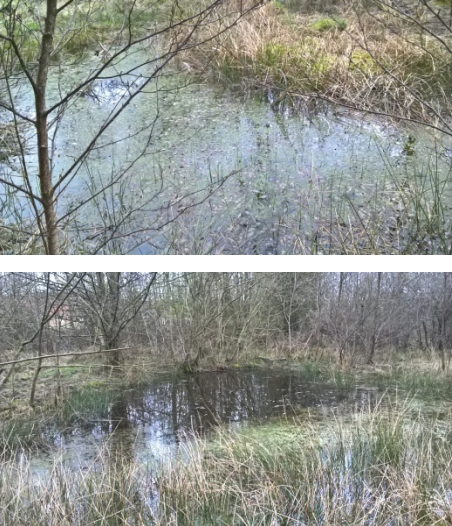
Location	1	<p>Total HSI Score: 0.75</p> <p>Good suitability with good pond condition</p>

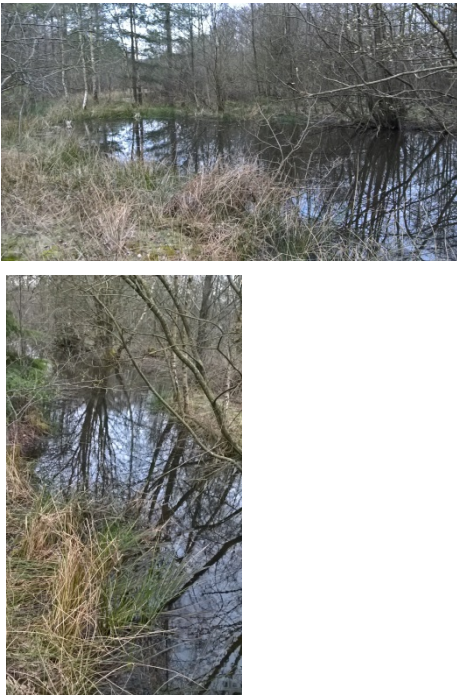
Location	1	<p>Total HSI Score: 0.68</p> <p>Average suitability with good pond condition</p>
			Pond area	0.3	
			Pond drying	0.9	
			Water quality	1	
			Shade	0.6	
			Fowl	1	
			Fish	0.33	
			Pond count	1	
			Terrestrial habitat	1	
			Macrophytes	0.4

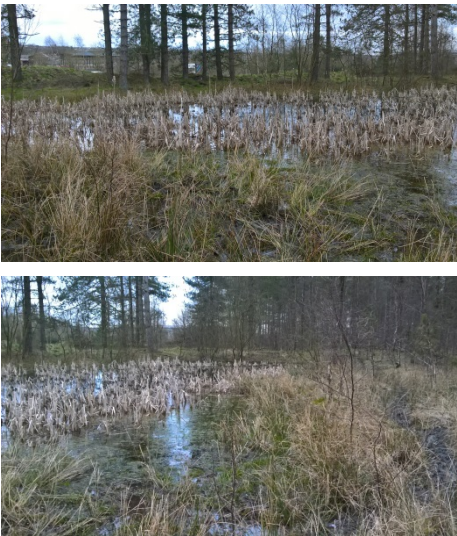
Location	1	<p>Total HSI Score: 0.95</p> <p>Excellent suitability with good pond condition</p>
			Pond area	0.9	
			Pond drying	1	
			Water quality	1	
			Shade	0.7	
			Fowl	1	
			Fish	1	
			Pond count	1	
			Terrestrial habitat	1

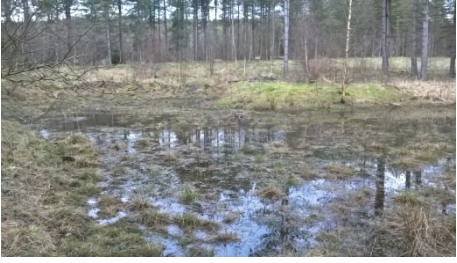
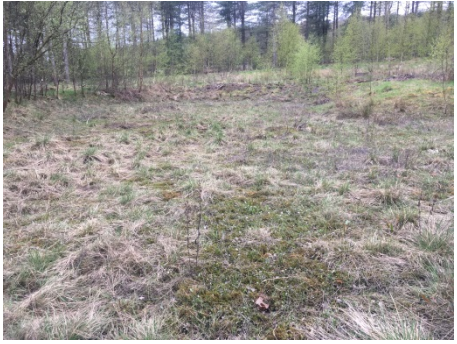
<p>After pond dried up:</p>

<table border="1"> <tr><td>Location</td><td>1</td></tr> <tr><td>Pond area</td><td>0.2</td></tr> <tr><td>Pond drying</td><td>0.1</td></tr> <tr><td>Water quality</td><td>0.67</td></tr> <tr><td>Shade</td><td>1</td></tr> <tr><td>Fowl</td><td>1</td></tr> <tr><td>Fish</td><td>1</td></tr> <tr><td>Pond count</td><td>1</td></tr> <tr><td>Terrestrial habitat</td><td>1</td></tr> <tr><td>Macrophytes</td><td>1</td></tr> <tr><td>Invasive species</td><td>Absent</td></tr> <tr><td>Major damage</td><td>Absent</td></tr> <tr><td>Silt levels</td><td>Moderate</td></tr> <tr><td>Dumped rubbish</td><td>Absent</td></tr> </table>	Location	1	Pond area	0.2	Pond drying	0.1	Water quality	0.67	Shade	1	Fowl	1	Fish	1	Pond count	1	Terrestrial habitat	1	Macrophytes	1	Invasive species	Absent	Major damage	Absent	Silt levels	Moderate	Dumped rubbish	Absent	<p>When water was present –</p> <p>Total HSI Score: 0.65</p> <p>Average suitability with good pond condition</p>

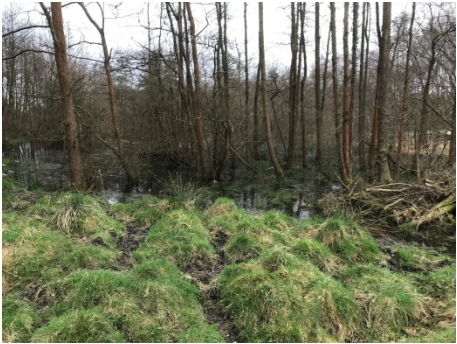
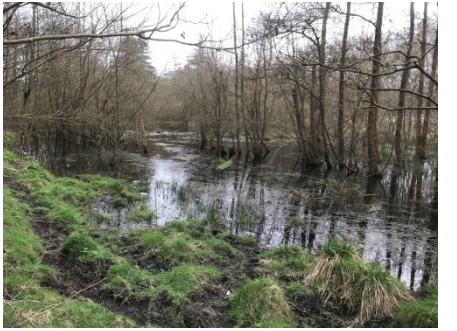
<table border="1"> <tr><td>Location</td><td>1</td></tr> <tr><td>Pond area</td><td>0.97</td></tr> <tr><td>Pond drying</td><td>0.5</td></tr> <tr><td>Water quality</td><td>1</td></tr> <tr><td>Shade</td><td>1</td></tr> <tr><td>Fowl</td><td>0.67</td></tr> <tr><td>Fish</td><td>1</td></tr> <tr><td>Pond count</td><td>1</td></tr> <tr><td>Terrestrial habitat</td><td>1</td></tr> <tr><td>Macrophytes</td><td>1</td></tr> <tr><td>Invasive species</td><td>Absent</td></tr> <tr><td>Major damage</td><td>Absent</td></tr> <tr><td>Silt levels</td><td>Low</td></tr> <tr><td>Dumped rubbish</td><td>Absent</td></tr> </table>	Location	1	Pond area	0.97	Pond drying	0.5	Water quality	1	Shade	1	Fowl	0.67	Fish	1	Pond count	1	Terrestrial habitat	1	Macrophytes	1	Invasive species	Absent	Major damage	Absent	Silt levels	Low	Dumped rubbish	Absent	<p>Total HSI Score: 0.89</p> <p>Excellent suitability with excellent pond condition</p>

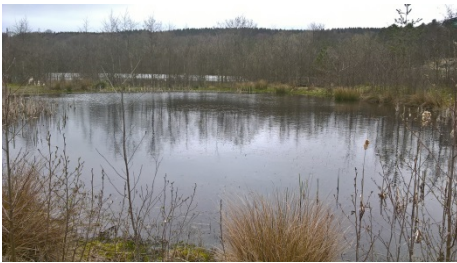
<table border="1"> <tr><td>Location</td><td>1</td></tr> <tr><td>Pond area</td><td>0.94</td></tr> <tr><td>Pond drying</td><td>0.9</td></tr> <tr><td>Water quality</td><td>1</td></tr> <tr><td>Shade</td><td>1</td></tr> <tr><td>Fowl</td><td>0.67</td></tr> <tr><td>Fish</td><td>0.67</td></tr> <tr><td>Pond count</td><td>1</td></tr> <tr><td>Terrestrial habitat</td><td>0.67</td></tr> <tr><td>Macrophytes</td><td>0.7</td></tr> <tr><td>Invasive species</td><td>Absent</td></tr> <tr><td>Major damage</td><td>Absent</td></tr> <tr><td>Silt levels</td><td>Low</td></tr> <tr><td>Dumped rubbish</td><td>Absent</td></tr> </table>	Location	1	Pond area	0.94	Pond drying	0.9	Water quality	1	Shade	1	Fowl	0.67	Fish	0.67	Pond count	1	Terrestrial habitat	0.67	Macrophytes	0.7	Invasive species	Absent	Major damage	Absent	Silt levels	Low	Dumped rubbish	Absent	<p>Total HSI Score: 0.84</p> <p>Excellent suitability with excellent pond condition</p>

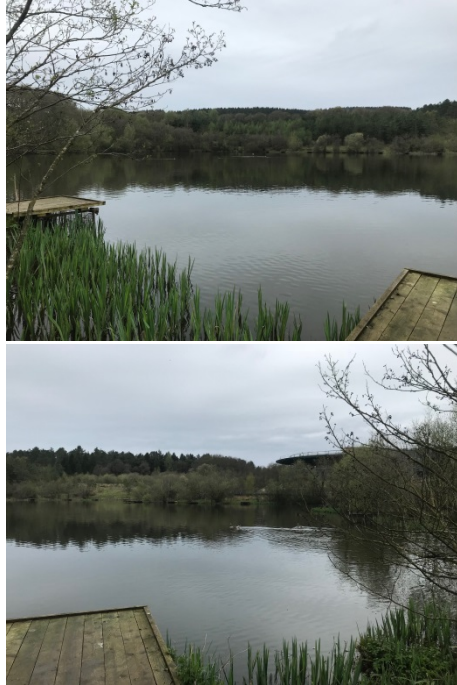
<table border="1"> <tr><td>Location</td><td>1</td></tr> <tr><td>Pond area</td><td>0.8</td></tr> <tr><td>Pond drying</td><td>0.9</td></tr> <tr><td>Water quality</td><td>1</td></tr> <tr><td>Shade</td><td>1</td></tr> <tr><td>Fowl</td><td>0.01</td></tr> <tr><td>Fish</td><td>0.01</td></tr> <tr><td>Pond count</td><td>1</td></tr> <tr><td>Terrestrial habitat</td><td>0.67</td></tr> <tr><td>Macrophytes</td><td>0.35</td></tr> <tr><td>Invasive species</td><td>Absent</td></tr> <tr><td>Major damage</td><td>Absent</td></tr> <tr><td>Silt levels</td><td>Moderate</td></tr> <tr><td>Dumped rubbish</td><td>Absent</td></tr> </table>	Location	1	Pond area	0.8	Pond drying	0.9	Water quality	1	Shade	1	Fowl	0.01	Fish	0.01	Pond count	1	Terrestrial habitat	0.67	Macrophytes	0.35	Invasive species	Absent	Major damage	Absent	Silt levels	Moderate	Dumped rubbish	Absent	<p>Unsuitable for great crested newts – Fishing pond</p> <p>Total HSI Score: 0.33</p> <p>Poor suitability with good pond condition</p>

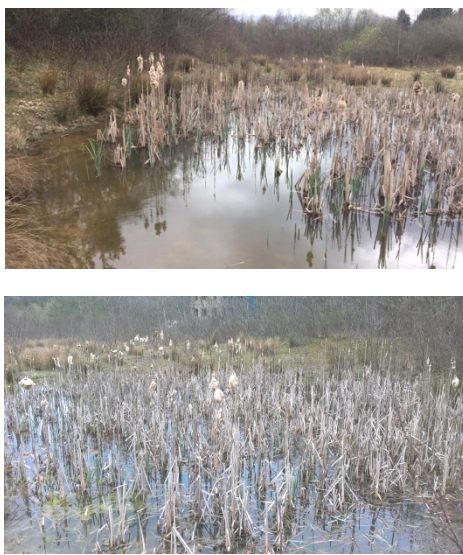
Location	1	<p>Total HSI Score: 0.68</p> <p>Average suitability with good pond condition</p>

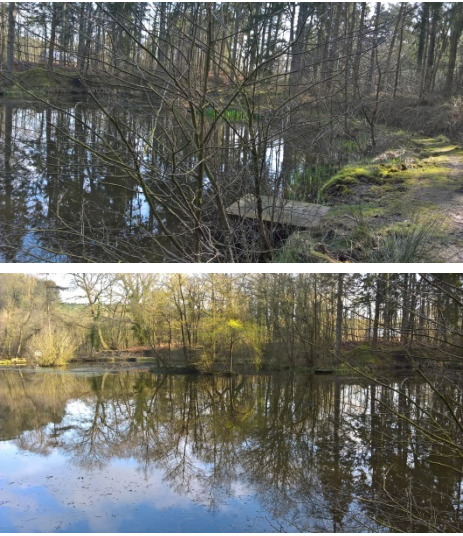
Location	1	<p>Unsuitable for great crested newts – Fishing pond</p> <p>Total HSI Score: 0.35</p> <p>Poor suitability With good pond condition</p>

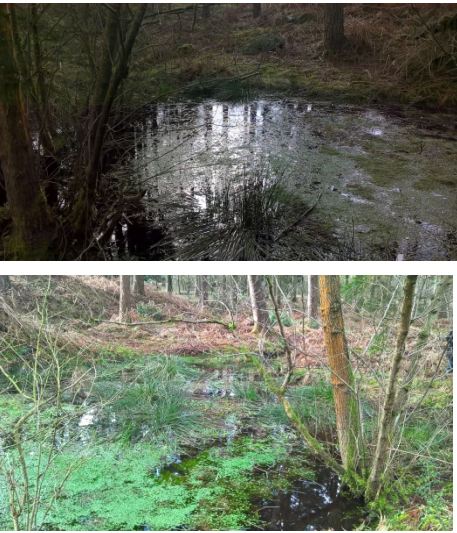
Location	1	<p>Total HSI Score: 0.66</p> <p>Average suitability with excellent pond condition</p>
			Pond area	0.05	
			Pond drying	0.5	
			Water quality	0.67

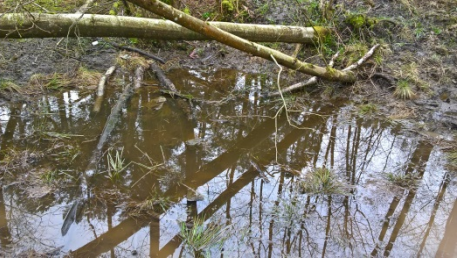
Location	1	<p>Total HSI Score: 0.56</p> <p>Below average suitability With poor pond condition</p>
			Pond area	0.05	
			Pond drying	0.5	
			Water quality	0.33	
			Shade	0.7	
			Fowl	1	
			Fish	1	
			Pond count	1	
			Terrestrial habitat	1	
			Macrophytes	0.5	
			Invasive species	Absent	
			Major damage	Present – Trampled banks, silting up water	
			Silt levels	Moderate	
Dumped rubbish	Present – plastic bags, plant pots

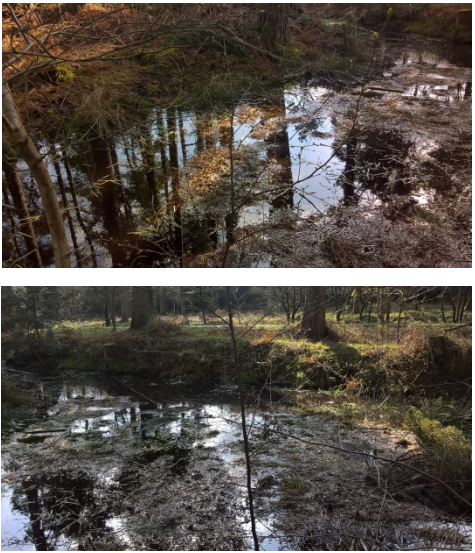
Location	1	<p>Total HSI Score: 0.81</p> <p>Excellent suitability with fair pond condition</p>
			Pond area	0.4	
			Pond drying	0.5	
			Water quality	0.67	
			Shade	1	
			Fowl	1	
			Fish	1	
			Pond count	1	
			Terrestrial habitat	1	
			Macrophytes	0.95	
			Invasive species	Absent	
			Major damage	Absent

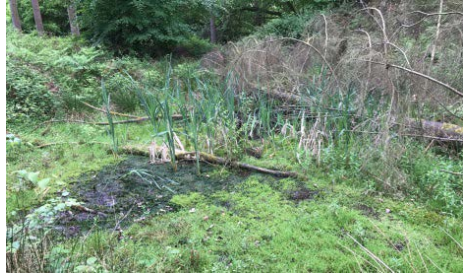
Location	1	<p>Total HSI Score: 0.80</p> <p>Excellent suitability with good pond condition</p>
			Pond area	0.4	
			Pond drying	0.5	
			Water quality	0.67	
			Shade	1

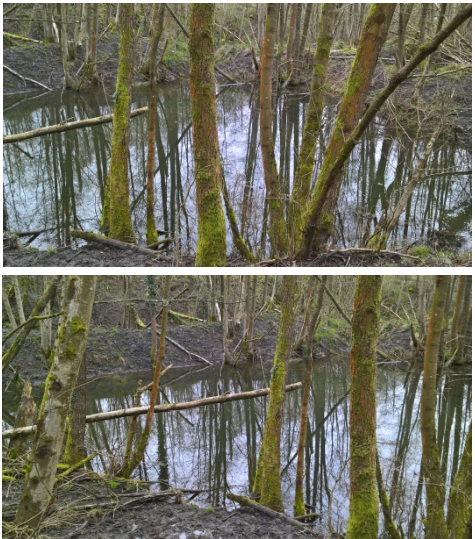
Location	1	<p>Total HSI Score: 0.75</p> <p>Good suitability with good pond condition</p>
			Pond area	0.6	
			Pond drying	0.9	
			Water quality	0.67	
			Shade	0.6	
			Fowl	0.67	
			Fish	1	
			Pond count	1	
			Terrestrial habitat	1	
			Macrophytes	0.4	
			Invasive species	Absent	
			Major damage	Absent	
			Silt levels	Moderate	
			Dumped rubbish	Absent

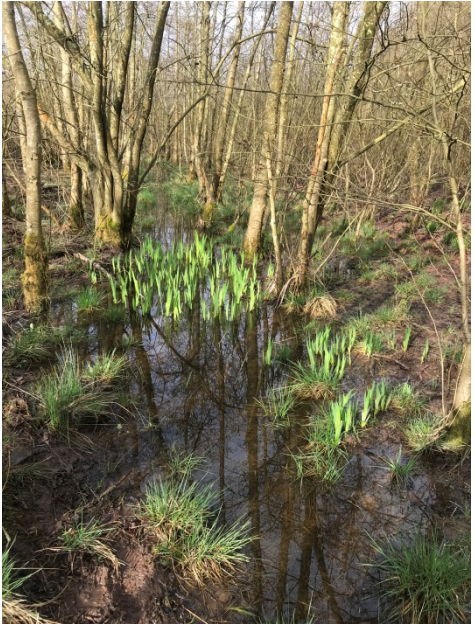
Location	1	<p>Unsuitable for great crested newts – Running stream</p> <p>Total HSI Score: 0.58</p> <p>Below average suitability with excellent pond condition</p>

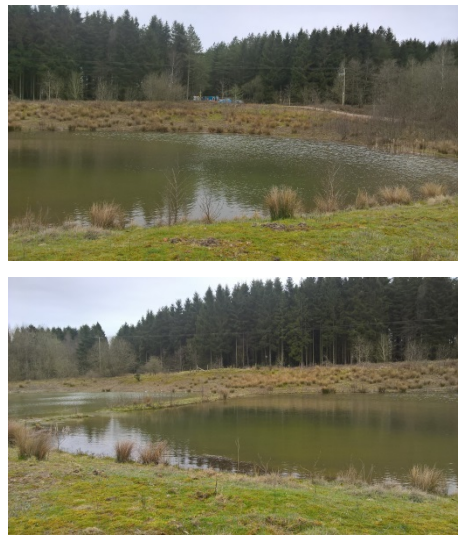
<table border="1"> <tr><td>Location</td><td>1</td></tr> <tr><td>Pond area</td><td>0.97</td></tr> <tr><td>Pond drying</td><td>0.9</td></tr> <tr><td>Water quality</td><td>0.33</td></tr> <tr><td>Shade</td><td>1</td></tr> <tr><td>Fowl</td><td>0.67</td></tr> <tr><td>Fish</td><td>0.33</td></tr> <tr><td>Pond count</td><td>1</td></tr> <tr><td>Terrestrial habitat</td><td>0.33</td></tr> <tr><td>Macrophytes</td><td>0.35</td></tr> <tr><td>Invasive species</td><td>Absent</td></tr> <tr><td>Major damage</td><td>Absent</td></tr> <tr><td>Silt levels</td><td>Moderate</td></tr> <tr><td>Dumped rubbish</td><td>Present - general litter</td></tr> </table>	Location	1	Pond area	0.97	Pond drying	0.9	Water quality	0.33	Shade	1	Fowl	0.67	Fish	0.33	Pond count	1	Terrestrial habitat	0.33	Macrophytes	0.35	Invasive species	Absent	Major damage	Absent	Silt levels	Moderate	Dumped rubbish	Present - general litter	<p>Total HSI Score: 0.61</p> <p>Average suitability with fair pond condition</p>

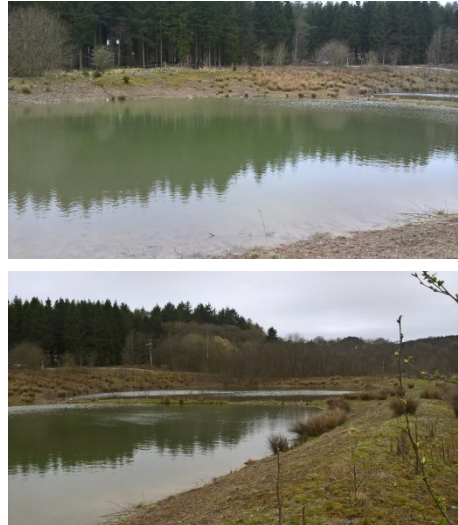
<table border="1"> <tr><td>Location</td><td>1</td></tr> <tr><td>Pond area</td><td>0.97</td></tr> <tr><td>Pond drying</td><td>0.9</td></tr> <tr><td>Water quality</td><td>0.33</td></tr> <tr><td>Shade</td><td>1</td></tr> <tr><td>Fowl</td><td>0.67</td></tr> <tr><td>Fish</td><td>0.33</td></tr> <tr><td>Pond count</td><td>1</td></tr> <tr><td>Terrestrial habitat</td><td>0.33</td></tr> <tr><td>Macrophytes</td><td>0.35</td></tr> <tr><td>Invasive species</td><td>Absent</td></tr> <tr><td>Major damage</td><td>Absent</td></tr> <tr><td>Silt levels</td><td>Moderate</td></tr> <tr><td>Dumped rubbish</td><td>Present – general litter</td></tr> </table>	Location	1	Pond area	0.97	Pond drying	0.9	Water quality	0.33	Shade	1	Fowl	0.67	Fish	0.33	Pond count	1	Terrestrial habitat	0.33	Macrophytes	0.35	Invasive species	Absent	Major damage	Absent	Silt levels	Moderate	Dumped rubbish	Present – general litter	<p>Total HSI Score: 0.61</p> <p>Average suitability with fair pond condition</p>

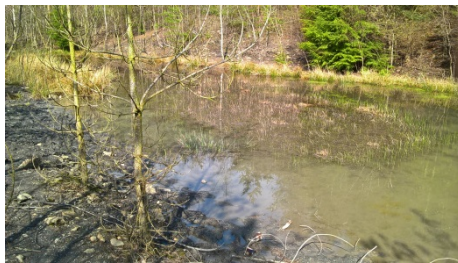
<table border="1"> <tr><td>Location</td><td>1</td></tr> <tr><td>Pond area</td><td>1</td></tr> <tr><td>Pond drying</td><td>1</td></tr> <tr><td>Water quality</td><td>0.67</td></tr> <tr><td>Shade</td><td>1</td></tr> <tr><td>Fowl</td><td>1</td></tr> <tr><td>Fish</td><td>1</td></tr> <tr><td>Pond count</td><td>1</td></tr> <tr><td>Terrestrial habitat</td><td>0.67</td></tr> <tr><td>Macrophytes</td><td>0.7</td></tr> <tr><td>Invasive species</td><td>Absent</td></tr> <tr><td>Major damage</td><td>Absent</td></tr> <tr><td>Silt levels</td><td>Moderate</td></tr> <tr><td>Dumped rubbish</td><td>Absent</td></tr> </table>	Location	1	Pond area	1	Pond drying	1	Water quality	0.67	Shade	1	Fowl	1	Fish	1	Pond count	1	Terrestrial habitat	0.67	Macrophytes	0.7	Invasive species	Absent	Major damage	Absent	Silt levels	Moderate	Dumped rubbish	Absent	<p>Total HSI Score: 0.89</p> <p>Excellent suitability with good pond condition</p>

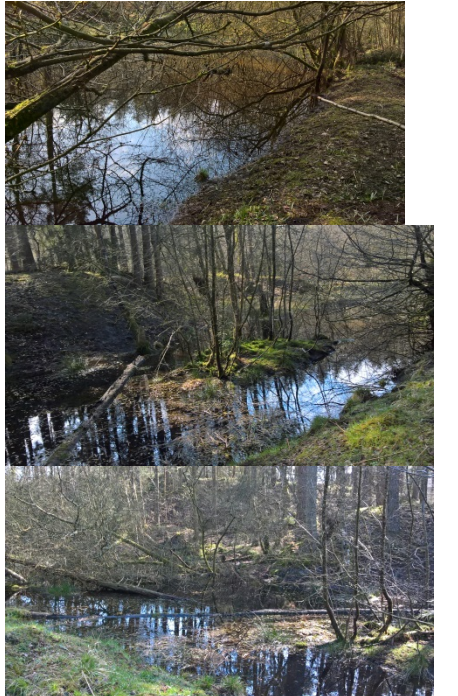
<table border="1"> <tr><td>Location</td><td>1</td></tr> <tr><td>Pond area</td><td>0.91</td></tr> <tr><td>Pond drying</td><td>1</td></tr> <tr><td>Water quality</td><td>1</td></tr> <tr><td>Shade</td><td>1</td></tr> <tr><td>Fowl</td><td>0.67</td></tr> <tr><td>Fish</td><td>1</td></tr> <tr><td>Pond count</td><td>1</td></tr> <tr><td>Terrestrial habitat</td><td>1</td></tr> <tr><td>Macrophytes</td><td>0.8</td></tr> <tr><td>Invasive species</td><td>Absent</td></tr> <tr><td>Major damage</td><td>Absent</td></tr> <tr><td>Silt levels</td><td>Moderate</td></tr> <tr><td>Dumped rubbish</td><td>Absent</td></tr> </table>	Location	1	Pond area	0.91	Pond drying	1	Water quality	1	Shade	1	Fowl	0.67	Fish	1	Pond count	1	Terrestrial habitat	1	Macrophytes	0.8	Invasive species	Absent	Major damage	Absent	Silt levels	Moderate	Dumped rubbish	Absent	<p>Total HSI Score: 0.93</p> <p>Excellent suitability with good pond condition</p>

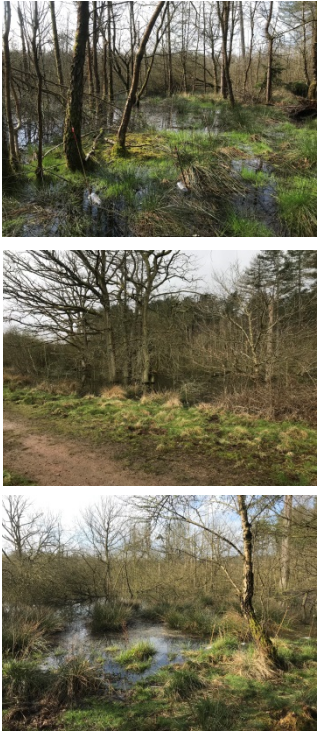
<table border="1"> <tr><td>Location</td><td>1</td></tr> <tr><td>Pond area</td><td>0.8</td></tr> <tr><td>Pond drying</td><td>0.9</td></tr> <tr><td>Water quality</td><td>0.67</td></tr> <tr><td>Shade</td><td>0.6</td></tr> <tr><td>Fowl</td><td>0.67</td></tr> <tr><td>Fish</td><td>1</td></tr> <tr><td>Pond count</td><td>1</td></tr> <tr><td>Terrestrial habitat</td><td>1</td></tr> <tr><td>Macrophytes</td><td>0.8</td></tr> <tr><td>Invasive species</td><td>Absent</td></tr> <tr><td>Major damage</td><td>Absent</td></tr> <tr><td>Silt levels</td><td>Moderate</td></tr> <tr><td>Dumped rubbish</td><td>Absent</td></tr> </table>	Location	1	Pond area	0.8	Pond drying	0.9	Water quality	0.67	Shade	0.6	Fowl	0.67	Fish	1	Pond count	1	Terrestrial habitat	1	Macrophytes	0.8	Invasive species	Absent	Major damage	Absent	Silt levels	Moderate	Dumped rubbish	Absent	<p>Total HSI Score: 0.83</p> <p>Excellent suitability with good pond condition</p>

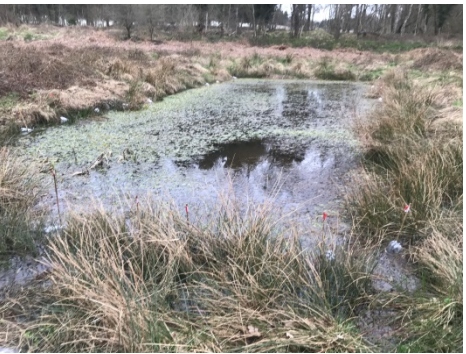
Location	1	<p>Total HSI Score: 0.82</p> <p>Excellent suitability</p> <p>with</p> <p>good pond condition</p>
			Pond area	0.4	
			Pond drying	1	
			Water quality	0.67	
			Shade	1	
			Fowl	0.67	
			Fish	1	
			Pond count	1	
			Terrestrial habitat	1	
			Macrophytes	0.8	
			Invasive species	Absent

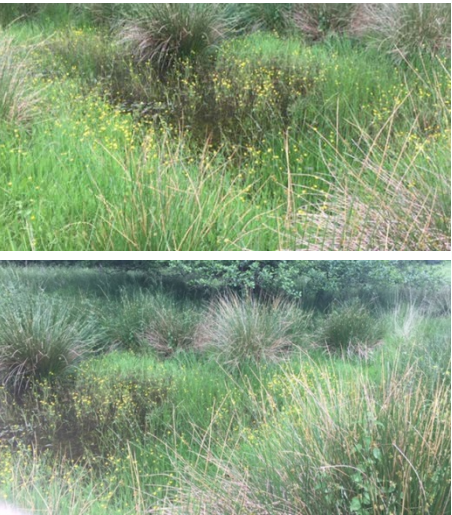
Location	1	<p>Total HSI Score: 0.58</p> <p>Below average suitability</p> <p>with</p> <p>excellent pond condition</p>
			Pond area	0.05	
			Pond drying	0.1	
			Water quality	1	
			Shade	1	
			Fowl	1	
			Fish	1	
			Pond count	1	
			Terrestrial habitat	1	
			Macrophytes	0.85	
			Invasive species	Absent	
			Major damage	Absent	
			Silt levels	Low	
Dumped rubbish	Absent

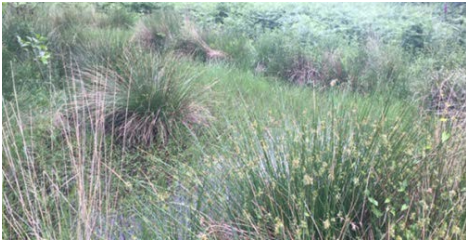
Location	1	<p>Total HSI Score: 0.55</p> <p>Below average suitability</p> <p>with</p> <p>excellent pond condition</p>
			Pond area	0.05	
			Pond drying	0.1	
			Water quality	0.67	
			Shade	1	
			Fowl	1	
			Fish	1	
			Pond count	1	
			Terrestrial habitat	1	
			Macrophytes	0.8	
			Invasive species	Absent	
			Major damage	Absent	
			Silt levels	Low	
Dumped rubbish	Absent				
24d	<p>Grid reference: SO 64239 14550</p> <p>Pond 24d is a newly formed pond located to the far west of pond 24a, 24b and 24c. It was noted that there was a pipe leading to this pond, so it is likely that this pond was formed from runoff water exiting this pipe. Pond 24d measures approximately 10 m x 15 m in size and is approximately 0.5 m in depth. Aquatic vegetation was very limited to a small section of bog pondweed. Most of the vegetation was marginal rush and grass species. Algae was present on the surface of the water, which suggests the water is high in nutrients (potentially from the runoff by nearby agricultural fields).</p> <p>Pond 24d was not assessed for Habitat Suitability in 2018 as it was not included in the commission.</p>

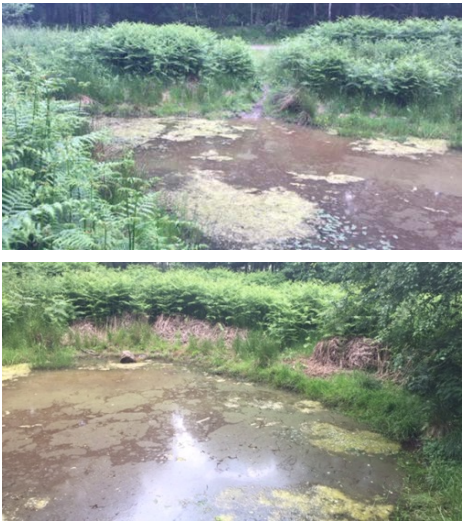
Location	1	<p>Total HSI Score: 0.61</p> <p>Average suitability</p> <p>with</p> <p>fair pond condition</p>

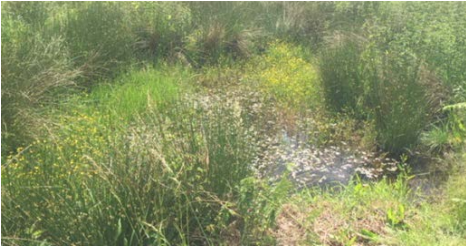
Location	1	<p>Total HSI Score: 0.58</p> <p>Below average suitability</p> <p>with</p> <p>excellent pond condition</p>
			Pond area	0.05	
			Pond drying	0.1	
			Water quality	1	
			Shade	1	
			Fowl	1	
			Fish	1	
			Pond count	1	
			Terrestrial habitat	1	
			Macrophytes	0.85	
			Invasive species	Absent	
			Major damage	Absent	
			Silt levels	Low	
Dumped rubbish	Absent				
25	<p>Grid reference: SO 64357 14548</p> <p>As with pond 24, this is a recently excavated pond within Laymoor Quag noted as 'a stronghold for great crested newts'. Pond 25 has been excavated to the same dimensions as pond 24 and is approximately 10m x 30m in size and between 0.5m to 1m deep. Abundant bog pondweed and occasional <i>Glyceria</i> sp. provides spawning potential. Cuckoo flower, soft rush and bulrush were also noted. Unlike pond 24, pond 25 has an area of open water. Water was moderate visibility. The north west edge of the pond has collapsed, which has provided a gradual slope allowing easier access into the pond and areas of shallow water. Tussocky grassland and nearby woodland provide abundant foraging potential and many log piles in the area provide good refuges for newts.</p>

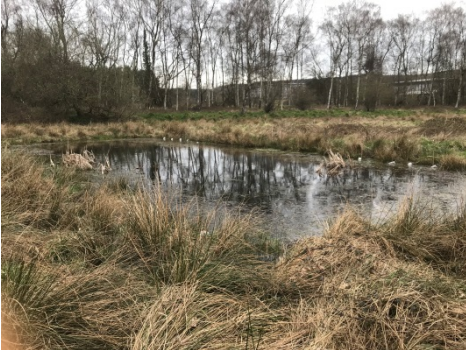
Location	1	<p>Total HSI Score: 0.87</p> <p>Excellent suitability</p> <p>with</p> <p>good pond condition</p>

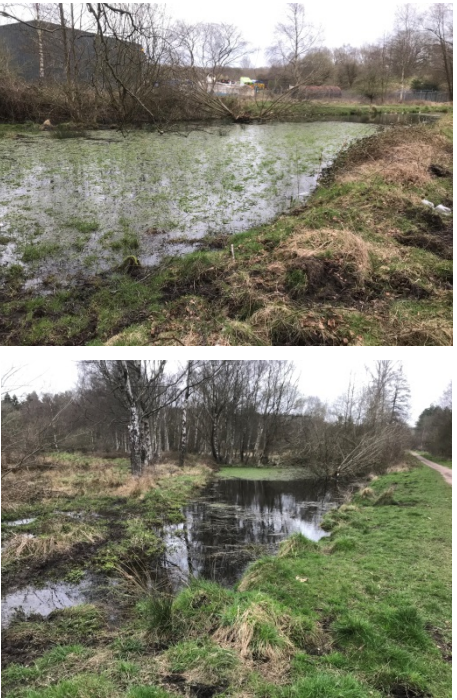
<table border="1"> <tr><td>Location</td><td>1</td></tr> <tr><td>Pond area</td><td>1</td></tr> <tr><td>Pond drying</td><td>0.5</td></tr> <tr><td>Water quality</td><td>1</td></tr> <tr><td>Shade</td><td>1</td></tr> <tr><td>Fowl</td><td>0.67</td></tr> <tr><td>Fish</td><td>1</td></tr> <tr><td>Pond count</td><td>1</td></tr> <tr><td>Terrestrial habitat</td><td>1</td></tr> <tr><td>Macrophytes</td><td>1</td></tr> <tr><td>Invasive species</td><td>Absent</td></tr> <tr><td>Major damage</td><td>Absent</td></tr> <tr><td>Silt levels</td><td>Low</td></tr> <tr><td>Dumped rubbish</td><td>Absent</td></tr> </table>	Location	1	Pond area	1	Pond drying	0.5	Water quality	1	Shade	1	Fowl	0.67	Fish	1	Pond count	1	Terrestrial habitat	1	Macrophytes	1	Invasive species	Absent	Major damage	Absent	Silt levels	Low	Dumped rubbish	Absent	<p>Total HSI Score: 0.90</p> <p>Excellent suitability with excellent pond condition</p>

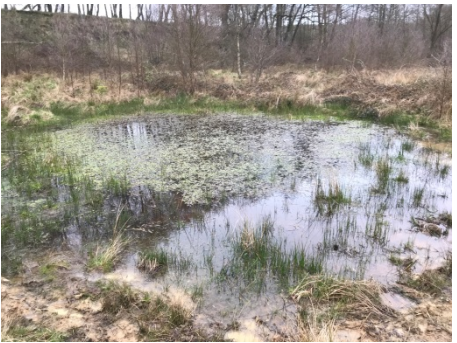
<table border="1"> <tr><td>Location</td><td>1</td></tr> <tr><td>Pond area</td><td>0.2</td></tr> <tr><td>Pond drying</td><td>0.5</td></tr> <tr><td>Water quality</td><td>0.67</td></tr> <tr><td>Shade</td><td>1</td></tr> <tr><td>Fowl</td><td>1</td></tr> <tr><td>Fish</td><td>0.67</td></tr> <tr><td>Pond count</td><td>1</td></tr> <tr><td>Terrestrial habitat</td><td>1</td></tr> <tr><td>Macrophytes</td><td>0.85</td></tr> <tr><td>Invasive species</td><td>Absent</td></tr> <tr><td>Major damage</td><td>Absent</td></tr> <tr><td>Silt levels</td><td>Moderate</td></tr> <tr><td>Dumped rubbish</td><td>Absent</td></tr> </table>	Location	1	Pond area	0.2	Pond drying	0.5	Water quality	0.67	Shade	1	Fowl	1	Fish	0.67	Pond count	1	Terrestrial habitat	1	Macrophytes	0.85	Invasive species	Absent	Major damage	Absent	Silt levels	Moderate	Dumped rubbish	Absent	<p>Total HSI Score: 0.72</p> <p>Good suitability with good pond condition</p>

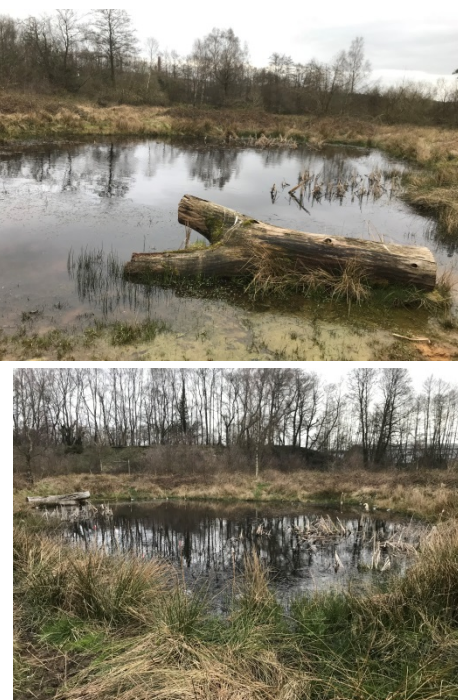
<table border="1"> <tr><td>Location</td><td>1</td></tr> <tr><td>Pond area</td><td>0.8</td></tr> <tr><td>Pond drying</td><td>0.5</td></tr> <tr><td>Water quality</td><td>0.67</td></tr> <tr><td>Shade</td><td>1</td></tr> <tr><td>Fowl</td><td>0.67</td></tr> <tr><td>Fish</td><td>0.33</td></tr> <tr><td>Pond count</td><td>1</td></tr> <tr><td>Terrestrial habitat</td><td>1</td></tr> <tr><td>Macrophytes</td><td>0.7</td></tr> <tr><td>Invasive species</td><td>Absent</td></tr> <tr><td>Major damage</td><td>Absent</td></tr> <tr><td>Silt levels</td><td>Moderate</td></tr> <tr><td>Dumped rubbish</td><td>Absent</td></tr> </table>	Location	1	Pond area	0.8	Pond drying	0.5	Water quality	0.67	Shade	1	Fowl	0.67	Fish	0.33	Pond count	1	Terrestrial habitat	1	Macrophytes	0.7	Invasive species	Absent	Major damage	Absent	Silt levels	Moderate	Dumped rubbish	Absent	<p>Total HSI Score: 0.73</p> <p>Good suitability with good pond condition</p>

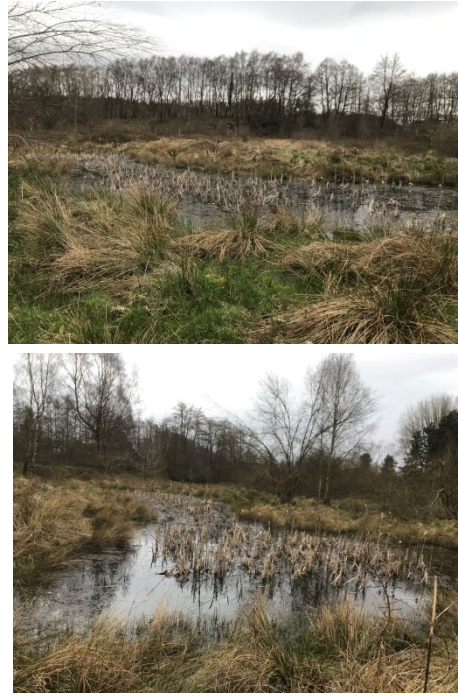
<table border="1"> <tr><td>Location</td><td>1</td></tr> <tr><td>Pond area</td><td>0.6</td></tr> <tr><td>Pond drying</td><td>0.5</td></tr> <tr><td>Water quality</td><td>0.67</td></tr> <tr><td>Shade</td><td>1</td></tr> <tr><td>Fowl</td><td>0.67</td></tr> <tr><td>Fish</td><td>0.33</td></tr> <tr><td>Pond count</td><td>1</td></tr> <tr><td>Terrestrial habitat</td><td>1</td></tr> <tr><td>Macrophytes</td><td>1</td></tr> <tr><td>Invasive species</td><td>Absent</td></tr> <tr><td>Major damage</td><td>Absent</td></tr> <tr><td>Silt levels</td><td>Moderate</td></tr> <tr><td>Dumped rubbish</td><td>Absent</td></tr> </table>	Location	1	Pond area	0.6	Pond drying	0.5	Water quality	0.67	Shade	1	Fowl	0.67	Fish	0.33	Pond count	1	Terrestrial habitat	1	Macrophytes	1	Invasive species	Absent	Major damage	Absent	Silt levels	Moderate	Dumped rubbish	Absent	<p>Total HSI Score: 0.73</p> <p>Good suitability with good pond condition</p>

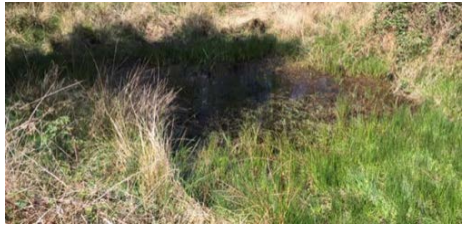
Location	1	<p>Total HSI Score: 0.54</p> <p>Below average suitability</p> <p>with</p> <p>good pond condition</p>
			Pond area	0.05	
			Pond drying	0.1	
			Water quality	0.67	
			Shade	1	
			Fowl	1	
			Fish	1	
			Pond count	1	
			Terrestrial habitat	1	
			Macrophytes	0.6	
			Invasive species	Absent	
			Major damage	Absent

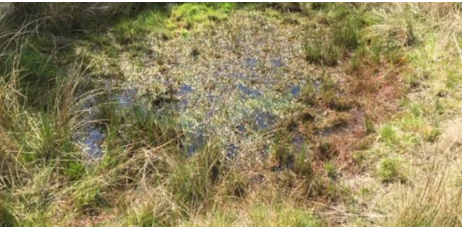
Location	1	<p>Total HSI Score: 0.56</p> <p>Below average suitability</p> <p>with</p> <p>good pond condition</p>
			Pond area	0.05	
			Pond drying	0.1	
			Water quality	0.67	
			Shade	1	
			Fowl	1	
			Fish	1	
			Pond count	1	
			Terrestrial habitat	1	
			Macrophytes	0.85	
			Invasive species	Absent

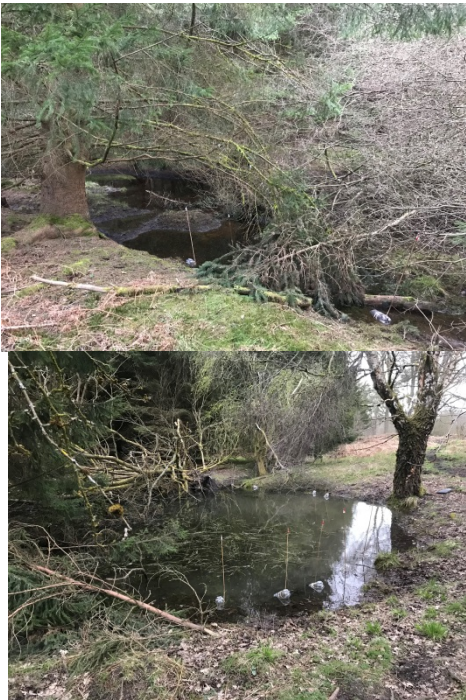
Location	1	<p>Total HSI Score: 0.65</p> <p>Average suitability with excellent pond condition</p>
			Pond area	0.4	
			Pond drying	0.1	
			Water quality	0.67	
			Shade	0.8	
			Fowl	1	
			Fish	1	
			Pond count	1	
			Terrestrial habitat	1	
			Macrophytes	0.6	
			Invasive species	Absent	
			Major damage	Absent	
			Silt levels	Low	
Dumped rubbish	Absent				
30	<p>Grid reference: SO 64496 15041</p> <p>This pond lies 50 m to the east of a cluster of ponds (Ponds 2,3,4,5,6,8) to the west of Forest Vale Road. Pond 30 is approximately 15 m x 7 m in size and approximately 0.5 m deep. In contrast to the 2013 report, water mint and bog pond weed were not noted, therefore spawning media was limited to dead leaves. Other species noted were water horsetail, broadleaf dock and soft rush. Emergent vegetation was limited and the water was clear. This pond is shaded by the trees surrounding it. One tree has grown at an angle leaning over the pond and many of its branches are just above the water. Grassland and woodland provides excellent terrestrial habitat throughout with abundant refugia present.</p>

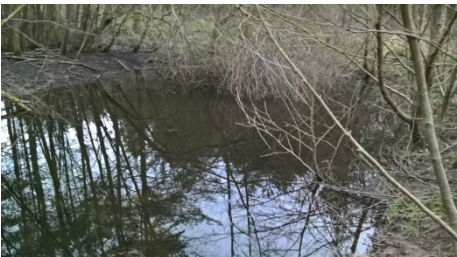
Location	1	<p>Total HSI Score: 0.62</p> <p>Average suitability with fair pond condition</p>

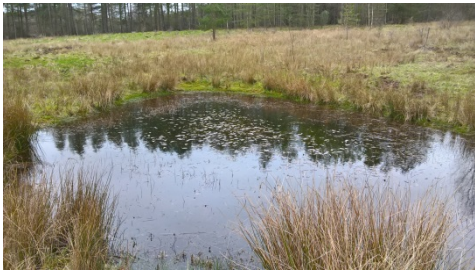
Location	1	<p>Total HSI Score: 0.82</p> <p>Excellent suitability with excellent pond condition</p>
			Pond area	0.2	
			Pond drying	1	
			Water quality	1	
			Shade	1	
			Fowl	1	
			Fish	1	
			Pond count	1	
			Terrestrial habitat	1	
			Macrophytes	0.7	
			Invasive species	Absent	
			Major damage	Absent	
			Silt levels	Low	
			Dumped rubbish	Absent	
32	<p>Grid reference: SO 64306 15693</p> <p>Pond 32 is located alongside the footpath through the Hawkwell Inclosure. This pond is no longer long and narrow as in the 2013 report as most of the pond has since dried up, and the pond now measures less than 5 m x 5 m in size. The water levels in this pond did not vary as previously reported. The water level remained shallow during the 2017 surveys and in 2018 the depth of the water had increased to an approximate maximum depth of 1 m. No aquatic vegetation was present and spawning media is limited to dead leaves. Nearby habitats consist mainly of woodland with an abundance of refugia.</p>

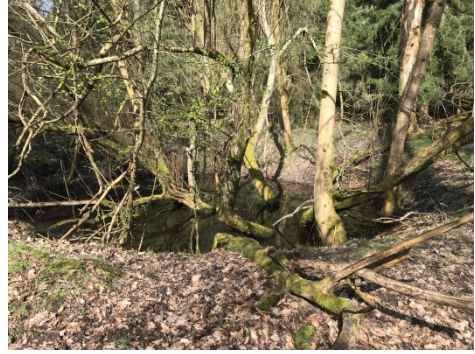
Location	1	<p>Total HSI Score: 0.31</p> <p>Poor suitability with fair pond condition</p>

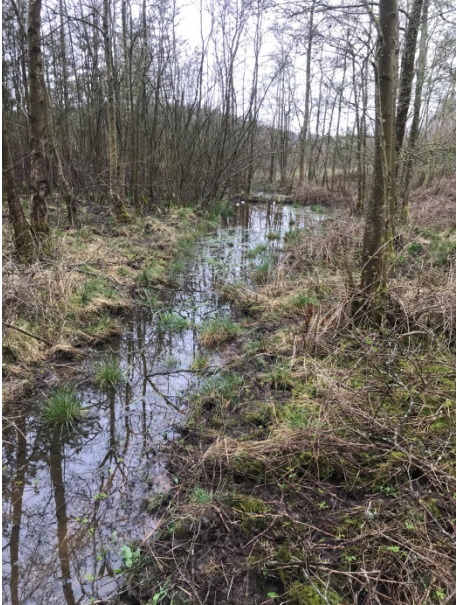
<table border="1"> <tr><td>Location</td><td>1</td></tr> <tr><td>Pond area</td><td>0.05</td></tr> <tr><td>Pond drying</td><td>0.5</td></tr> <tr><td>Water quality</td><td>0.67</td></tr> <tr><td>Shade</td><td>0.8</td></tr> <tr><td>Fowl</td><td>0.67</td></tr> <tr><td>Fish</td><td>1</td></tr> <tr><td>Pond count</td><td>1</td></tr> <tr><td>Terrestrial habitat</td><td>1</td></tr> <tr><td>Macrophytes</td><td>0.65</td></tr> <tr><td>Invasive species</td><td>Absent</td></tr> <tr><td>Major damage</td><td>Absent</td></tr> <tr><td>Silt levels</td><td>Moderate</td></tr> <tr><td>Dumped rubbish</td><td>Absent</td></tr> </table>	Location	1	Pond area	0.05	Pond drying	0.5	Water quality	0.67	Shade	0.8	Fowl	0.67	Fish	1	Pond count	1	Terrestrial habitat	1	Macrophytes	0.65	Invasive species	Absent	Major damage	Absent	Silt levels	Moderate	Dumped rubbish	Absent	<p>Total HSI Score: 0.60</p> <p>Average suitability with good pond condition</p>

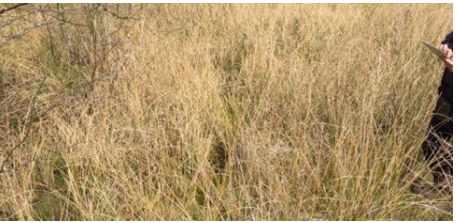
<table border="1"> <tr><td>Location</td><td>1</td></tr> <tr><td>Pond area</td><td>N/A - dry</td></tr> <tr><td>Pond drying</td><td>0.1</td></tr> <tr><td>Water quality</td><td>N/A - dry</td></tr> <tr><td>Shade</td><td>1</td></tr> <tr><td>Fowl</td><td>1</td></tr> <tr><td>Fish</td><td>1</td></tr> <tr><td>Pond count</td><td>1</td></tr> <tr><td>Terrestrial habitat</td><td>1</td></tr> <tr><td>Macrophytes</td><td>N/A - dry</td></tr> <tr><td>Invasive species</td><td>Absent</td></tr> <tr><td>Major damage</td><td>Absent</td></tr> <tr><td>Silt levels</td><td>N/A</td></tr> <tr><td>Dumped rubbish</td><td>Absent</td></tr> </table>	Location	1	Pond area	N/A - dry	Pond drying	0.1	Water quality	N/A - dry	Shade	1	Fowl	1	Fish	1	Pond count	1	Terrestrial habitat	1	Macrophytes	N/A - dry	Invasive species	Absent	Major damage	Absent	Silt levels	N/A	Dumped rubbish	Absent	<p>Unsuitable for HSI - Dry</p>

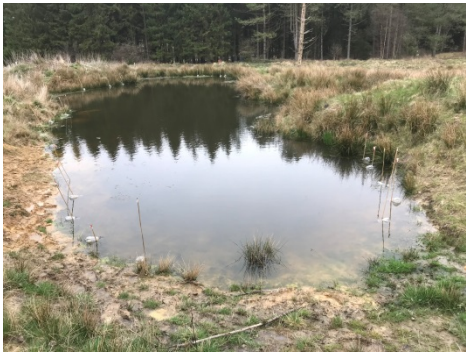
Location	1	<p>Total HSI Score: 0.82</p> <p>Excellent suitability with good pond condition</p>
			Pond area	0.6	
			Pond drying	0.9	
			Water quality	0.67	
			Shade	1	
			Fowl	0.67

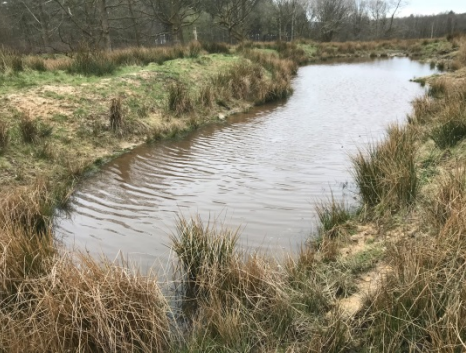
Location	1	<p>Total HSI Score: 0.82</p> <p>Excellent suitability with good pond condition</p>

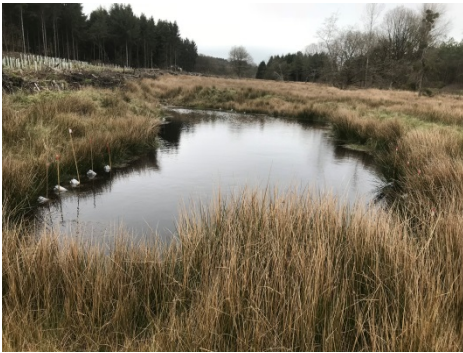
Location	1	<p>Total HSI Score: 0.83</p> <p>Excellent suitability with good pond condition</p>
			Pond area	0.6	
			Pond drying	0.9	
			Water quality	0.67	
			Shade	1	
			Fowl	0.67	
			Fish	1

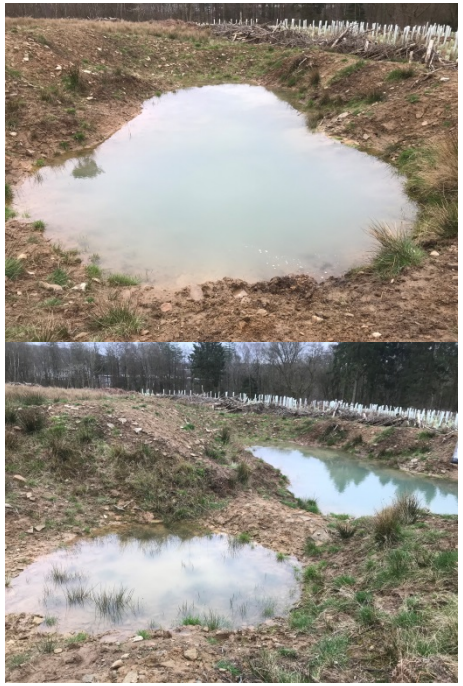
Location	1	<p>Total HSI Score: 0.60</p> <p>Average suitability with good pond condition</p>

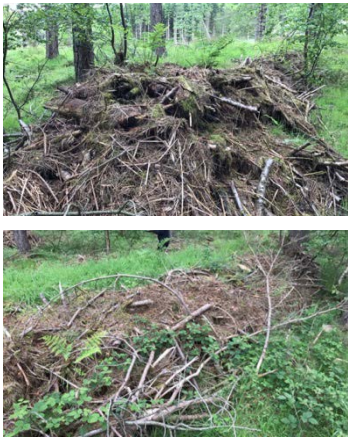
Size	1	0.60  GOOD
		Surrounding habitat	1	
		Signs of flooding	1	
		Shading opportunities	1	
		Basking opportunities	1	
		Signs of damage	1	
		Naturalness of appearance	1	
		Habitat connectivity	1	
		Proximity to area of water	0.01	
<b>MP12</b> <ul style="list-style-type: none"> <li>- Moderate vegetation cover on south facing side</li> </ul>

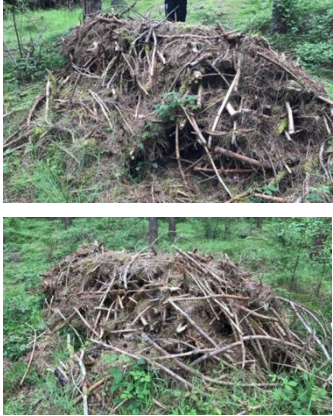
Size	1	0.56  GOOD
		Surrounding habitat	1	
		Signs of flooding	1	
		Shading opportunities	1	
		Basking opportunities	1	
		Signs of damage	1	
		Naturalness of appearance	1	
		Habitat connectivity	0.5	
		Proximity to area of water	0.01

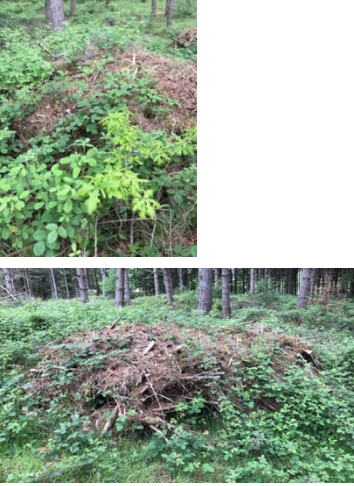
Size	1	0.59 GOOD
			Surrounding habitat	1	
			Signs of flooding	1	
			Shading opportunities	1	
			Basking opportunities	1	
			Signs of damage	1	
			Naturalness of appearance	1	
			Habitat connectivity	1	
			Proximity to area of water	0.01	
MP14	- Extensive bramble cover all over but tree cover more open

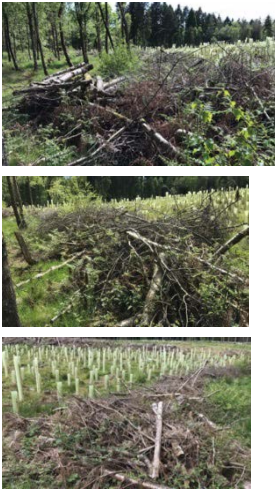
Size	1	0.49  FAIR
		Surrounding habitat	1	
		Signs of flooding	1	
		Shading opportunities	0.5	
		Basking opportunities	1	
		Signs of damage	0.01	
		Naturalness of appearance	1	
		Habitat connectivity	0.5	
		Proximity to area of water	0.5	
<b>MP24</b> <ul style="list-style-type: none"> <li>- Approximately 5 m*3 m*3 m in size</li> <li>- Limited vegetation and tree cover</li> </ul>

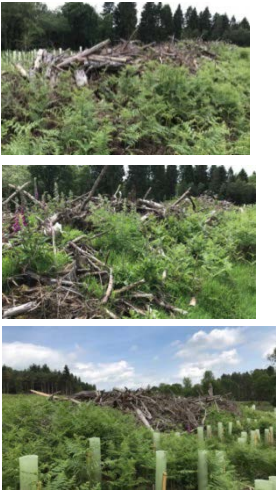
Size	1	0.79  EXCELLENT
		Surrounding habitat	1	
		Signs of flooding	1	
		Shading opportunities	0.5	
		Basking opportunities	1	
		Signs of damage	1	
		Naturalness of appearance	1	
		Habitat connectivity	0.5	
		Proximity to area of water	0.5	
<b>MP28</b> <ul style="list-style-type: none"> <li>- Moderate vegetation cover provided by surrounding scrub</li> </ul>

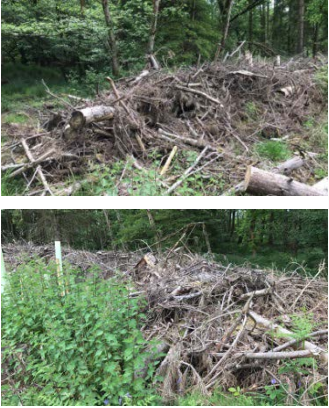
Size	1	0.48  FAIR
		Surrounding habitat	1	
		Signs of flooding	1	
		Shading opportunities	0.5	
		Basking opportunities	0.5	
		Signs of damage	1	
		Naturalness of appearance	1	
		Habitat connectivity	0.5	
Proximity to area of water	0.01

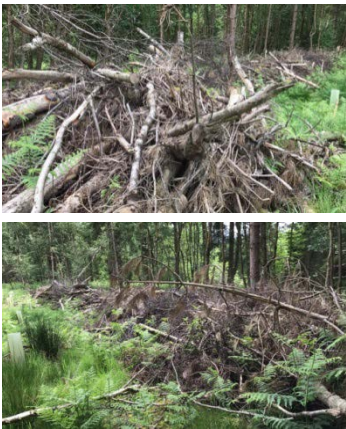
Size	1	0.51  GOOD
		Surrounding habitat	1	
		Signs of flooding	1	
		Shading opportunities	0.5	
		Basking opportunities	0.5	
		Signs of damage	1	
		Naturalness of appearance	1	
		Habitat connectivity	1	
		Proximity to area of water	0.01	
<b>MP34</b> - Approximately 3 m *2 m *0.5 m in size - Over 100 metres from nearest body of water

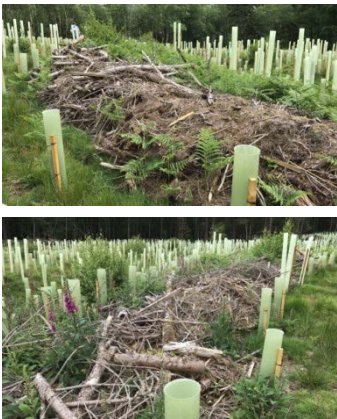
Size	1	0.46  FAIR
		Surrounding habitat	1	
		Signs of flooding	1	
		Shading opportunities	0.1	
		Basking opportunities	1	
		Signs of damage	1	
		Naturalness of appearance	1	
		Habitat connectivity	1	
		Proximity to area of water	0.01	
<b>MP36</b> - Approximately 10 m *2 m *1 m in size - Over 100 metres from nearest body of water

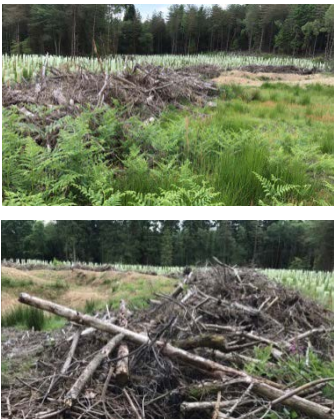
Size	1	0.27  POOR
		Surrounding habitat	0.67	
		Signs of flooding	1	
		Shading opportunities	0.1	
		Basking opportunities	1	
		Signs of damage	1	
		Naturalness of appearance	1	
		Habitat connectivity	0.01	
		Proximity to area of water	0.01	
<b>MP38</b> - Approximately 15 m *5 m *4 m in size - Over 100 metres from nearest body of water

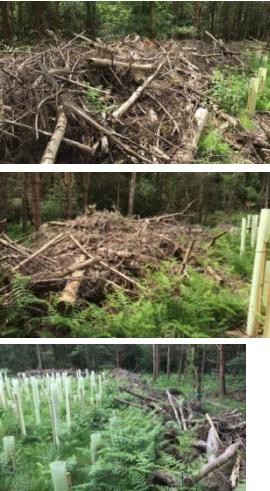
<b>MP39</b> - Approximately 50 m *3 m *3 m - Over 100 m metres from nearest body of water

Size	1	0.51  GOOD
		Surrounding habitat	1	
		Signs of flooding	1	
		Shading opportunities	0.5	
		Basking opportunities	0.5	
		Signs of damage	1	
		Naturalness of appearance	1	
		Habitat connectivity	1	
		Proximity to area of water	0.01	
<b>MP40</b> - Approximately 50 m*3 m*3 m - Over 100 m metres from nearest body of water

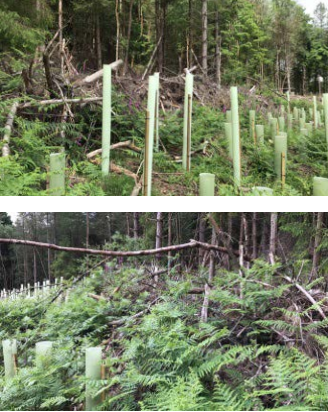
Size	1	0.51  GOOD
		Surrounding habitat	1	
		Signs of flooding	1	
		Shading opportunities	0.5	
		Basking opportunities	0.5	
		Signs of damage	1	
		Naturalness of appearance	1	
		Habitat connectivity	1	
		Proximity to area of water	0.01

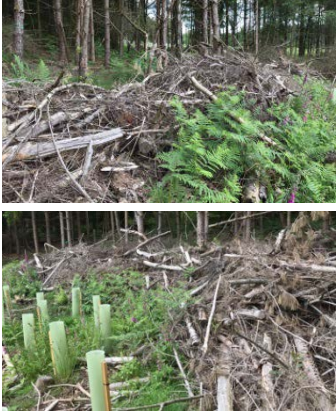
<b>MP41</b> - Part of the same windrow as MP40, but this particular section 20 m*3 m*3 m in size

Size	1	0.51  GOOD
		Surrounding habitat	1	
		Signs of flooding	1	
		Shading opportunities	0.5	
		Basking opportunities	0.5	
		Signs of damage	1	
		Naturalness of appearance	1	
		Habitat connectivity	1	
		Proximity to area of water	0.01	
<b>MP42</b> - Approximately 10 m*0.5 m*0.5 m in size - Over 100 metres from the nearest water body

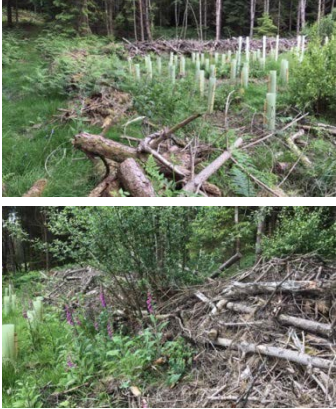
Size	1	0.51  GOOD
		Surrounding habitat	1	
		Signs of flooding	1	
		Shading opportunities	0.5	
		Basking opportunities	0.5	
		Signs of damage	1	
		Naturalness of appearance	1	
		Habitat connectivity	1	
		Proximity to area of water	0.01	
<b>MP44</b> - Approximately 20 m*1 m*1 m in size - Over 100 metres from the nearest body of water

Size	1	0.48  FAIR
		Surrounding habitat	1	
		Signs of flooding	1	
		Shading opportunities	0.05	
		Basking opportunities	0.05	
		Signs of damage	1	
		Naturalness of appearance	1	
		Habitat connectivity	0.5	
		Proximity to area of water	0.01

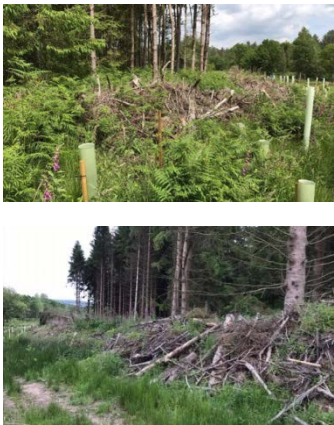
<b>MP49</b> <ul style="list-style-type: none"> <li>- Extremely long windrow running parallel to coniferous woodland area</li> <li>- Approximately 100 m*2 m*2 m in size</li> <li>- Surrounding habitats is partly good, however, some areas are bare and open</li> </ul>

Size	1	0.68  GOOD
		Surrounding habitat	1	
		Signs of flooding	1	
		Shading opportunities	0.5	
		Basking opportunities	0.5	
		Signs of damage	1	
		Naturalness of appearance	0.5	
		Habitat connectivity	0.5	
		Proximity to area of water	0.5	
<b>MP50</b> <ul style="list-style-type: none"> <li>- Approximately 30 m*3 m*3 m in size</li> <li>- Limited shading opportunities provided by tree cove, however, some potentially provided by extensive vegetation cover (bracken and foxglove)</li> </ul>

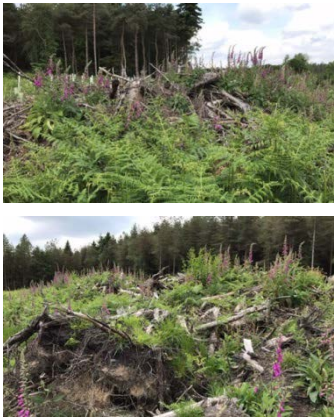
Size	1	0.59  GOOD
		Surrounding habitat	0.67	
		Signs of flooding	1	
		Shading opportunities	0.1	
		Basking opportunities	0.5	
		Signs of damage	1

Naturalness of appearance	1	
		Habitat connectivity	0.5	
		Proximity to area of water	0.5

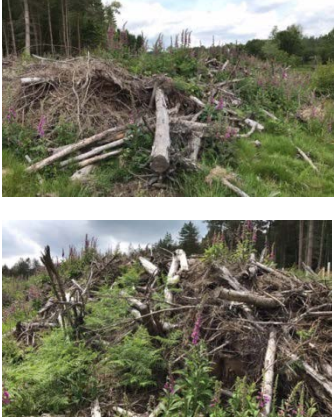
<b>MP51</b> <ul style="list-style-type: none"> <li>- Approximately 30 m*3 m*4 m</li> <li>- Limited shading opportunities provided by tree cove, however, some potentially provided by extensive vegetation cover (bracken and foxglove)</li> <li>- Approximately 20 metres from nearest body of water</li> </ul>

Size	1	0.72 GOOD
		Surrounding habitat	1	
		Signs of flooding	1	
		Shading opportunities	0.1	
		Basking opportunities	1	
		Signs of damage	1	
		Naturalness of appearance	1	
		Habitat connectivity	1	
		Proximity to area of water	0.5	
<b>MP52</b> <ul style="list-style-type: none"> <li>- Approximately 100 m*3 m*4 m in size</li> </ul>

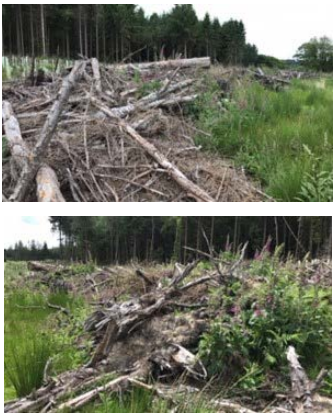
MP53	- Approximately 20 m*2 m*1 m in size

Size	1	0.72 GOOD
			Surrounding habitat	1	
			Signs of flooding	1	
			Shading opportunities	0.1	
			Basking opportunities	1	
			Signs of damage	1	
			Naturalness of appearance	1	
			Habitat connectivity	0.5	
			Proximity to area of water	1	
MP54	- Approximately 25 m*2 m*2 m in size

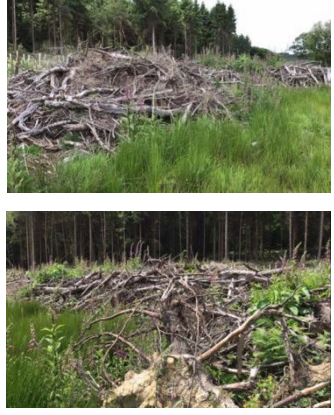
Size	1	0.69 GOOD
			Surrounding habitat	0.67	
			Signs of flooding	1	
			Shading opportunities	0.1	
			Basking opportunities	1	
			Signs of damage	1	
			Naturalness of appearance	1	
			Habitat connectivity	0.5	
			Proximity to area of water	1

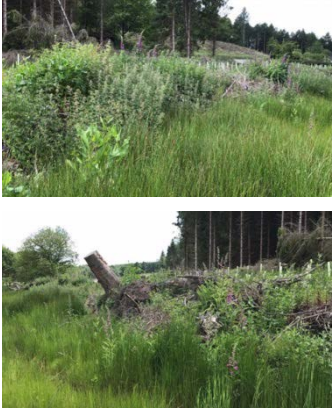
MP57	- Approximately 40 m*2 m*2 m in size

Size	1	0.61 GOOD
			Surrounding habitat	1	
			Signs of flooding	0.5	
			Shading opportunities	0.1	
			Basking opportunities	1	
			Signs of damage	1	
			Naturalness of appearance	1	
			Habitat connectivity	0.5	
			Proximity to area of water	0.5	
MP58	- Approximately 6 m*2 m*2 m in size

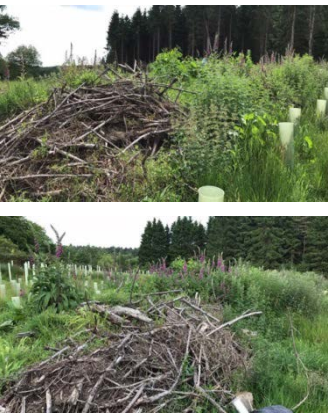
<b>MP59</b> <ul style="list-style-type: none"> <li>- Approximately 25 m *2 m*4 m in size</li> <li>- Extensive vegetation cover from nettle and foxglove may increase shading</li> </ul>

Size	1	<p style="text-align: center;">0.93 EXCELLENT</p>
		Surrounding habitat	1	
		Signs of flooding	1	
		Shading opportunities	0.5	
		Basking opportunities	1	
		Signs of damage	1	
		Naturalness of appearance	1	
		Habitat connectivity	1	
		Proximity to area of water	1	
<b>MP60</b> <ul style="list-style-type: none"> <li>- Approximately 30 m*2 m *2 m in size</li> <li>- Extensive vegetation cover from nettle and foxglove may increase shading</li> <li>- Vegetation cover is so extensive that potentially basking spots could be limited</li> </ul>

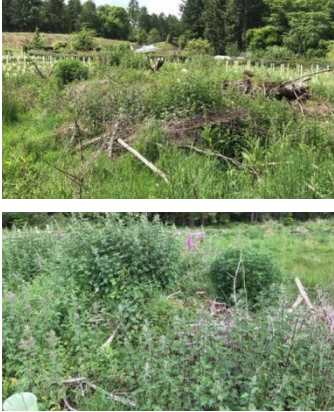
<b>MP61</b> <ul style="list-style-type: none"> <li>- Approximately 10 m*5 m*1 m in size and circular in shape</li> <li>- Extensive vegetation cover from nettle and foxglove may increase shading</li> <li>- Vegetation cover is so extensive that potentially basking spots could be limited</li> </ul>

Size	1	<p style="text-align: center;">0.74 EXCELLENT</p>
		Surrounding habitat	0.67	
		Signs of flooding	1	
		Shading opportunities	0.1	
		Basking opportunities	1	
		Signs of damage	1	
		Naturalness of appearance	1	
		Habitat connectivity	1	
		Proximity to area of water	1
