Great Crested Newt Monitoring Survey 2021

Cinderford Northern Quarter, Forest of Dean

Client:	Forest of Dean Council
Document No.:	11075 101
Revision:	P01
Status:	Final
Print Size:	A4
Date:	06/01/2022

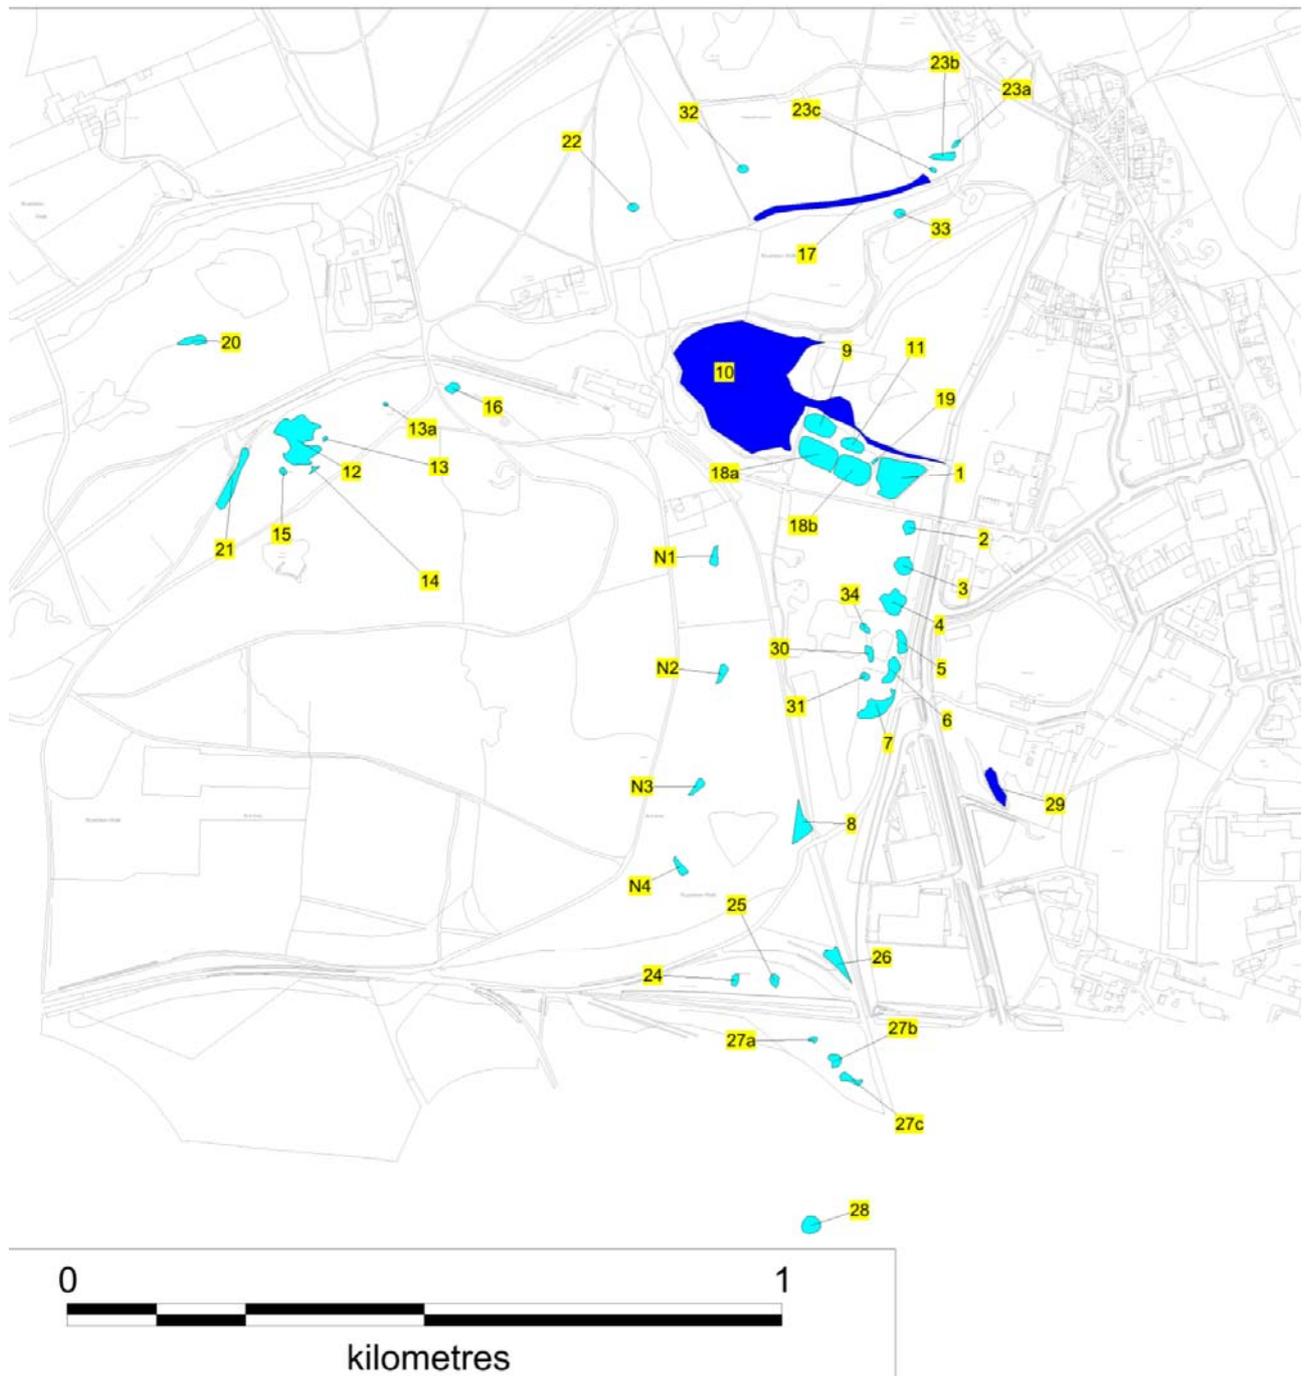
Figure 1: Pond Location Plan

2.1.1 Surveys were undertaken under the appropriate Natural England GCN licence and were overseen by Dave Harvey (class licence CL08 registration number: 2016-20243-CLS-CLS). Survey dates and weather conditions are provided in Appendix 3. Pond locations were provided by the client and are shown in Figure 1 & 2.

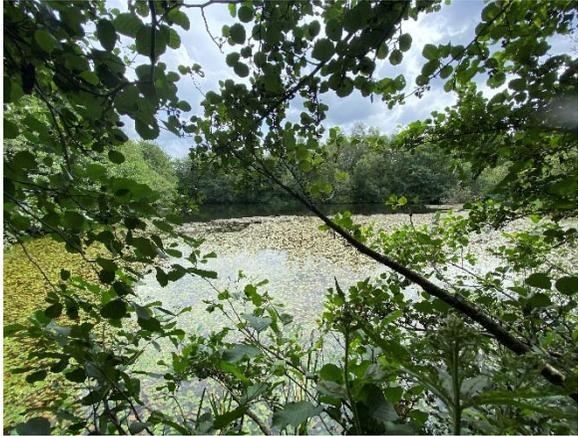
Pond Number	Pond Description	Photo	Pond Condition Assessment Criteria	Score per Index	Total HSI score and overall pond condition score
1 & 19	<p>Grid reference:</p> <p>Pond 1: SO 64515 15221 Pond 19: SO 64493 15282</p> <p>Pond 1 is a large man-made pond said to have been created following open cast mining of coal and set within a cluster of man-made ponds and fishing lakes.</p> <p>Pond 19 is a small channel joined to the NW corner and often dry. Surrounding terrestrial habitat is largely alder and willow carr providing good habitat for newts but not extensive and home to a resident sounder of wild boar. Fish including carp are present and the pond regularly occupied by small numbers of waterfowl. The pond is used by breeding common toads.</p>

Location	1	<p>Total HSI Score: 0.72</p> <p>Good suitability with poor pond condition</p>
			Pond area	0.85	
			Pond drying	0.9	
			Water quality	0.67

Shade	0.6	
			Fowl	0.67	
			Fish	0.33	
			Pond count	1	
			Terrestrial habitat	0.67	
			Macrophytes	0.8	
			Invasive species	Present – Montbretia on western bank	
			Major damage	Absent	
			Silt levels	Moderate	
Dumped Rubbish	Present – plastics and food containers on banks, access poor possibly blown				
2	<p>Grid reference: SO 64535 15182</p> <p>Northernmost pond of cluster south of forestry track and alongside Forest Vale Road. Set within dense coniferous woodland thinning of woodland was taking place during surveys creating disturbance. Three</p>		Location	1	<p>Total HSI Score: 0.75</p> <p>Good suitability with fair pond condition</p>
			Pond area	1	
			Pond drying	0.9	
			Water quality	1	
			Shade	0.4	
			Fowl	1

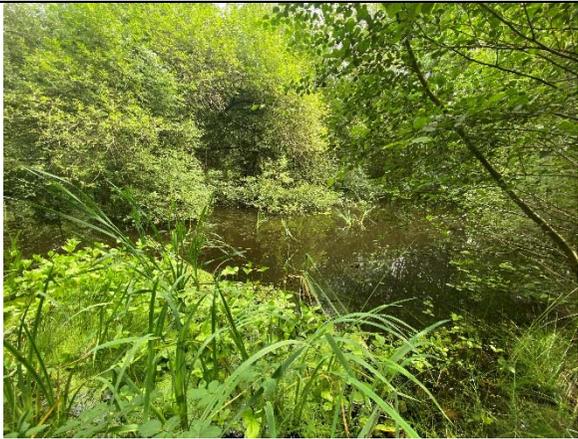
Pond Number	Pond Description	Photo	Pond Condition Assessment Criteria	Score per Index	Total HSI score and overall pond condition score
	spine sticklebacks are present along with some unidentified 4-5" fish in low numbers.

Fish	0.33	
			Pond count	1	
			Terrestrial habitat	1	
			Macrophytes	0.5	
			Invasive species	Absent	
			Major damage	Absent	
			Silt levels	Moderate	
			Dumped Rubbish	Present – Car seats, drink and food containers, CD's.	
3	Grid reference: SO 64537 15150 Part of cluster south of forestry track and to west of Forest Vale Road. Set on eastern edge of dense coniferous woodland, thinning of woodland is taking place during surveys creating some disturbance. Abundant foals water cress and water forget me not provide excellent GCN egg laying opportunity.

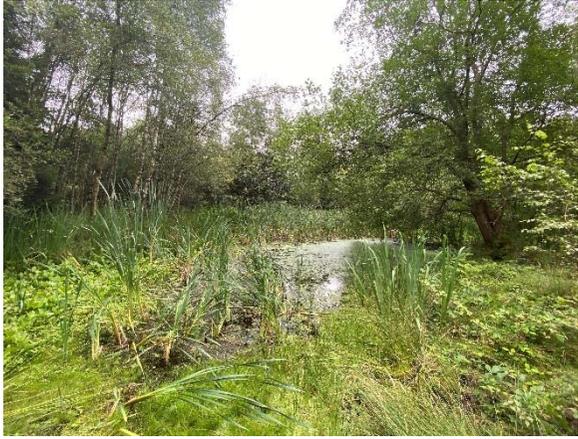
Location	1	Total HSI Score: 0.97 Excellent suitability with good pond condition
			Pond area	0.8	
			Pond drying	0.9	
			Water quality	1

Shade	1	
			Fowl	1	
			Fish	1	
			Pond count	1	
			Terrestrial habitat	1	
			Macrophytes	1	
			Invasive species	Absent	
			Major damage	Absent	
			Silt levels	Moderate

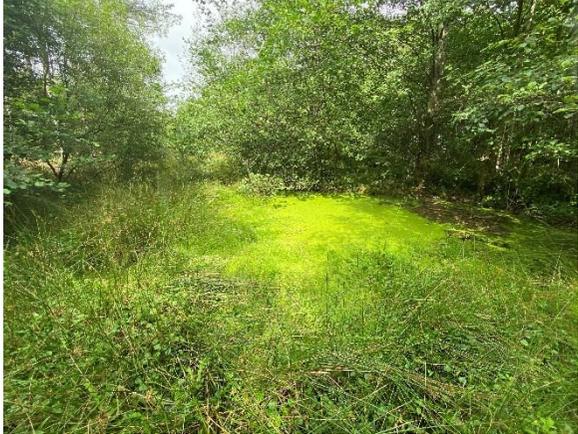
Pond Number	Pond Description	Photo	Pond Condition Assessment Criteria	Score per Index	Total HSI score and overall pond condition score
			Dumped Rubbish	Absent	
4	Grid reference: SO 64536 15076 Part of cluster south of forestry track and to west of Forest Vale Road. Set on eastern edge of dense coniferous woodland, thinning of woodland was taking place during surveys creating some disturbance. Water mint, foos water cress, sweet grass, and water forget me not provide excellent GCN egg laying opportunity. Water levels remained high throughout surveys.

Location	1	Total HSI Score: 0.93 Excellent suitability with fair pond condition
			Pond area	0.6	
			Pond drying	0.9	
			Water quality	1	
			Shade	0.9	
			Fowl	1	
			Fish	1	
			Pond count	1	
			Terrestrial habitat	1	
			Macrophytes	1	
			Invasive species	Absent	
			Major damage	Absent	
			Silt levels	Moderate – high accumulation of leaf litter	
			Dumped Rubbish	Present – plastics and cans

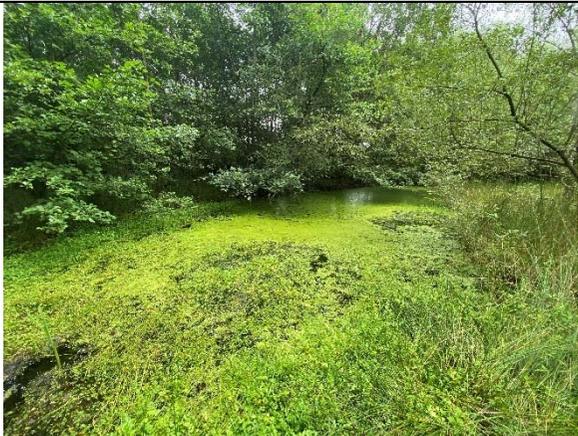
5	Grid reference: SO 64529 15020 Part of cluster south of forestry track and to west of Forest Vale Road. Set on eastern edge of dense coniferous woodland, thinning of woodland was taking place during surveys creating some disturbance. Abundant foos		Location	1	Total HSI Score: 0.72 Good suitability with good pond condition.
			Pond area	0.1	
			Pond drying	0.9	
			Water quality	1	
			Shade	0.6	
			Fowl	1

Pond Number	Pond Description	Photo	Pond Condition Assessment Criteria	Score per Index	Total HSI score and overall pond condition score
	water cress and water mint provide excellent GCN egg laying opportunity.

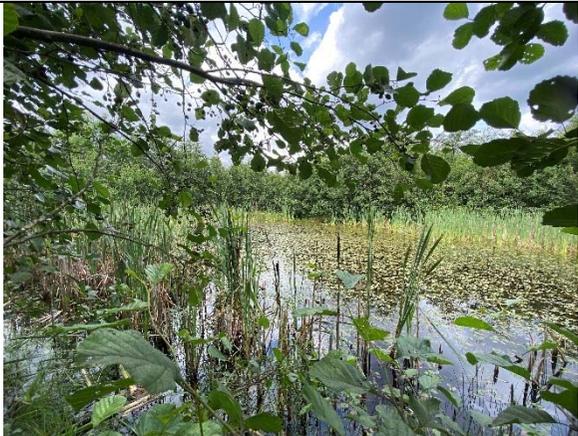
Pond Number	Pond Description	Photo	Pond Condition Assessment Criteria	Score per Index	Total HSI score and overall pond condition score
	open cast mining of coal. Surrounding terrestrial habitat is largely alder and willow carr providing good habitat for newts and home to a resident sounder of wild boar, some thinning of alder carr on the southern banks would be beneficial. Banks of the pond are lightly poached by the actions of wallowing boar.

Shade	0.4	
			Fowl	0.67	
			Fish	1	
			Pond count	1	
			Terrestrial habitat	0.67	
			Macrophytes	0.9	
			Invasive species	Absent	
			Major damage	Absent. Some minor poaching by wallowing boar.	
			Silt levels	Low	
			Dumped Rubbish	Present – plastic food and drink containers	
11	Grid reference: SO 64462 15299 Part of a cluster of man-made ponds including ponds 1, 19, 9, 18a & 18b said to have been created following open cast mining of coal. Surrounding terrestrial habitat is largely alder and willow carr providing good habitat for newts and home to a resident sounder of wild boar. Banks of the pond are lightly poached by the actions of wallowing boar.		Location	1	Total HSI Score: 0.90 Excellent suitability with fair pond condition.

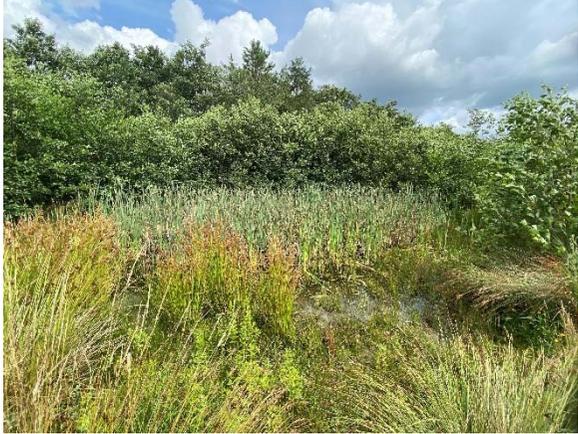
Major damage	Absent. Some minor poaching by wallowing boar.	
			Silt levels	Moderate	
			Dumped Rubbish	Present – plastic food and drink containers	
13	Grid reference: SO 63744 15322 A small shallow pond that dried out during surveys although vegetation indicate it usually holds water.

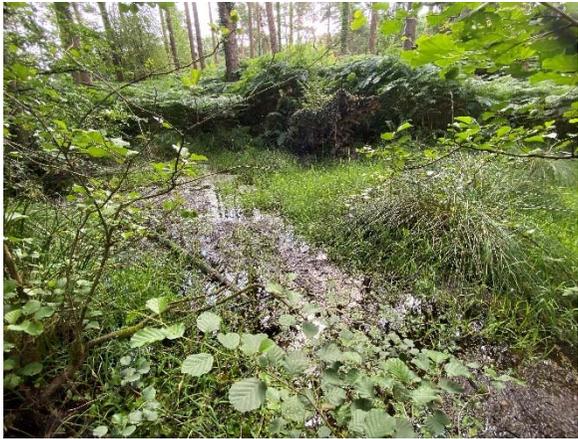
Location	1	Total HSI Score: 0.59 Below average suitability with good pond condition.
			Pond area	0.1	
			Pond drying	0.1	
			Water quality	0.67	
			Shade	0.8	
			Fowl	1	
			Fish	1	
			Pond count	1	
			Terrestrial habitat	1	
			Macrophytes	0.95	
			Invasive species	Absent	
			Major damage	Absent	
			Silt levels	Moderate

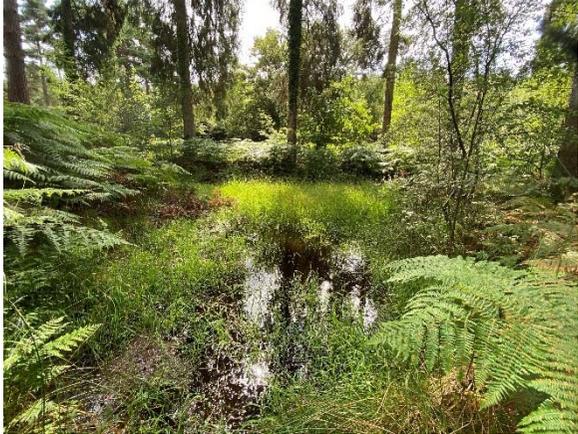
Pond Number	Pond Description	Photo	Pond Condition Assessment Criteria	Score per Index	Total HSI score and overall pond condition score
			Dumped Rubbish	Absent	
14	Grid reference: SO 63762 15290 A wet ditch alongside a forestry track.

Location	1	Total HSI Score: 0.82 Excellent suitability with good pond condition.
			Pond area	0.4	
			Pond drying	0.5	
			Water quality	0.67	
			Shade	1	
			Fowl	1	
			Fish	1	
			Pond count	1	
			Terrestrial habitat	1	
			Macrophytes	1	
			Invasive species	Absent	
			Major damage	Absent	
			Silt levels	Moderate	
			Dumped Rubbish	Absent	
16	Grid reference: SO 63811 15384 Set within a depression this pond has steep banks and is surrounded by coniferous woodland home to a small sounder of boar. The pond is heavily silted and contains no macrophytes.		Location	1	Total HSI Score: 0.73 Good suitability with fair pond condition.
			Pond area	0.6	
			Pond drying	0.9	
			Water quality	0.67

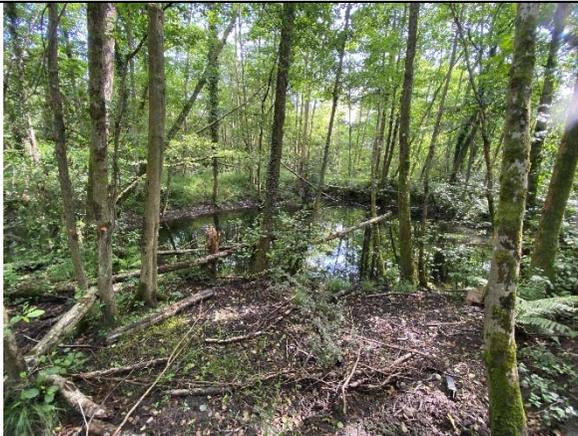
Terrestrial habitat	0.67	
			Macrophytes	0.3	
			Invasive species	Absent	
			Major damage	Absent	
			Silt levels	High	
			Dumped Rubbish	Absent	
18a	<p>Grid reference: SO 64475 15247</p> <p>Large man-made pond part of a cluster including ponds 1, 19, 9, & 18b said to have been created following open cast mining of coal, a channel in the centre joins the pond with 18b. Home to a resident sounder of wild boar the banks are heavily poached. Large carp were noted and discussion with local fisherman indicates that other coarse fish are likely present. Mallard and Canada goose were observed regularly. The pond is used by breeding common toads. <i>Ophrydium versatile</i> algae was also noted.</p>

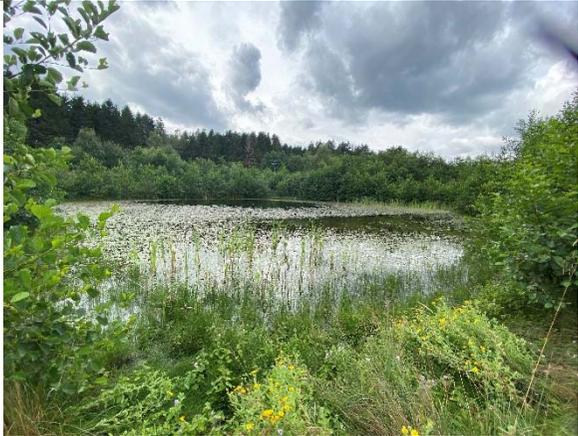
Location	1	<p>Total HSI Score: 0.29</p> <p>Poor suitability with poor pond condition.</p>

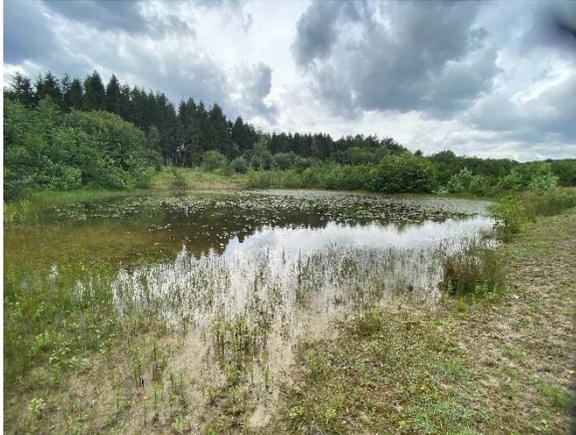
Pond Number	Pond Description	Photo	Pond Condition Assessment Criteria	Score per Index	Total HSI score and overall pond condition score
			Silt levels	Moderate	
			Dumped Rubbish	Present – clothing, food and drink containers, metal, glass, and plastics.	
18b	<p>Grid reference: SO 64475 15247</p> <p>Large man-made pond part of a cluster including ponds 1, 19, 9, & 18a said to have been created following open cast mining of coal, a channel in the centre joins the pond with 18a. Home to a resident sounder of wild boar the banks are heavily poached. Large carp were noted and discussion with local fisherman indicates that other coarse fish are likely present. Mallard and Canada goose were observed regularly. The pond is used by breeding common toads. <i>Ophrydium versatile</i> algae was also noted.</p>

Location	1	Total HSI Score: 0.31
			Pond area	0.92	Poor suitability with poor pond condition.

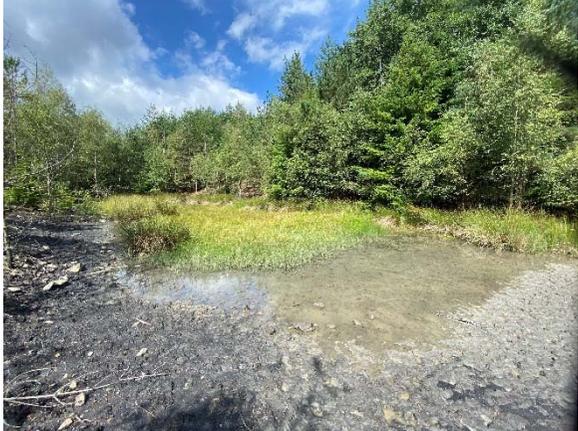
Pond Number	Pond Description	Photo	Pond Condition Assessment Criteria	Score per Index	Total HSI score and overall pond condition score
	Man-made pond set within former open cast coal mine, surrounding soil heavy in clay and coal. Home to a resident sounder of boar the banks are heavily poached. Surrounding mixed woodland is young and lacks structural heterogeny. Water levels were consistently low throughout the surveys.

Pond area	0.3	Good suitability with poor pond condition.
		Pond drying	1		
		Water quality	0.33		
		Shade	1		
		Fowl	1		
		Fish	1		
		Pond count	1		
		Terrestrial habitat	0.33		
		Macrophytes	0.9		
		Invasive species	Absent		
		Major damage	Present – banks heavily poached by boar		
		Silt levels	Moderate		
		Dumped Rubbish	Absent		
21	Grid reference: SO 63594 15248 A long pond with steep banks and extensive area of sphagnum moss at the southern end doubling pond size at high water. Water levels were consistently high throughout the survey period.		Location	1	Total HSI Score: 0.91 Excellent suitability with good pond condition.

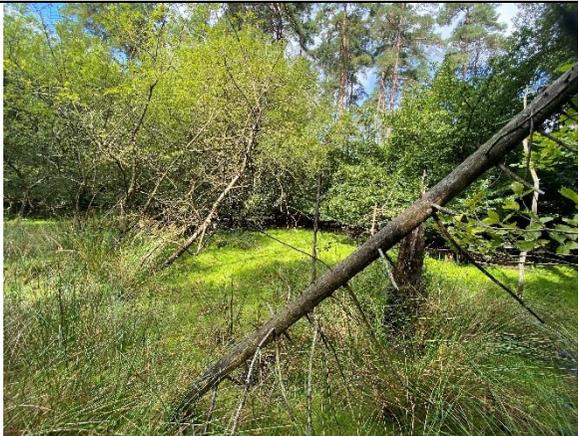
Terrestrial habitat	1	
			Macrophytes	0.9	
			Invasive species	Absent	
			Major damage	Absent	
			Silt levels	Moderate	
			Dumped Rubbish	Absent	
23a,b,c&17	<p>Grid reference: SO 64630 15702</p> <p>A single large waterbody comprising ponds 17, 23a, b, & c. Water levels fluctuated during survey window but remained as one waterbody. Pond is alongside forestry track regularly used by dogwalkers, dogs were observed entering the pond on several occasions and litter is high.</p>		Location	1	<p>Total HSI Score: 0.91</p> <p>Excellent suitability with fair pond condition.</p>
		Pond area	0.85		
		Pond drying	1		
		Water quality	1		
		Shade	1		
		Fowl	0.67		
		Fish	1		
		Pond count	1		
		Terrestrial habitat	1

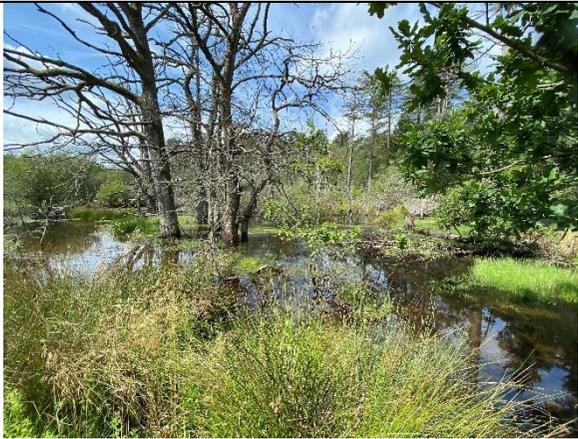
Macrophytes	0.7	
			Invasive species	Absent	
			Major damage	Absent	
			Silt levels	Moderate	
			Dumped Rubbish	Present - Motorbike frame and wheel in pond, plastic food and drink packaging	
24	<p>Grid reference: SO 64298 14549</p> <p>Man-made rectangular pond forming part of a cluster with 25 & 26 set within tussocky wet grassland of Laymoor Quag nature reserve north of the disused railway line. Dominated by broad leaved pondweed with some Typha and rush. Bottle trapping was halted following the discovery of water shrew at pond 25.</p>

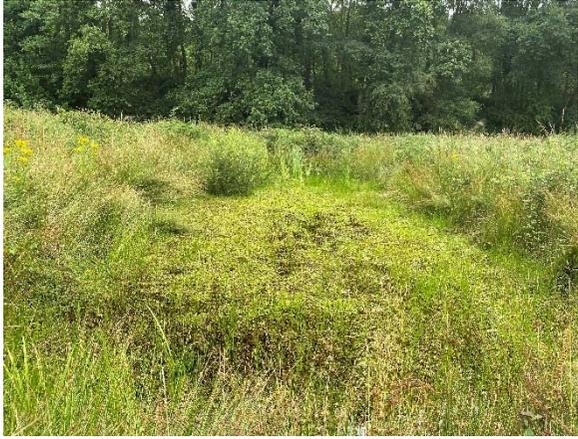
Location	1	<p>Total HSI Score: 0.89</p> <p>Excellent suitability with good pond condition.</p>
			Pond area	0.4	
			Pond drying	1	
			Water quality	1	
			Shade	1	
			Fowl	1	
			Fish	1	
			Pond count	1	
			Terrestrial habitat	1

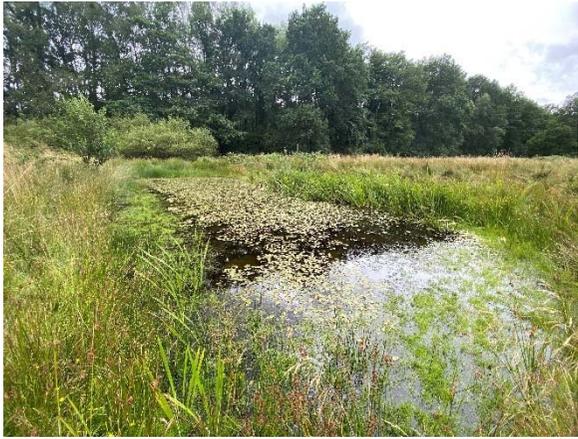
Pond Number	Pond Description	Photo	Pond Condition Assessment Criteria	Score per Index	Total HSI score and overall pond condition score
			Dumped Rubbish	Absent	
25	<p>Grid reference: SO 64357 14548</p> <p>Man-made rectangular pond forming part of a cluster with 24 & 26 set within tussocky wet grassland of Laymoor Quag nature reserve north of the disused railway line. Dominated by broad leaved pondweed with some Typha and sweet grass. Bottle trapping was halted following the discovery of water shrew.</p>

Location	1	<p>Total HSI Score: 0.90</p> <p>Excellent suitability with good pond condition.</p>
			Pond area	0.4	
			Pond drying	1	
			Water quality	1	
			Shade	1	
			Fowl	1	
			Fish	1	
			Pond count	1	
			Terrestrial habitat	1	
			Macrophytes	0.9	
			Invasive species	Absent	
			Major damage	Absent	
			Silt levels	Moderate	
Dumped Rubbish	Absent				
26	<p>Grid reference: SO 64457 14548</p> <p>Located at the side of the forestry track and forming part of a cluster with 24 & 26 set within tussocky wet grassland of Laymoor Quag nature reserve north of the disused railway line. Abundant crowfoot and sweet grass with some broad-leaved pondweed. Bottle trapping was halted following the discovery of water shrew at pond 25.</p>		Location	1	<p>Total HSI Score: 0.89</p> <p>Excellent suitability with excellent pond condition.</p>

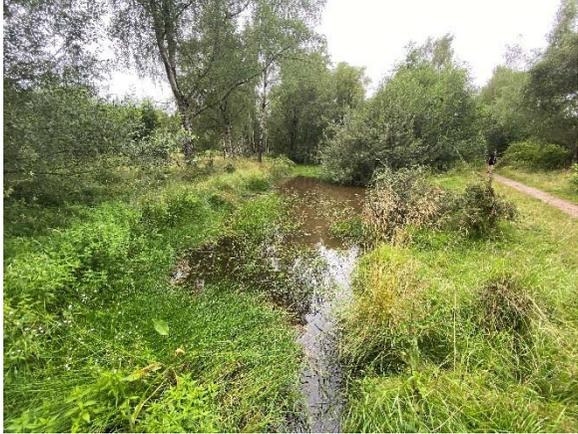
Terrestrial habitat	1	
			Macrophytes	0.9	
			Invasive species	Absent	
			Major damage	Absent	
			Silt levels	Low	
			Dumped Rubbish	Absent	
27a	<p>Grid reference: SO 64412 14465</p> <p>Forming part of a cluster of ponds south of Laymoor Quag with ponds 27b & c. This small pond dried out during surveys while surrounding water levels remained high.</p>

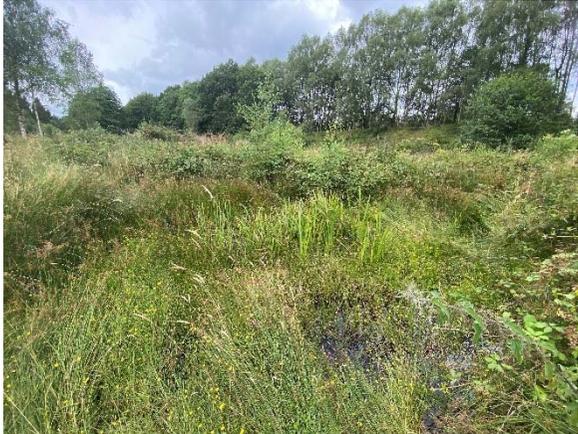
Location	1	<p>Total HSI Score: 0.58</p> <p>Below average suitability with good pond condition.</p>
			Pond area	0.05	
			Pond drying	0.1	
			Water quality	1	
			Shade	1	
			Fowl	1	
			Fish	1	
			Pond count	1	
			Terrestrial habitat	1	
			Macrophytes	0.85	
			Invasive species	Absent	
			Major damage	Absent	
			Silt levels	Moderate

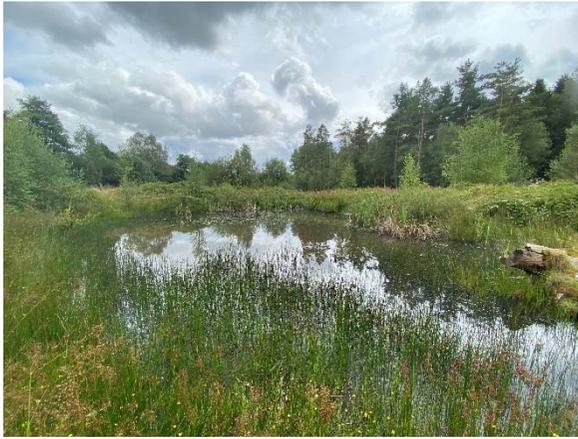
Pond Number	Pond Description	Photo	Pond Condition Assessment Criteria	Score per Index	Total HSI score and overall pond condition score
			Dumped Rubbish	Absent	
27b	<p>Grid reference: SO 64439 14438</p> <p>Forming part of a cluster of ponds south of Laymoor Quag with ponds 27a & c. Water levels remained high throughout the survey period. A resident sounder of boar was observed on many occasions, banks are poached through wallowing.</p>

Location	1	<p>Total HSI Score: 0.67</p> <p>Average suitability with poor pond condition.</p>
			Pond area	0.4	
			Pond drying	0.5	
			Water quality	1	
			Shade	1	
			Fowl	0.67	
			Fish	0.33	
			Pond count	1	
			Terrestrial habitat	1	
			Macrophytes	0.4	
			Invasive species	Absent	
			Major damage	Present – banks poached and denuded, extensive boar wallowing at northern end	
			Silt levels	Moderate	
			Dumped Rubbish	Absent	
27c	<p>Grid reference: SO 64462 14409</p> <p>Forming part of a cluster of ponds south of Laymoor Quag with ponds 27a & b. Water levels remained high throughout the survey period. A</p>		Location	1	<p>Total HSI Score: 0.75</p> <p>Good suitability with good pond condition.</p>

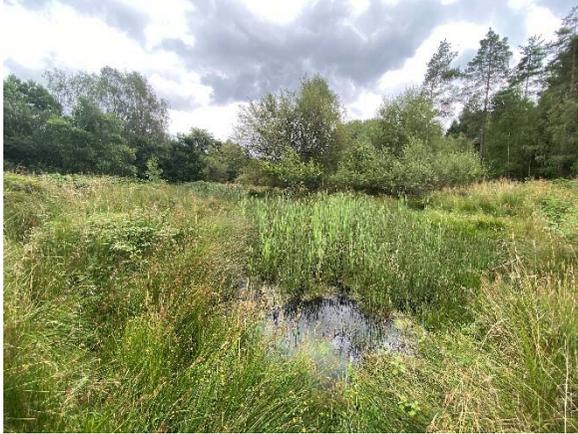
Fowl	0.67	
			Fish	0.33	
			Pond count	1	
			Terrestrial habitat	1	
			Macrophytes	1	
			Invasive species	Absent	
			Major damage	Absent – only minor poaching by boar	
			Silt levels	Moderate	
			Dumped Rubbish	Absent	
28	Grid reference: SO 64457 14205 A small pond on the woodland edge south of ponds 27a-c, surrounded by many depressions and with much coal at the surface indicating likely result of open cast mining.

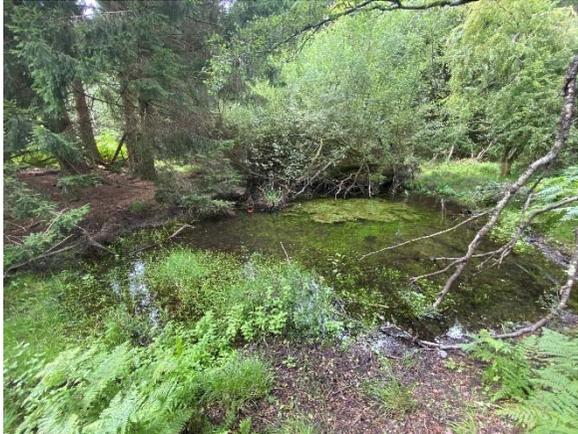
Location	1	Total HSI Score: 0.64 Average suitability with good pond condition.
			Pond area	0.3	
			Pond drying	0.1	
			Water quality	1	
			Shade	0.6	
			Fowl	1	
			Fish	1	
			Pond count	1	
			Terrestrial habitat	1	
			Macrophytes	0.6	
			Invasive species	Absent	
			Major damage	Absent	
			Silt levels	Low

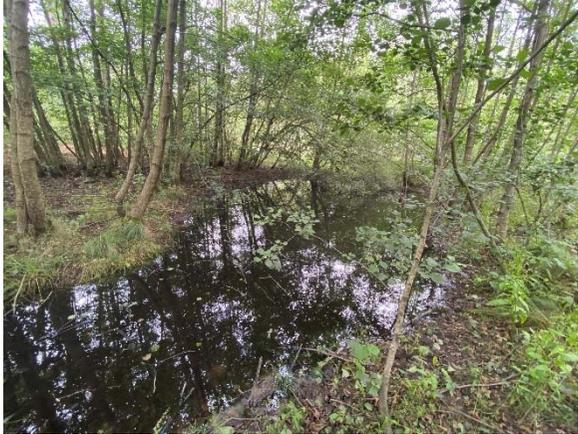
Pond Number	Pond Description	Photo	Pond Condition Assessment Criteria	Score per Index	Total HSI score and overall pond condition score
			Dumped Rubbish	Present – Plastic bucket and lid in pond	
30	Grid reference: SO 64496 15041 Part of a cluster with ponds 2-5. Heavily shaded within woodland and with no macrophytes.

Location	1	Total HSI Score: 0.64 Average suitability with good pond condition.
			Pond area	0.1	
			Pond drying	0.9	
			Water quality	1	
			Shade	0.4	
			Fowl	1	
			Fish	1	
			Pond count	1	
			Terrestrial habitat	1	
			Macrophytes	0.3	
			Invasive species	Absent	
			Major damage	Absent	
			Silt levels	Low	
			Dumped Rubbish	Present – Glass, tin and plastic drink containers	
31	Grid reference: SO 64478 14996 Sat alongside pond 6 in the woodland clearing surrounded by tussocky grassland. This small pond has one of the most biologically diverse invertebrate communities of all ponds monitored.		Location	1	Total HSI Score: 0.79 Good suitability with excellent pond condition.

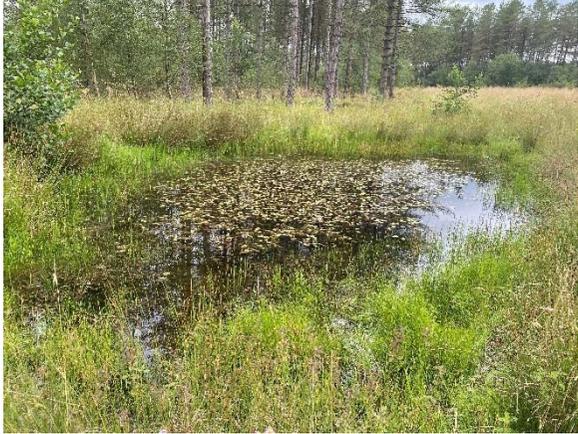
Fish	1	
			Pond count	1	
			Terrestrial habitat	1	
			Macrophytes	1	
			Invasive species	Absent	
			Major damage	Absent	
			Silt levels	Low	
			Dumped Rubbish	Absent	
N1	<p>Grid reference: SO 64279 15152</p> <p>One of four man-made ponds at the east of the site. Banks are steep with little vegetation, the pond lined with clay and excavated soil banded around the pond. Surrounding habitat is rank grassland with bracken and scrub, habitat piles have been created nearby and a variety of whips / saplings planted. The pond would benefit from re-profiling of banks to form shallower margins.</p>

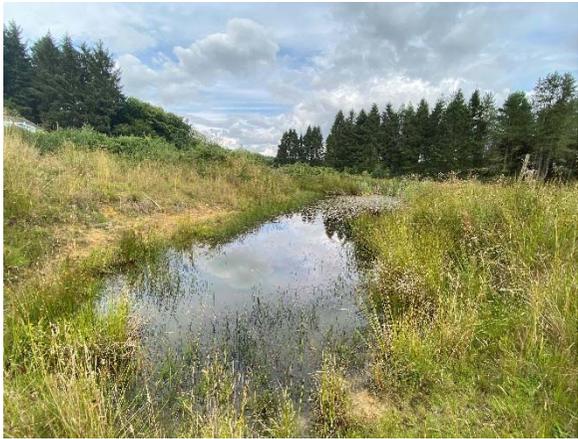
Location	1	<p>Total HSI Score: 0.84</p> <p>Excellent suitability with good pond condition.</p>
			Pond area	0.4	
			Pond drying	0.9	
			Water quality	0.67	
			Shade	1	
			Fowl	1

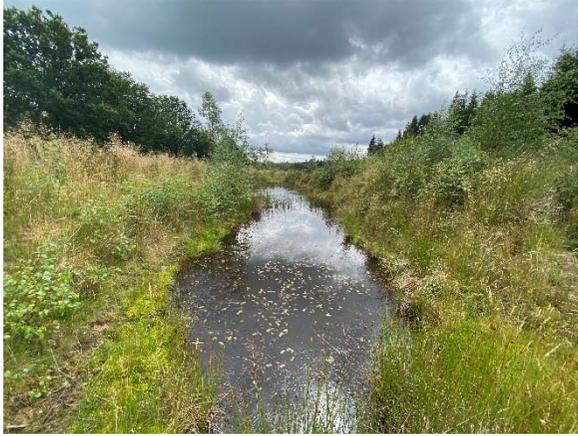
Pond Number	Pond Description	Photo	Pond Condition Assessment Criteria	Score per Index	Total HSI score and overall pond condition score
			Dumped Rubbish	Absent	
N2	<p>Grid reference: SO 64291 15022</p> <p>One of four man-made ponds at the east of the site. Banks are steep with little vegetation, the pond lined with clay and excavated soil banded around the pond. Surrounding habitat is rank grassland with bracken and scrub, habitat piles have been created nearby and a variety of whips / saplings planted. The pond would benefit from re-profiling of banks to form shallower margins, some wallowing by boar is helping to establish shallows at the northern end.</p>

Location	1	<p>Total HSI Score: 0.79</p> <p>Good suitability with good pond condition.</p>
			Pond area	0.4	
			Pond drying	0.9	
			Water quality	0.67	
			Shade	1	
			Fowl	1	
			Fish	1	
			Pond count	1	
			Terrestrial habitat	1	
			Macrophytes	0.4

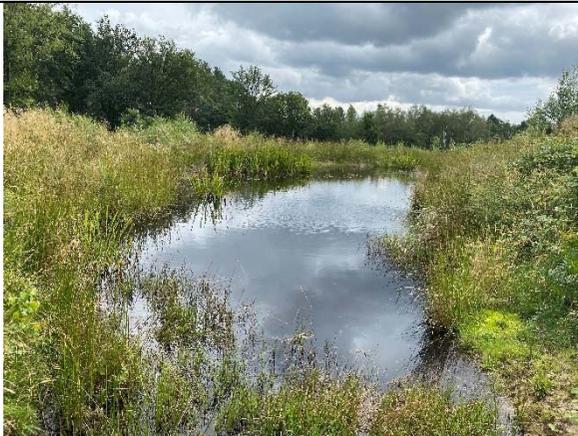
Pond count	1	
			Terrestrial habitat	1	
			Macrophytes	0.4	
			Invasive species	Absent	
			Major damage	Absent – only minor poaching of banks	
			Silt levels	Moderate	
			Dumped Rubbish	Absent	
N4	Grid reference: SO 64245 14723 One of four man-made ponds at the east of the site. Banks are steep with little vegetation, the pond lined with clay and excavated soil banded around the pond. Surrounding habitat is rank grassland with bracken and scrub, habitat piles have been created nearby and a variety of whips / saplings planted. The pond would benefit from re-profiling of banks to form shallower margins, poaching by boar at northern and southern ends of the pond is aiding the establishment of macrophytes.

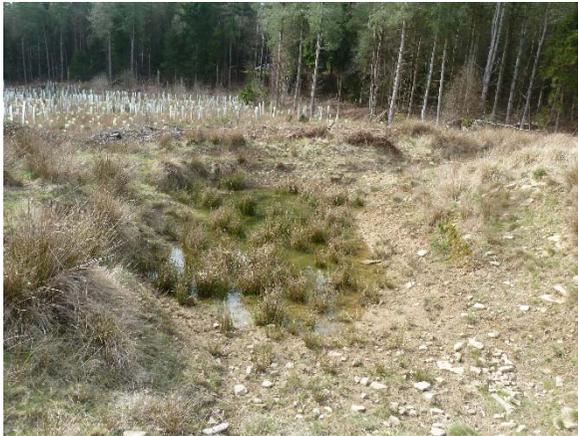
Location	1	Total HSI Score: 0.69
