**Condition Appraisal  
Of  
Listed Buildings at Risk  
In  
Forest of Dean District Council Area  
For Forward Planning**

Survey carried out by Tony Gwynne & Samm Jarman

Survey Date: 2017-2018

Published: July 2019

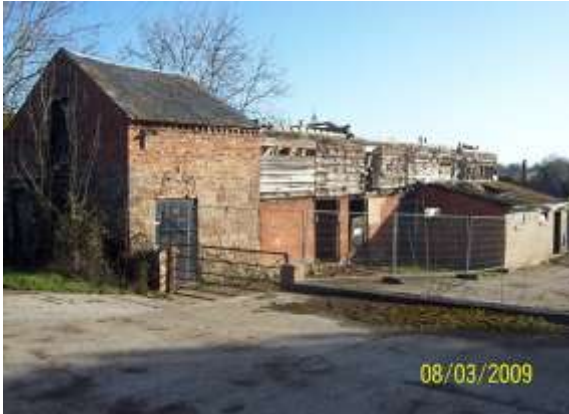
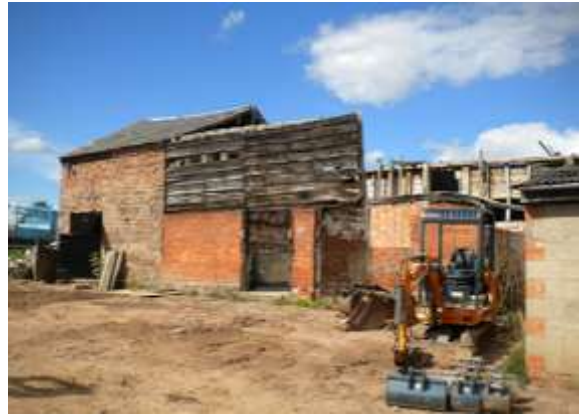
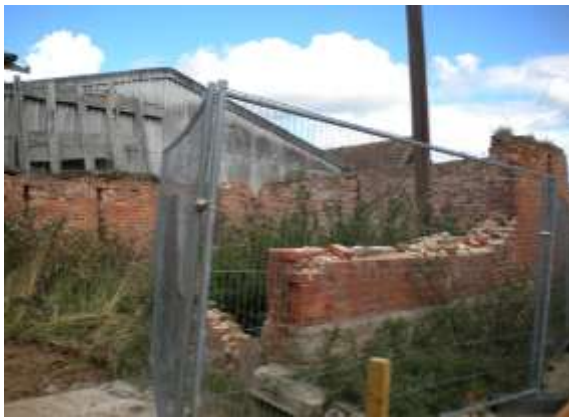
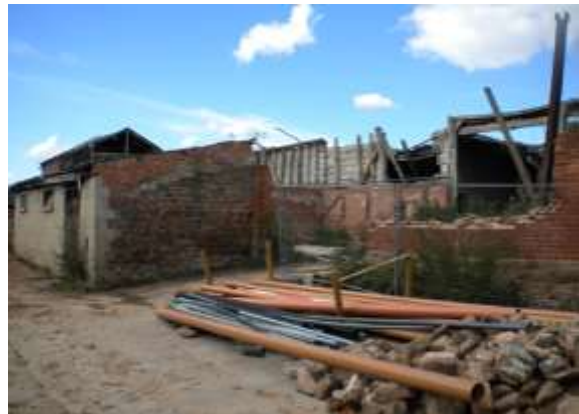
In March 2006 the barn and cow shed condition was reported in the buildings at risk register as worsening and was upgraded from risk category 3 to 1 which is an immediate priority risk. The building part timber framed upper portions upon a brick ground floor continued to decay to a point of no return.

This historic building which was listed in its own right as well as forming part of the curtilage and setting of the Grade II\* farm house was in an advanced stage of structural collapse an application was made for its demolition. Many of the original materials had been removed prior to the current owners occupation.

The original listed building no longer exists and can be removed from the buildings at risk register.

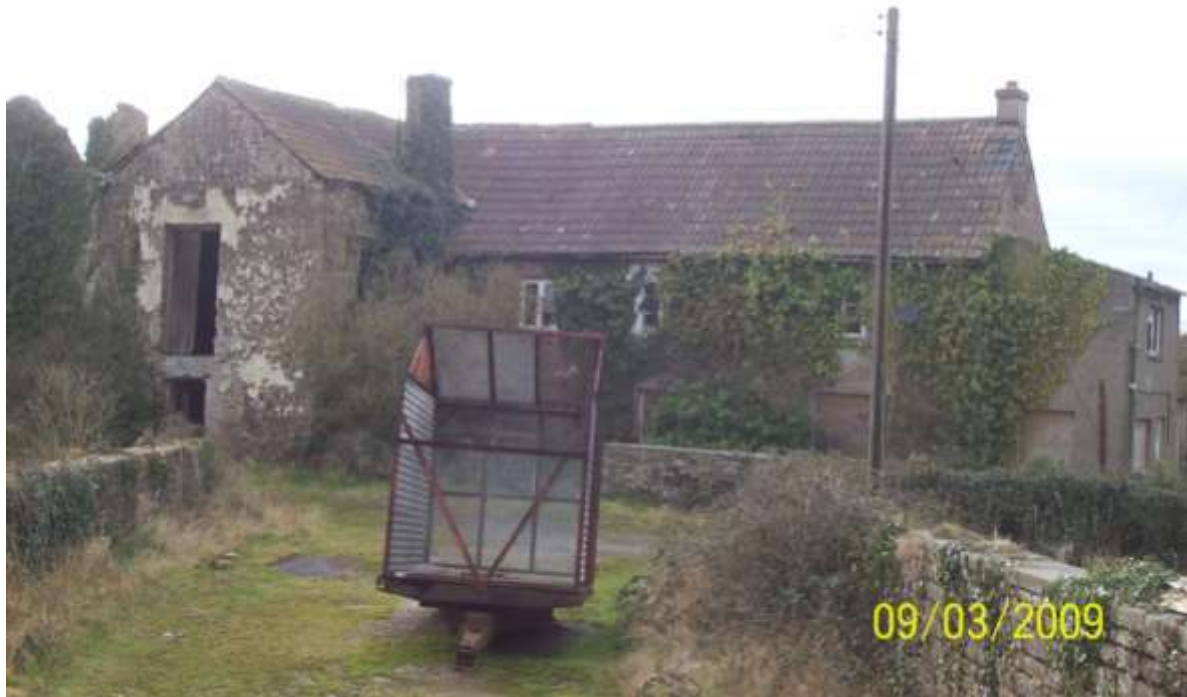
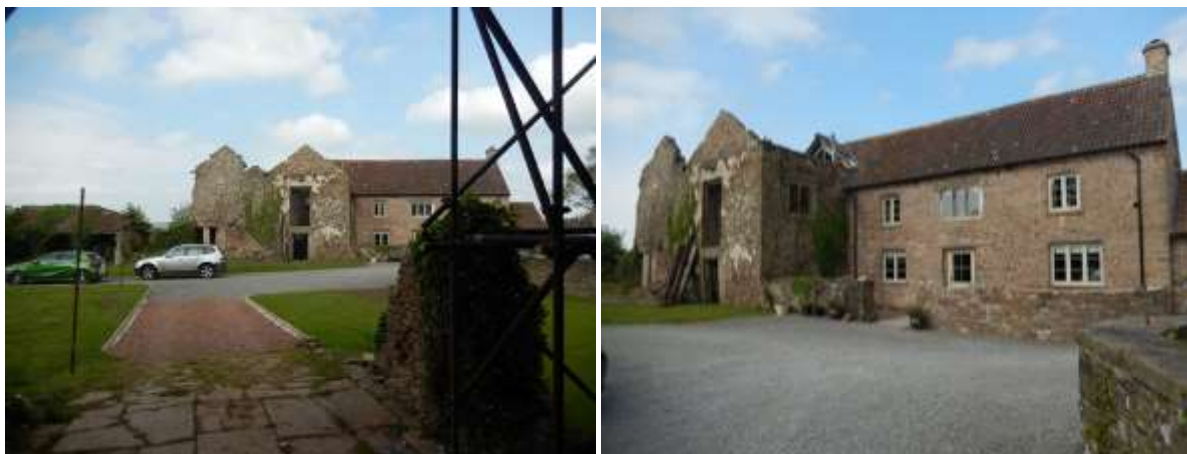
Above the farmhouse and granary building 2017. The main house has been complete renovated however there is considerable work required for the rest of the buildings within the farmstead and these will continue to be on the Buildings at Risk Register.

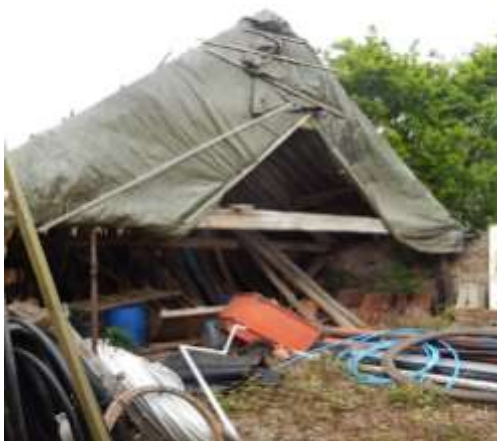
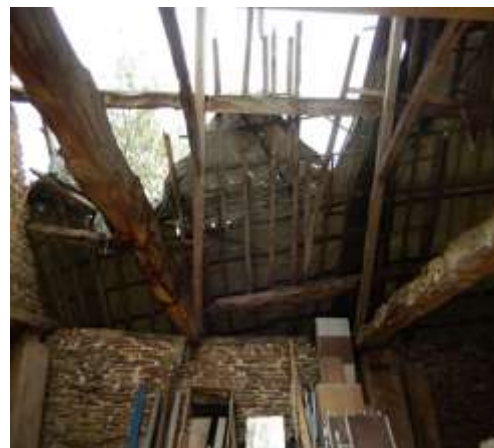
The North Barn has not been maintained and is in a deteriorated condition and requires extensive repairs/replacement of defective roof timbers and re-fixing of sound roof tiles to make the building watertight. The external walls require repairs and localised rebuilding/re-pointing to stabilise the walls to prevent further deterioration of the structure.

1. The owner has already carried out emergency works to prevent further collapse and to stabilise the structure and has confirmed that he intends to carry out urgent repairs/replacement works to make it watertight (possibly re-roofing with profiled metal sheeting- subject to listed building consent) and carry out total renovations within the next five years and any urgent works will be carried out as they become necessary to stabilise the structure and prevent any further decay and loss of the original fabric.
2. This building should remain on the buildings at risk register and the condition of the building should be monitored.

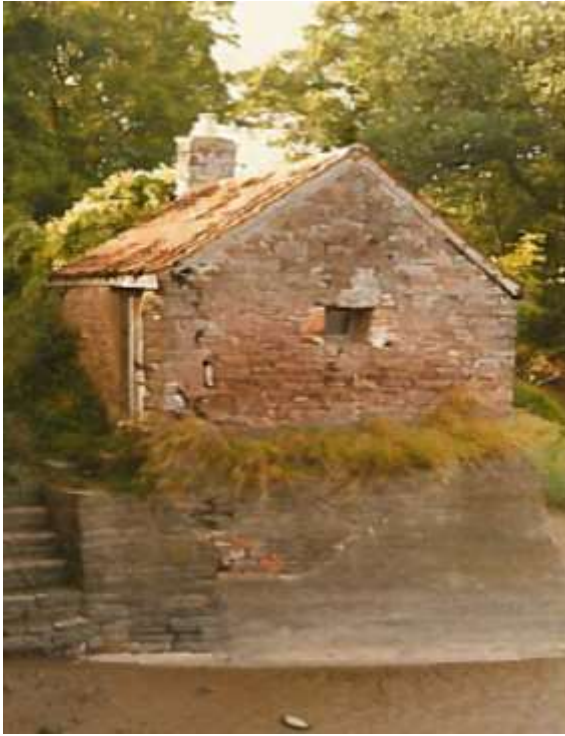
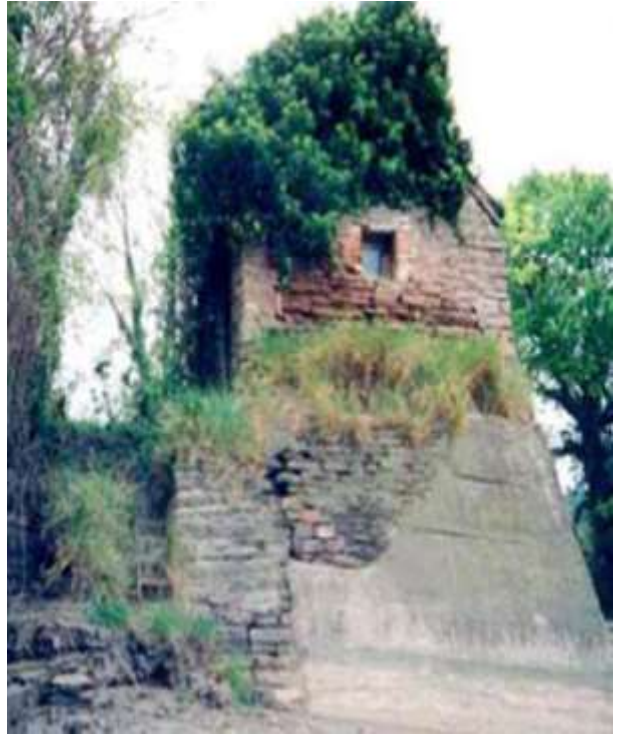
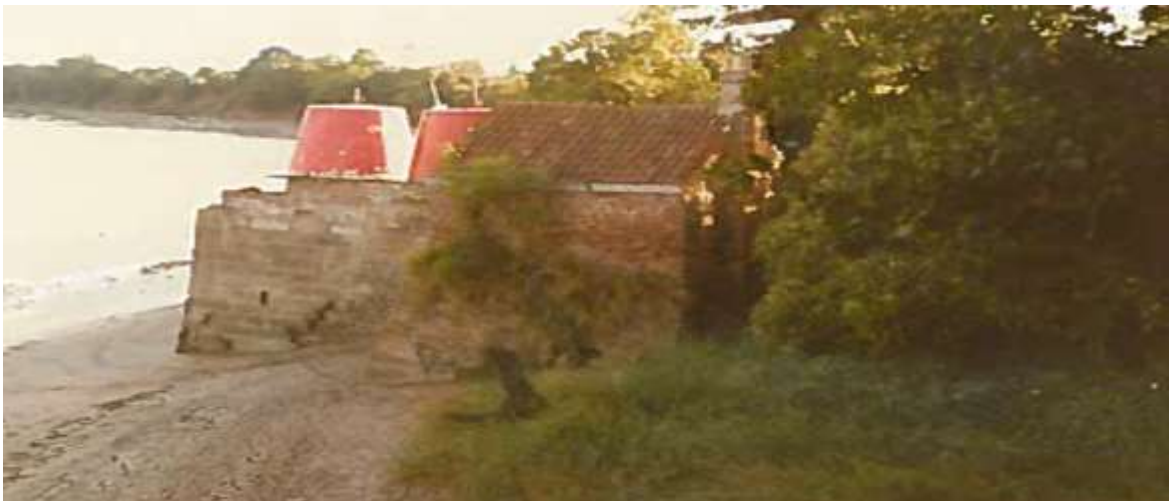
*15<sup>th</sup> August 1989*

In March 2006 the fish house was in a much deteriorated condition and was in risk category 1 which is an immediate priority risk. Following an application made to Historic England, to delist the building due to its ruinous state following fire damage, its roofless shell, partially collapsed state and with regular tidal flooding following flood defence work it was deemed that the surviving fabric of the Fish House did not clearly reflect its previous form or function.

On the 14th December 2009 the Fish House and Landing stage at Collow Pill were removed from the Schedule of Historic Buildings and therefore delisted. Sadly, since that time, the building has fallen victim to the waters and no longer exists.

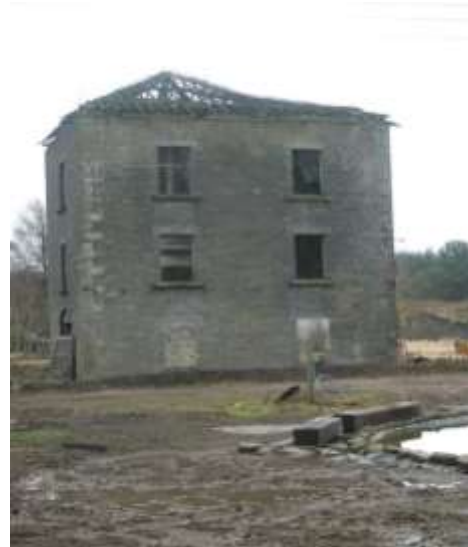
*2011 the Pumphouse has the remains of its roof.*

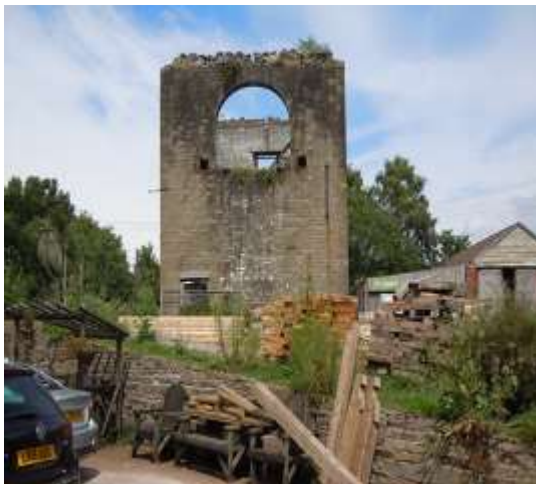
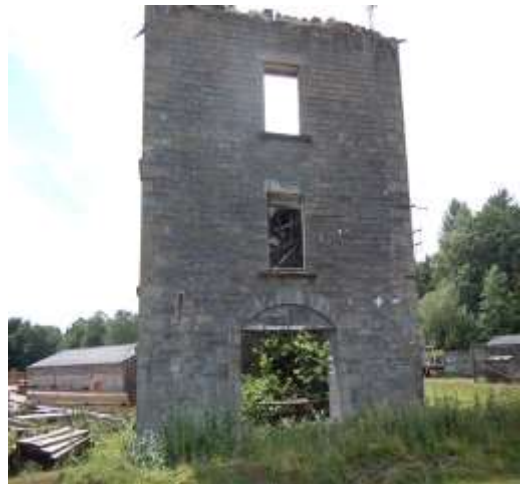
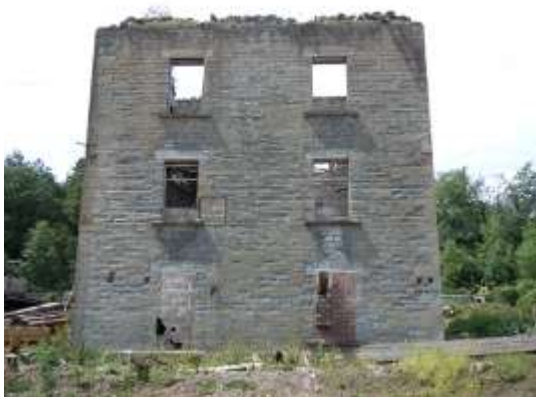
*2017 the Pumphouse is only a shell, all the floors are gone, roof structure and the masonry is very loose in various areas. This building is at high risk of collapse.*

In March 2006 the building was in risk category 1 and 2 and was in poor condition and at extreme risk of further deterioration. Since then it is apparent that there has been no maintenance and the roof has totally collapsed into the building.

Stone work at roof level has deteriorated, appears loose and loss of the historic fabric has occurred. The loose stone work is a potential danger to anyone in or around the building and the top of the wall requires capping urgently in matching lime mortar to stabilise the stone work and prevent further loss of the building fabric

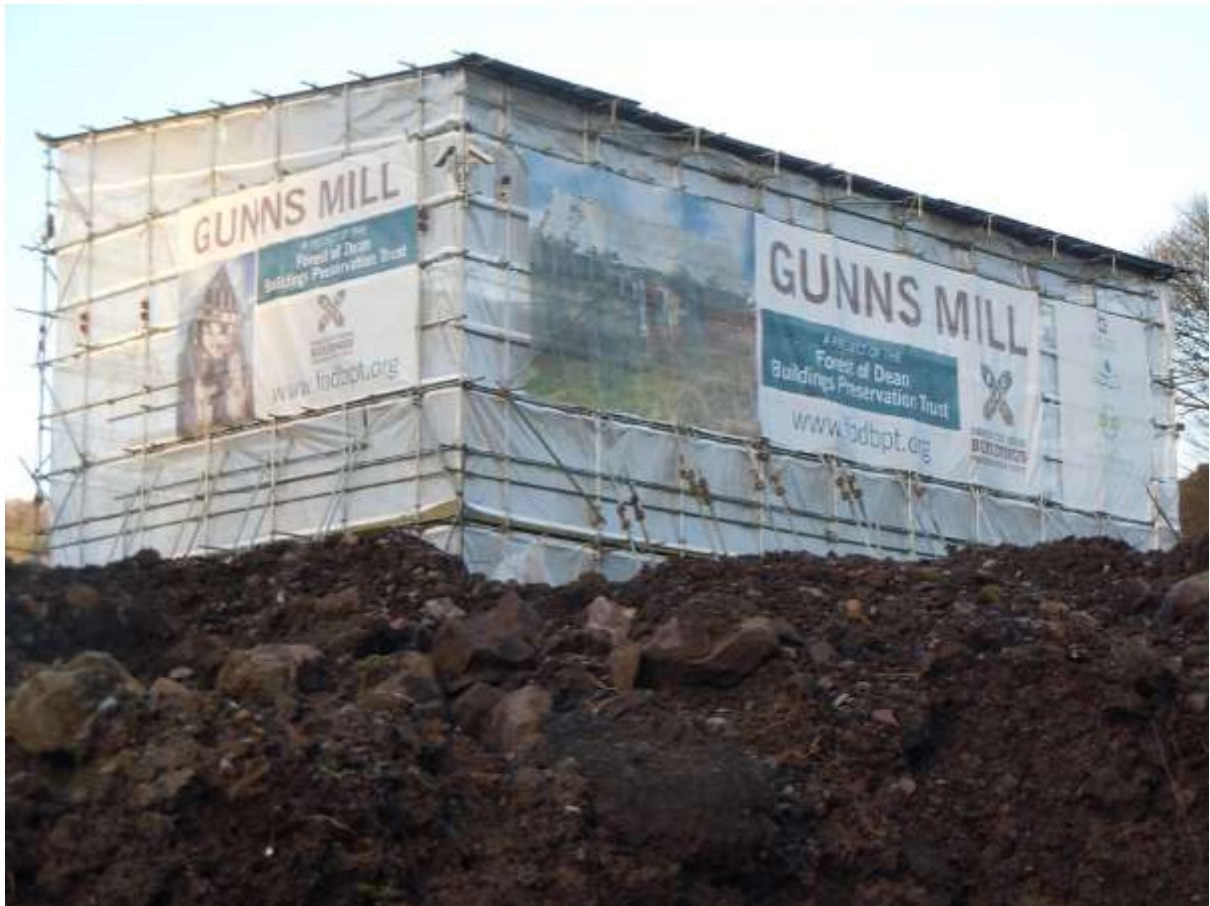
*The mill building reclad following an overhaul of the scaffolding 2015*

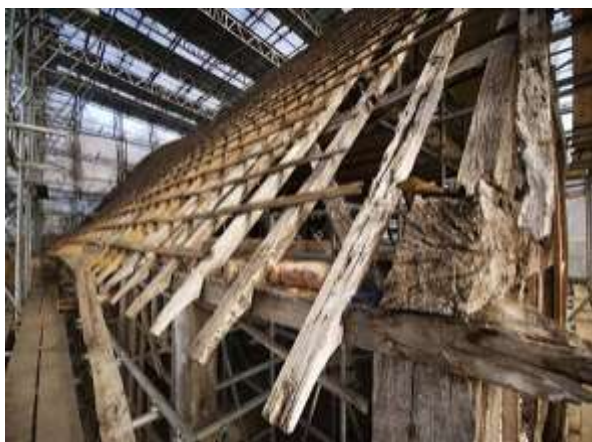
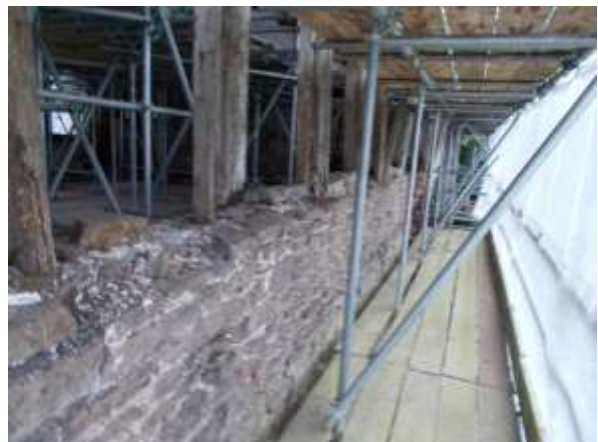
*The roof has been stripped back to allow a detailed survey to be done, The pictures show just how frail the building is.*

In March 2006 the building was reported in the buildings at risk register as risk category 1 which is an immediate priority risk. Since then, The FoDBPT has acquired ownership of the building and has concentrated on stopping further deterioration, employed a project manager and structural engineer and has constructed a retaining wall to secure the site boundary. The building has been stabilised and is supported and surrounded by scaffolding and is completely weatherproofed in plastic sheeting. An interpretation board has been put up on the site to provide information on the building.

This building should remain on the buildings at risk register and the condition of the building should be monitored.

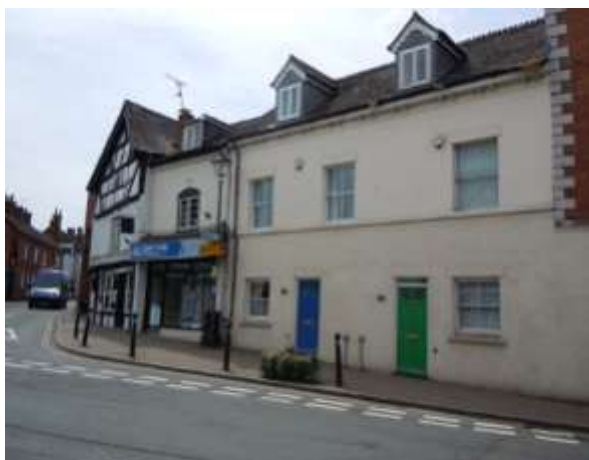
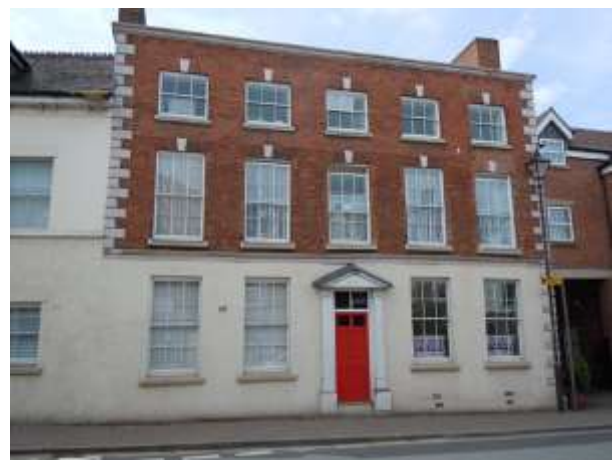
2017

Planning Permission was granted under P0401/06/LBC for the conversion of the existing building into 6 self-contained flats. This permission was part of a bigger scheme under made under P1050/05/FUL - Erection of 26 sheltered housing units and conversion of existing premises into 6 flats. Alterations to vehicular access and layout of associated parking facilities.

No further works are necessary and can be removed from the buildings at risk register

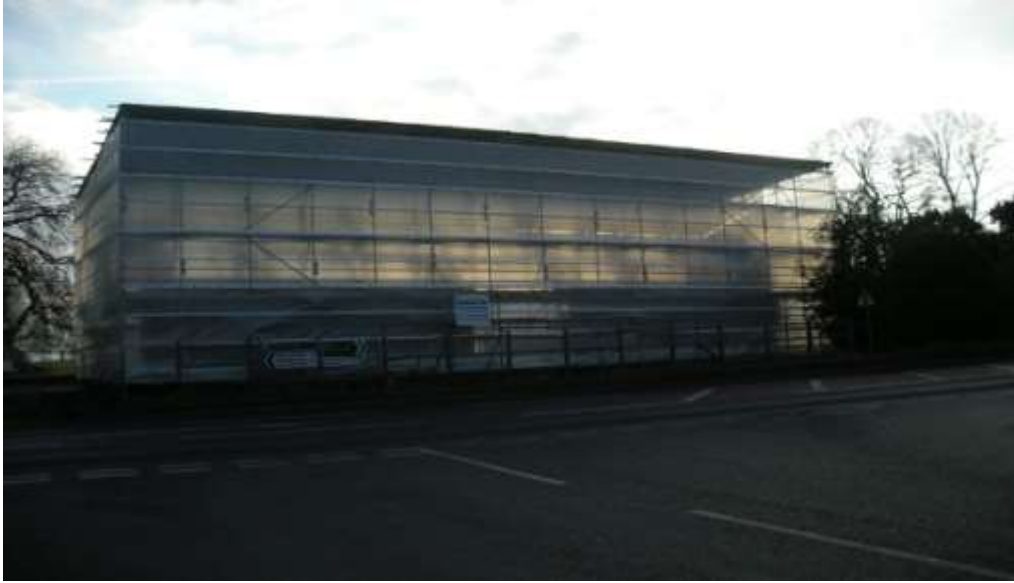
In 2006, the building was recorded as being at risk with timber framed connections parting and a planning application was pending on 19th April 2006.

The building was inspected on 13th July 2017 and has now been renovated to a good standard. Although the building was not accessible at the time of the inspection it was viewed externally from the road side and it is evident that the pitched roof has now been retiled in rosemary tiles (small clay plain tiles) with conservation roof lights and external walls have horizontal timber cladding—it is clear if this has covered over the original brick noggin and exposed timber frame.

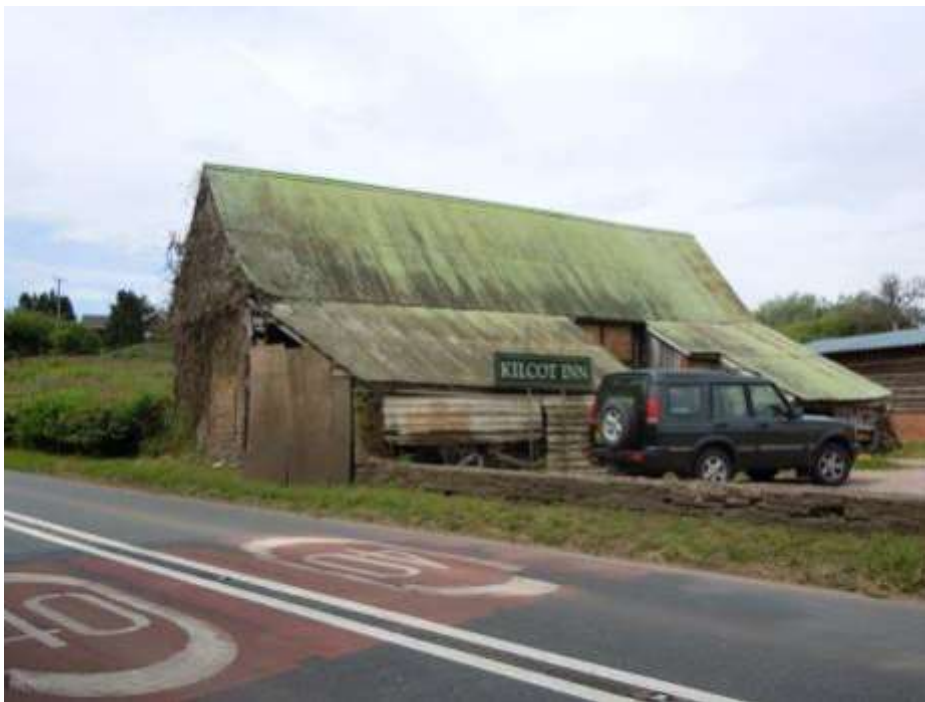
In March 2006 the barn was in risk category 3 and was in fair condition. Since then it is apparent that there has been a lack of maintenance and the external gable end wall on the side elevation (closest to the pub) has partially collapsed away at plinth level, is bowing outward and has a large vertical crack up to the timber cladding level. The wall is in a potentially dangerous condition and it requires temporary support to stabilise the wall and prevent further collapse of the building.

The building is in danger of collapse, water penetration, external timbers rotten and damaged brickwork.

Site is to remain on Buildings at Risk Register and to be visited in the next review.

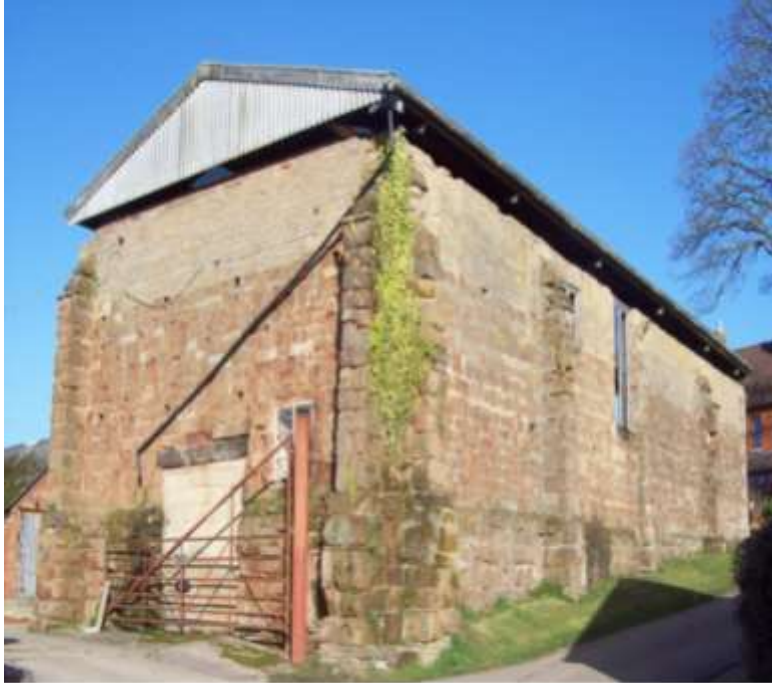
2009

The store was listed without the roof - which in the last 30 years has been replaced with modern corrugated cement fibre sheets supported by timber purlins and a steel frame erected within the building which is keeping the building weather tight.

Externally, the roughly course and squared red sandstone walls are suffering from extensive wind erosion and scaling of the stone faces has occurred, lime mortar has eroded away leaving open joints and loose areas of stone and is generally in very poor condition. The external walls require urgent repairs and localised rebuilding/re-pointing to stabilise the walls to prevent further deterioration of the structure.

The site will remain on the Buildings at Risk Register and will be visited during the next review.

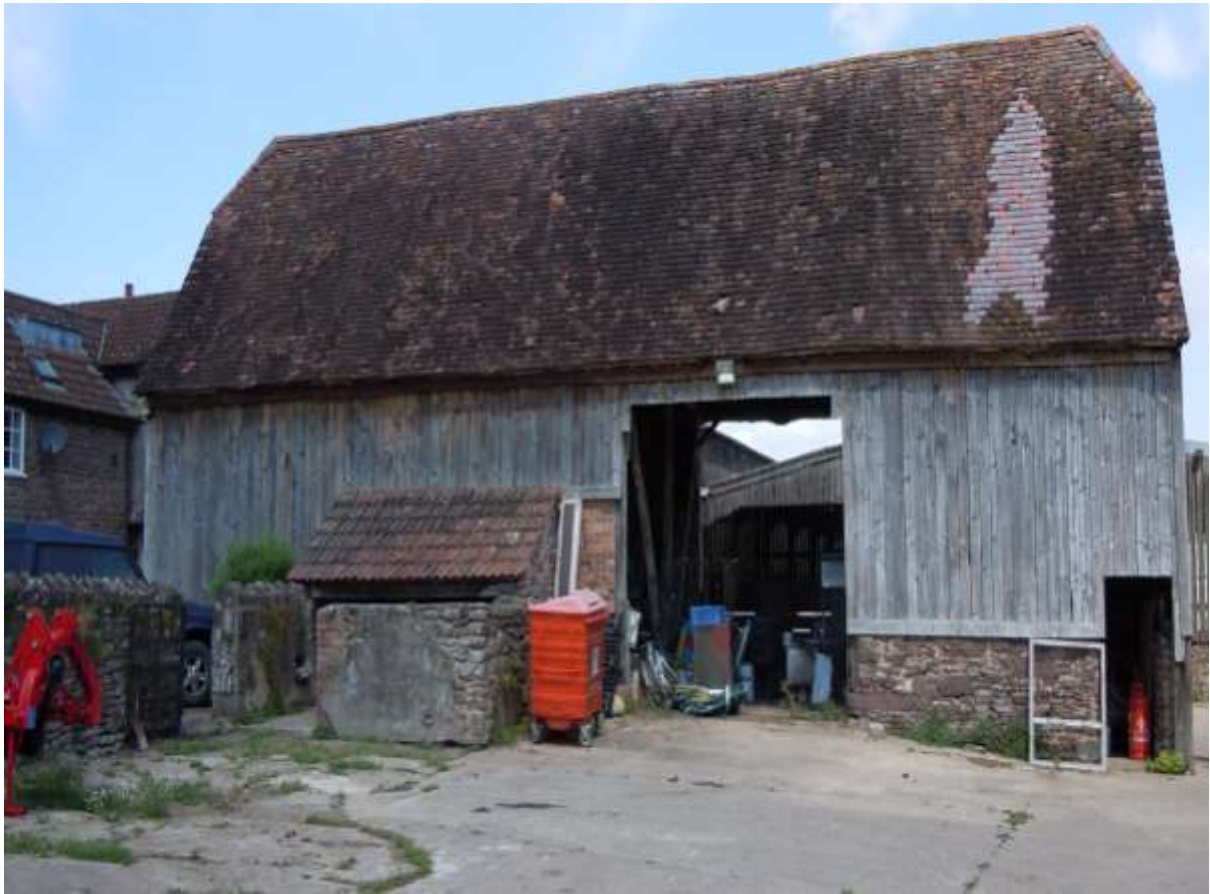
2017

The owner has confirmed that vertical timber cladding has been fixed over the original oak frame and brick noggin /wattle and daub infill panels to the walls of the barn to keep the building weather tight and prevent any further deterioration of the panels which were beginning to fall apart, particularly the higher panels which were potentially dangerous to any walking below them.

The gable end wall adjacent to the farmhouse house has been partially timber clad, but the remaining exposed timber frame with brick noggin /wattle and daub infill panels are in a very deteriorated condition and daub has started to laminate off the wattle panels. The panels are a potential danger and require urgent repair works to make them weather proof and prevent further loss of this important historic fabric.

The timber frame appears structurally sound, the clay Rosemary roof tiles are in fair condition and the owner has agreed to re-fix/replace slipped tiles/defective tiles to match the existing to ensure the building is weather tight.

Defective mortar to the stone work plinth and remaining rubble wall to gable end stairs requires re-pointing in lime mortar to match the original.

Site to remain on the Buildings at Risk Register and will be visited during next review.

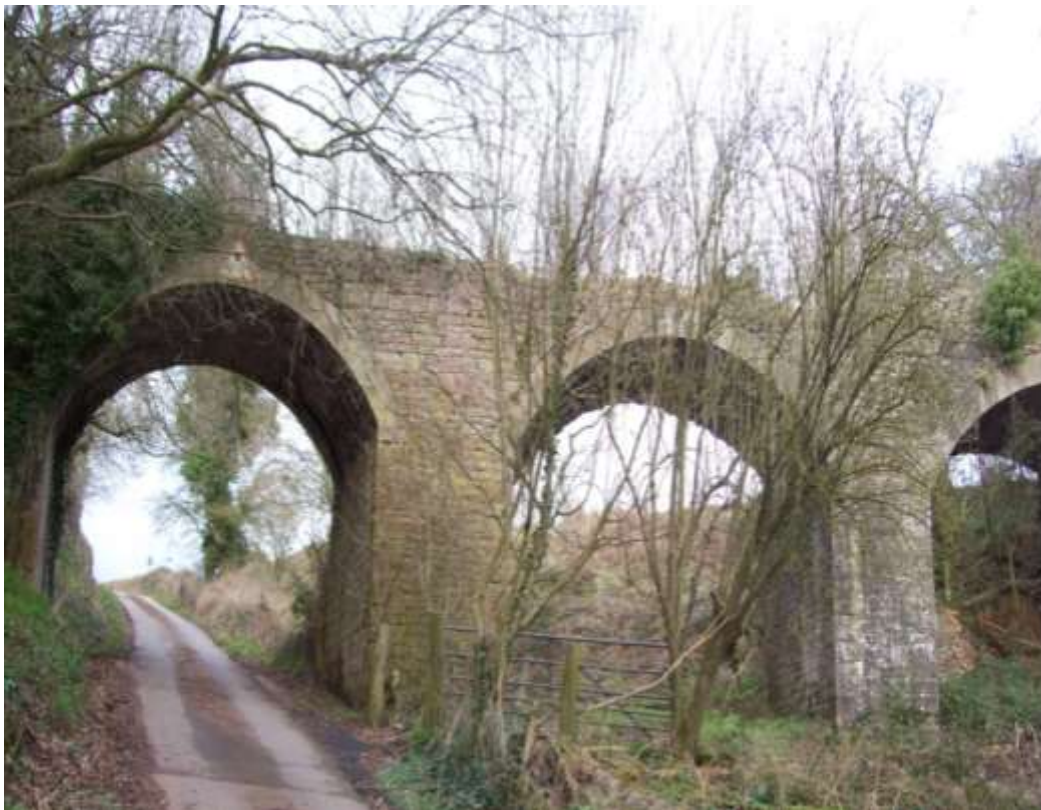
2009

Extensive vegetation and tree growth is evident. Main walls appears stable however, upper courses of stonework appear loose and the majority of the mortar joints are defective.

Main arches appears to be stable however a number of the face voussoirs are missing from the crown of the central arch on the upper road level side and the mortar joints are defective

Main walls appears to be stable however upper courses of stone work at the bridge abutments appears loose and the majority of the mortar joints are defective

Extensive vegetation and tree growth is evident to the complete structure. Main stone walls and arches appears stable however, there are areas of stonework that appear loose and the majority of the mortar joints are defective allowing the ingress of moisture, frost action and root growth causing progressive deterioration of the structure and loss of the historic fabric.

Periodic inspections are required to monitor the condition of the complete structure. Remain on register and to be visited during next review.

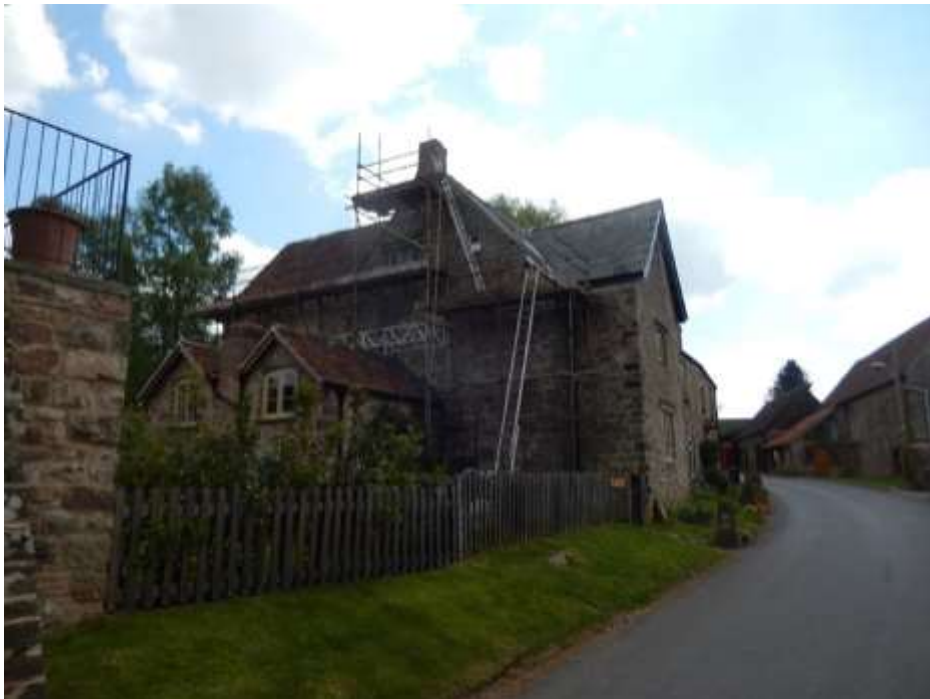
The cottages were inspected on 4th May 2017, although there was no internal access, it is evident that sensitive repair and renovation works are in progress. The owner later confirmed the following by email:

- Ingress of water into the building through a lack of maintenance and defective roof coverings etc over the past decades has caused extensive water damage to the interior and the decay of roof and floor timbers which have partially collapsed in areas.
- The roof structure, slate roof coverings and windows are being repaired and the building is now water tight.
- The work is being inspected by building control and I can confirm that repairs have also been carried out to the first and second floors, chimneys and stone walls and repair / renovation works are still in progress.

This building should remain on the buildings at risk register and the condition of the building should be monitored.

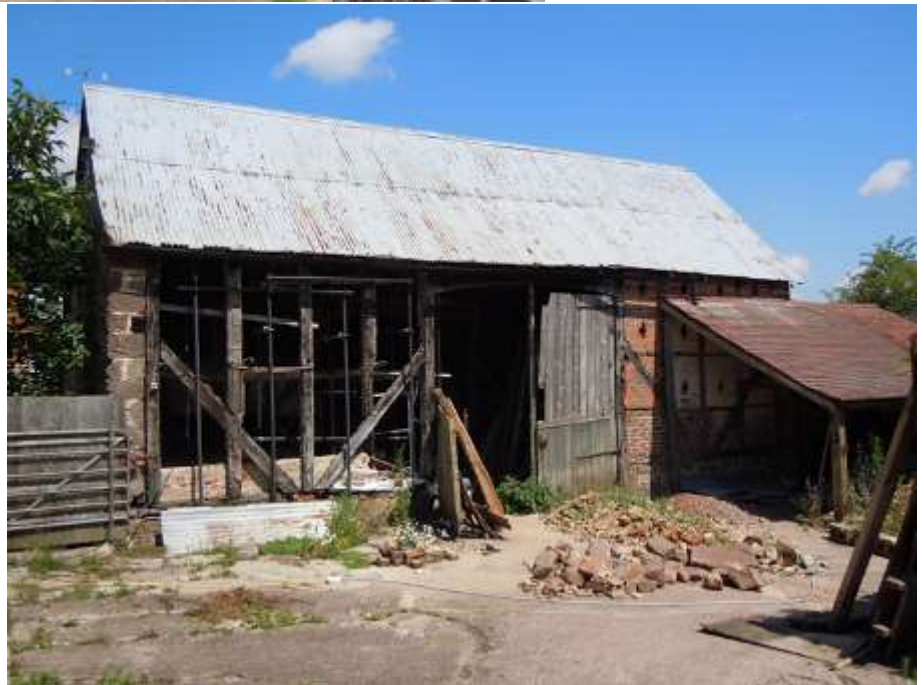
2017

- Infill brick panels were taken down by the owner as they claim they were in a state of collapse and intends to reinstate them back in lime mortar to match the existing.
- Repair /renovation works are in progress, rebuilding/re-pointing of defective areas of stone walls have been carried out.
- The owner has submitted a building regulations application for the works which is currently being inspected by building control

This building should remain on the buildings at risk register and the condition of the building should be monitored.

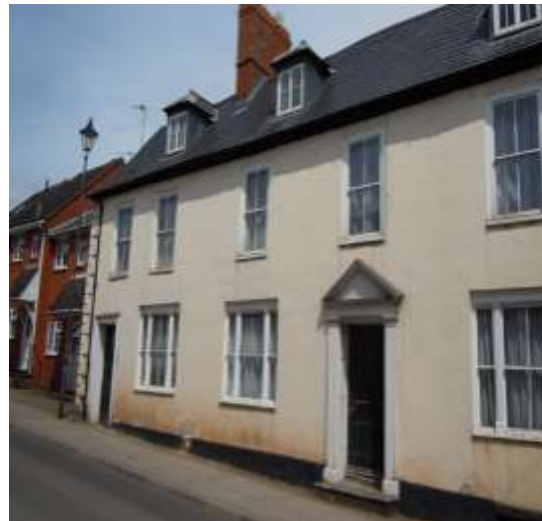
2017

The building was inspected externally from the front elevation on 22nd May 2017. There was no internal access or access to the rear of the building. It is evident that since 2006, the building had been renovated with a new slate roof covering and lead work, front elevation re-rendered in lime with a painted finish. It appears the windows have been repaired. The standard of the work is not what you would expect of a listed building- for example, one or two roof tiles have slipped, lead work is poorly detailed, lime rendering has blown off in small areas and rot is evident in windows. This condition will deteriorate if not addressed.

Although this building should be taken off the buildings at risk register, it is recommended that its upkeep is monitored.

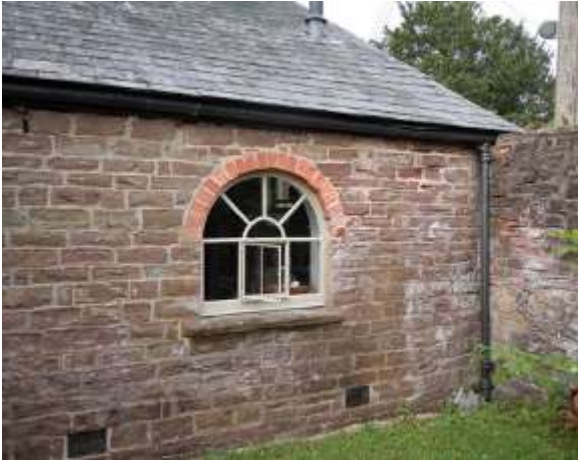
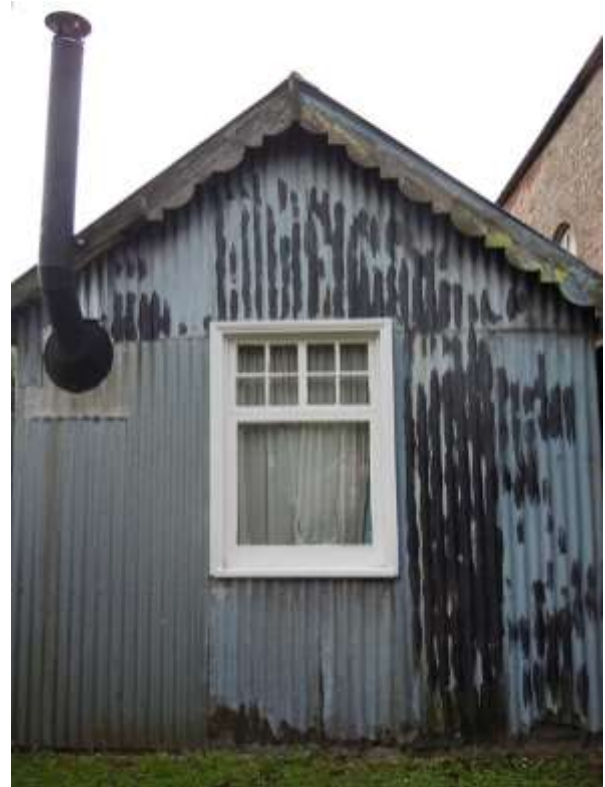
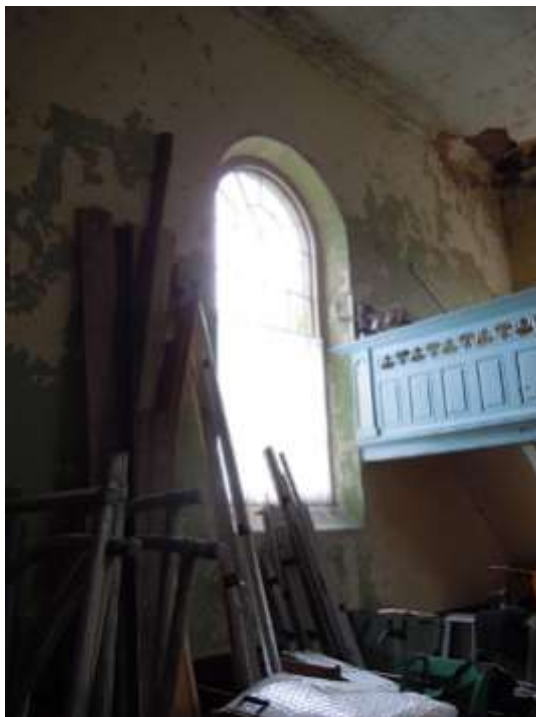
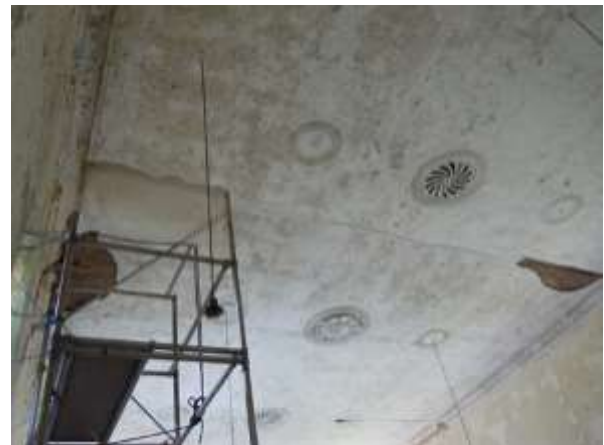
2017

- The chapel and school building has been re-roofed using slate, treated battens and a breathable roof membrane. The iron rainwater goods are in good condition. The existing chapel roof structure was not accessible at the time of the inspection but the owner has agreed for me to carry out a future inspection including a defective hidden gutter which needs repair. The school house roof appears in good condition (there is a good lead flashing at the roof/wall junction of the chapel which appears to be defective lime fillet).

- The chapel is undergoing repairs to the original windows, floor and ceiling and restoration works to the chapel and school buildings are ongoing and may take over 5 years to complete (indicated by the owner).

This building should remain on the buildings at risk register until the chapel ceiling, floor and windows etc have been repaired. The condition of the building should be monitored.

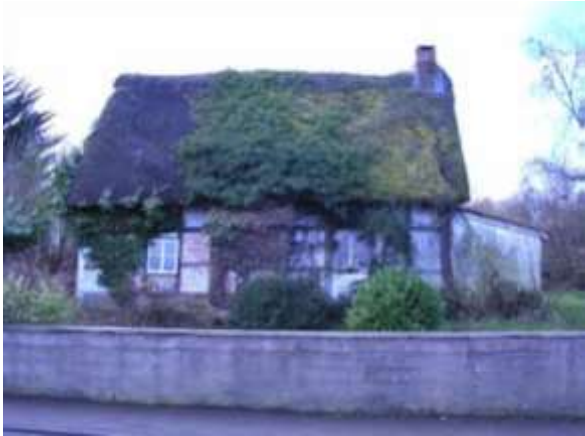
In March 2006 the barn was recorded as being in risk category 3 and the thatch was in poor condition.

*Ivy House in 2006 At Risk*

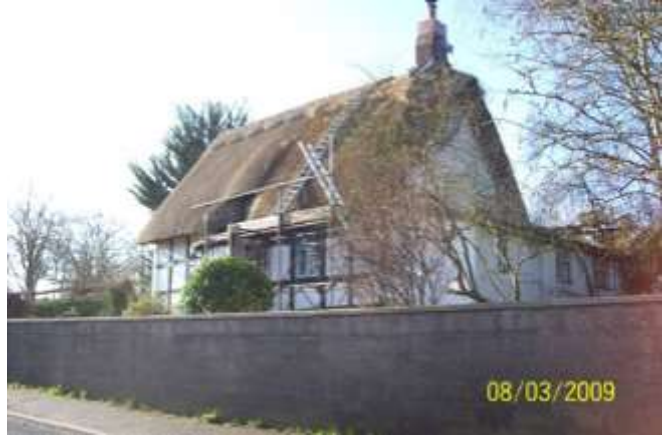
*Undergoing rethatching of the roof 2009*

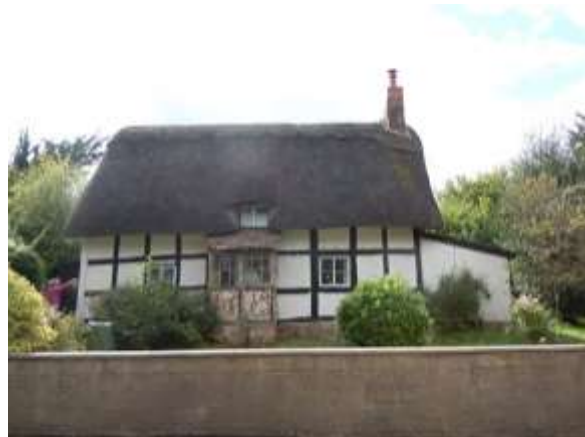
Ivy House was inspected on 11th September 2017 and was found to be in a good state of repair externally. There was no access internally, but the owner confirmed it was in a good state of repair which I have no reason to doubt. The owner confirmed that it was re-thatched in 2008 and appears to be to a good standard and can now be taken off the buildings at risk register.

*Ivy House front elevation in 2017*

Whilst the porch requires attention the house as a whole is in good overall condition and therefore no longer at risk and can be removed– another success story.

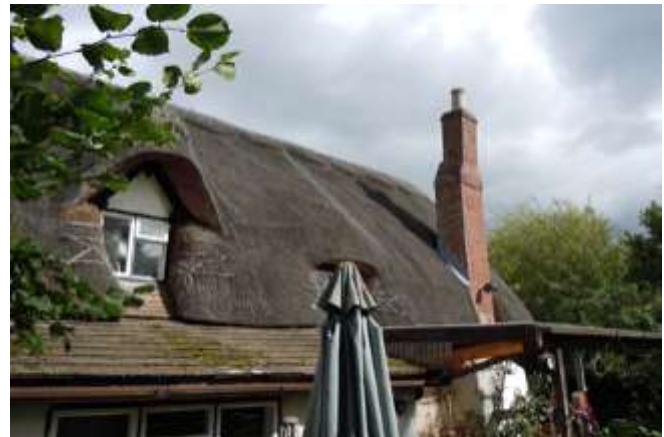
*Rear elevation 2017*

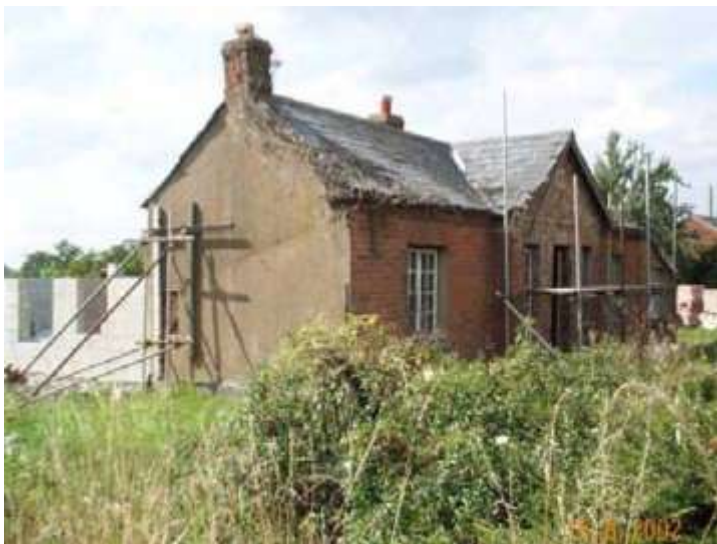
In March 2006 the barn was recorded as being in risk category 4 and was in poor condition.

Long Course was inspected on 11th September 2017 and it was obvious that the building has been subject to extensive repair works since the last inspection in 2006 and is now in a good state of repair. The owners were out at the time of the inspection and there was no access internally.

The building can now be taken off the buildings at risk register.

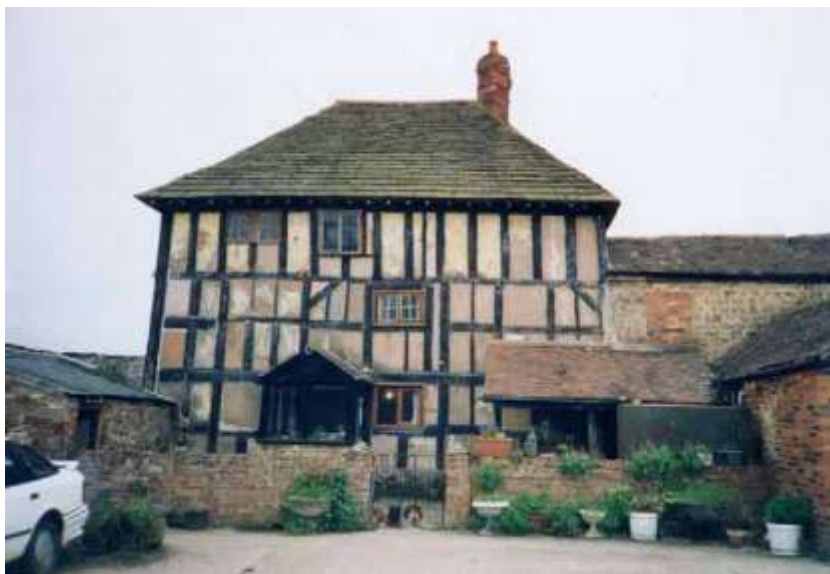
2006

**Farm House-** The building was completely repaired and restored in 2012 to a very high standard and is a credit to the owners, who used an agent and builders who were experienced in carrying out works to listed buildings.

The farmhouse is in a good state of repair should be taken off the buildings at risk register.

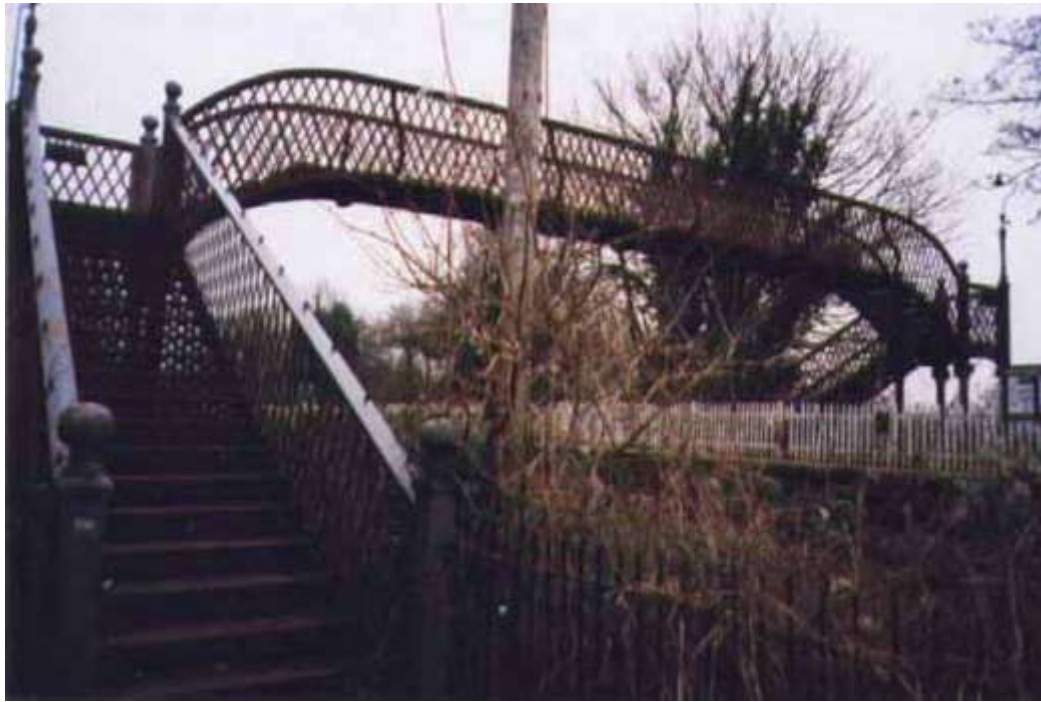
2006

In March 2006, the foot bridge was recorded as a risk category 4 and required a thorough maintenance programme, including structural strengthening, rust removal and repainting. The condition deteriorated and Forest of Dean Building Control served a dangerous structures notice as the bridge was reported to be unsafe, and it was cordoned off with danger keep out signs to prevent any access - which were still in place at the time of the initial inspection.

However, since that time, it has been undergoing renovation, including being repaired/strengthened, overhauled and repainted by a specialist. The footbridge has been fully restored and put back in place since 2018.

Whilst this structure has been restored, owing to its vulnerability of vandalism, it is considered reasonable that the structure remains on the buildings at risk register (as low risk) for the time being so that its condition can be monitored.

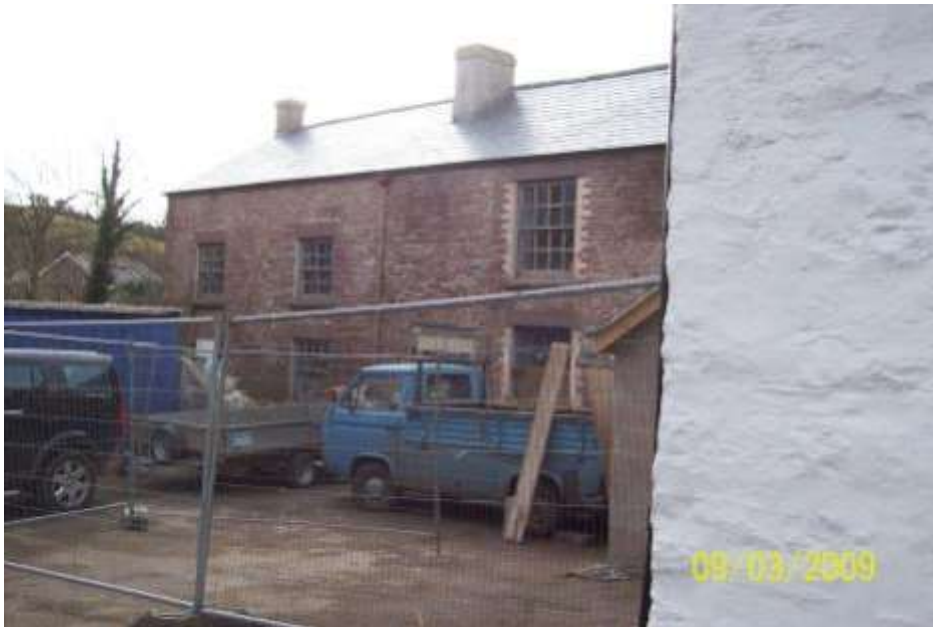
*Renovation underway in 2009*

In March 2006, the building was recorded as a risk category 4, it had ceased to operate as a public house, was partially occupied, was in a state of decay including slipped roof tiles, damaged windows and was at risk. The building was up for auction on 2/2/2006.

Since then the building has been brought back into a good condition and is now occupied.

This building is in a good state of repair and should be taken off the buildings at risk register.
