**Condition Appraisal  
Of  
Listed Buildings at Risk  
In  
Forest of Dean District Council Area  
For Forward Planning**

Survey carried out by Tony Gwynne & Samm Jarman

Survey Date: 2017-2018

Published: July 2019

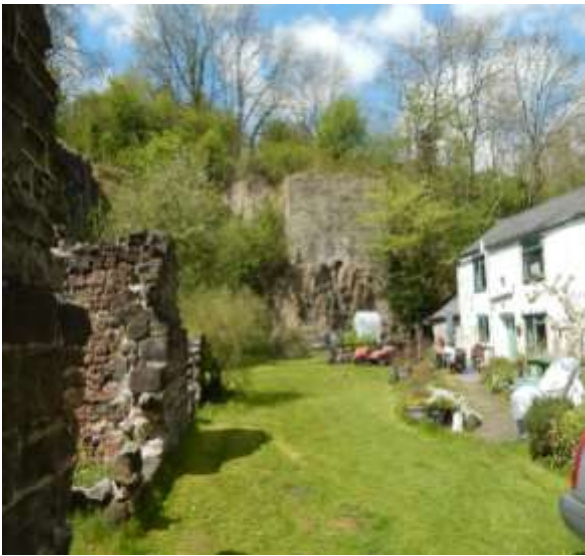
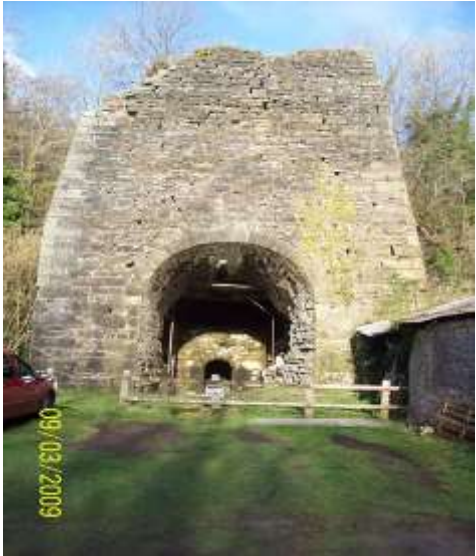
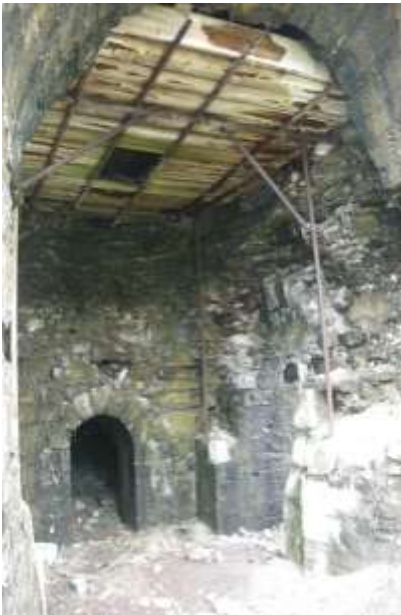
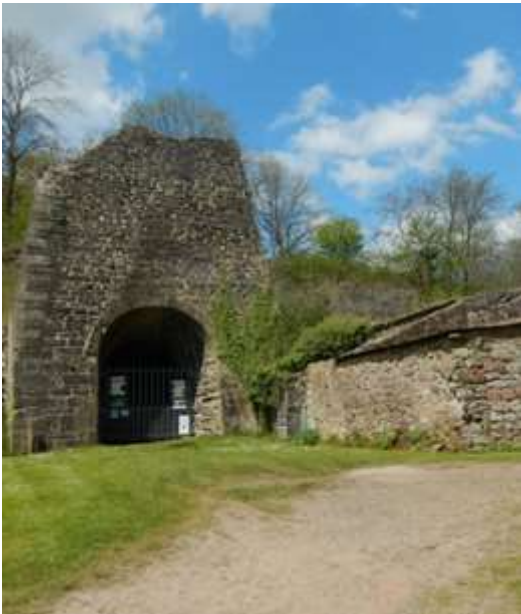
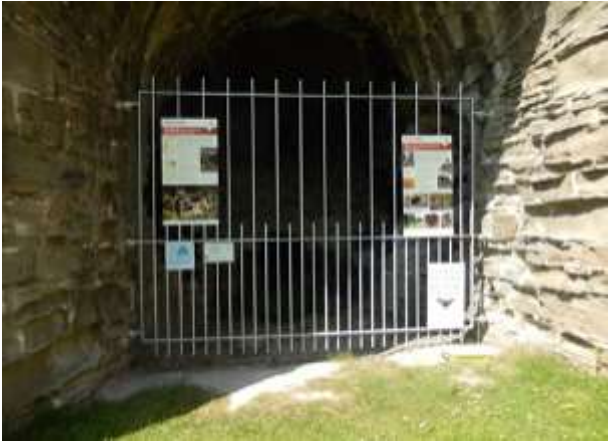
In March 2006 the building was reported in the buildings at risk register as risk category 4. Since then, The FoDBPT has acquired ownership of the site and has carried out repairs and consolidation works to the main furnace which is now in a good state of repair. Further works are necessary to the engine house and cottage. This project is ongoing and expected to be completed within the next 5 years.
